Assessment of Facilities

Conference Center

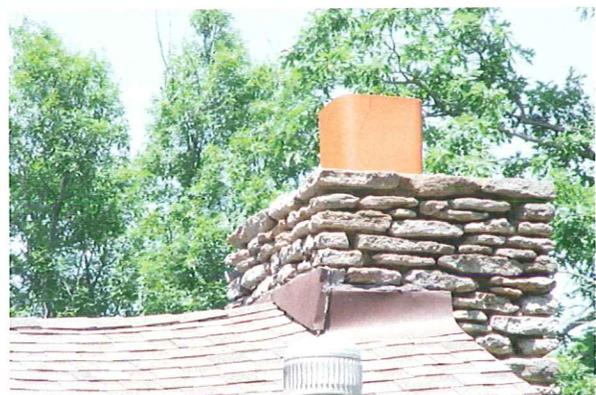
Fig. 1

- The ceiling of the north bunk room at the 2nd floor is showing a sign of failure as it is clearly visible that the ceiling is sagging down approximately 2" from its original position. Further inspection noted that the roof rafters are failing and it is very noticeable at the exterior of the building at the stone chimney. (See Fig. 1)

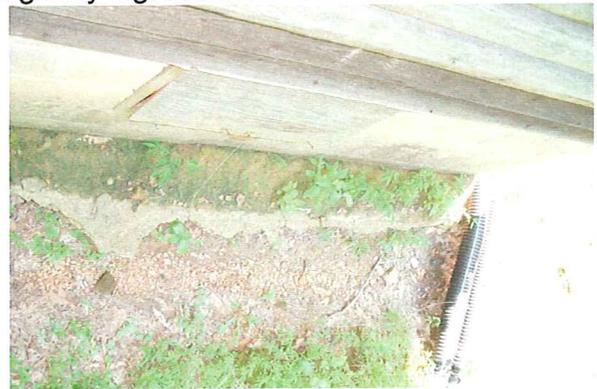
Fig. 2

- All interior exit doors need to be equipped with exit lights and emergency lighting.
- All exterior doors need to be equipped with emergency lighting.
- Presently there is only one means of emergency egress from the second floor. The building code requires two means of emergency egress.
- The smoke alarms in the building are stand alone battery type and need to be replaced.
- The concrete footing of the building in the southwest corner is exposed and there are signs of undermining and erosion in this area. (See Fig. 2)

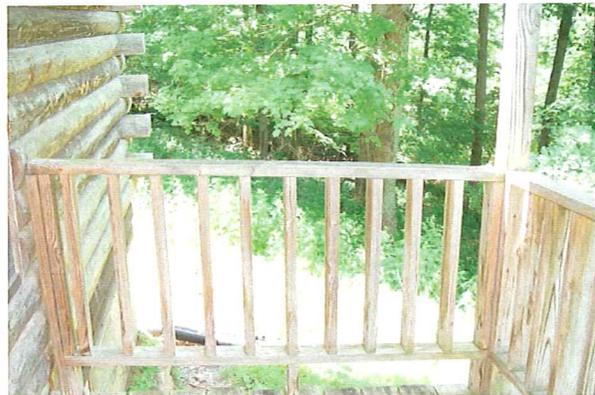
Fig. 3

- All of the furniture in the building will need to be disposed of due to mold growth and odors that have permeated the fabric.
- All exposed surfaces will need to be cleaned thoroughly.
- The porches on the west side of the building are sagging at the southwest corner at the outer edge. This is a result of the settlement of the concrete footing on which the porch post rests. (See Fig. 3)
- The porch railing is currently at 36" above the finish porch level. The building code requires that the railing be at least 42" above the finish porch level.
- The railing at the elevated walkway is currently at 36" above the finish walk level. The building code requires that the railing be at least 42" above the finish walkway level.

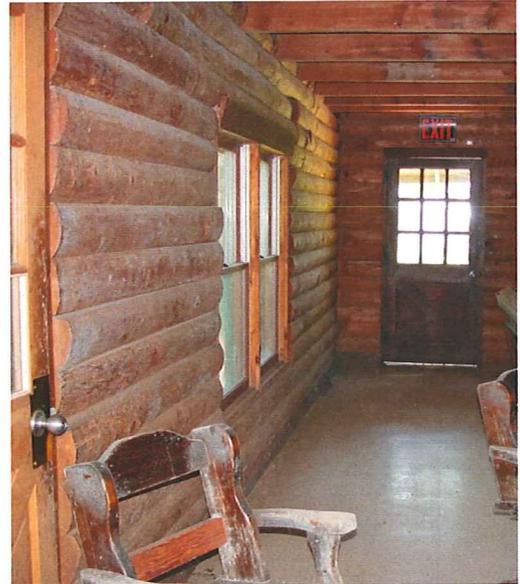
Fig. 4

- All exterior doors do not seal tight against the frames and do not close properly. (See Fig. 4)

- The log walls on the 1st floor level appear to be coated with mold in several areas. This needs to be cleaned thoroughly. (See Fig. 4)
- The site immediately around the Cabin needs to be cleaned up.
- The existing sanitary septic system needs to be investigated further to determine if it is still functional.
- The building is not accessible to disabled persons and does not meet current ADAAG accessibility requirements.
- The entire building has a persistent musty/mold odor that has been caused by the mold growth and lack of use. Additionally, the crawl space under the first floor has been sealed up preventing the free movement of ventilation air. This also causes odors that will be difficult to eliminate, if even possible.
