*Facility Assessment
Report & Recommendations*

Renovation of the Capital Plaza Complex

Frankfort, Kentucky

January 16, 2008

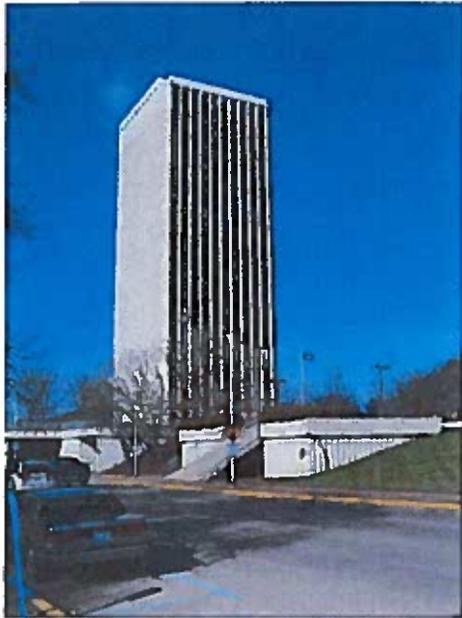
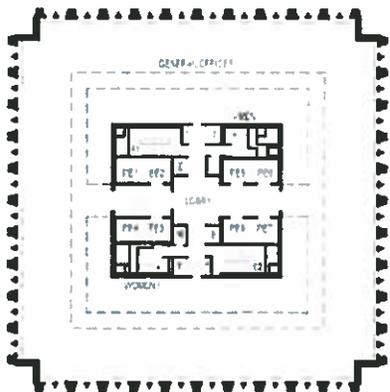
The Capital Plaza Office Tower scored a total of 35.1 out of a possible maximum of 100 points. This score means that this facility requires major remodeling with costs exceeding 50% of the replacement cost. This score, being very low in its category, is near the score that would classify this facility as unsatisfactory and requiring replacement.

- Repair exterior concrete skin.
- Replace curtainwall system and glass.
- Replace existing escalators.
- Rework typical office floor restrooms into accessible facilities.

- Upgrade stairwells.
- New cabs in elevators.
- Replace existing roof.
- Replace window washing equipment.
- Remove existing office partition system.
- Provide new plumbing soil, waste and vent piping.

- Replace offsite cooling tower.
- Replace HVAC equipment on each floor.
- Replace HVAC equipment on mechanical floors.
- Clean and seal existing upper floor ductwork.

- Provide new light fixtures, data, and electrical service
- Upgrade existing sprinkler system to include perimeter offices.
- Upgrade building access control, emergency communication systems.

- List of code deficiencies:
 - Non compliance with seismic design requirements
 - Inadequate accessibility to restrooms, exit doors
 - Firestopping systems at thru-wall penetrations

- Exit signs
 - Lack of complete fire-protection and fire alarm systems
 - Non-compliance with energy code
- List of functional deficiencies:
 - Limited flexibility of floor plan layout and existing modular partition system

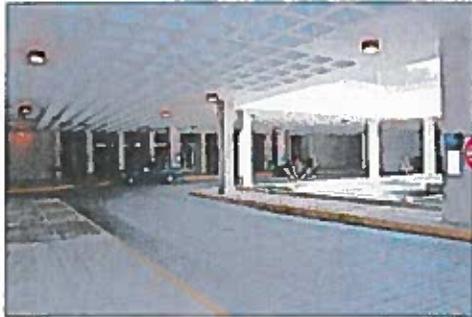
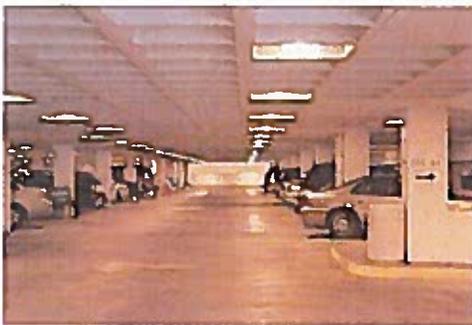
The overall structural condition of the garage is good, however the deterioration noted during our field investigation combined with the results of the chloride testing is indicative of a growing threat to the structure over the long term.

The investigation showed that the garage requires major modernization costing between 25-50 percent of replacement costs.

- The concrete is showing considerable spalling and delamination.
- Chloride levels are sufficient to support corrosion.
- Precast fins are deteriorating.
- Drainage and ponding are an issue.
- Inadequate stormwater drainage system.
- Lighting does not meet current recommended levels.
- Stairs do not meet code.
- Pedestrian and vehicular wayfinding needs to be improved.
- Spalling of waffle slabs/joist/beams needs to be repaired.

We suggest implementing a repair program coupled with installation of an overlay topping to stop the deterioration.

- Provide concrete overlay to restore concrete structure of garage (\$7,915,000) and achieve better drainage and lower maintenance over 20 year life.
- Remove and replace all plaza wearing surface with new design (\$23,635,000).

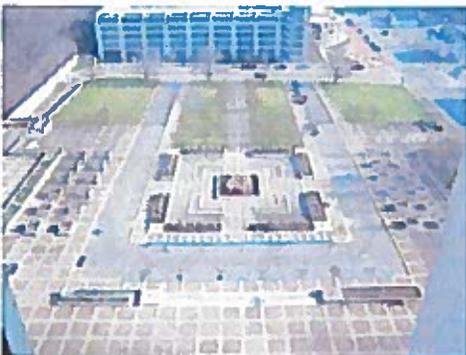
PLAZA: The Plaza requires major remodeling with costs exceeding 50% of the total replacement cost. The low assessment score of 36.1 almost classifies the plaza as unsatisfactory and requiring replacement.

- Corrosion damage to slab edges affects 15-20 percent of plaza.
- 30-40 percent of joints are wider than code allows.
- Majority of expansion joints have failed.
- Concrete pedestals have failed.
- Structural wearing slab is deteriorating.
- 20% of the Tower Plaza driveway has disintegrated.

- Flashing and membrane at planters are beyond useful life.
- There are accessibility issues throughout the Plaza.

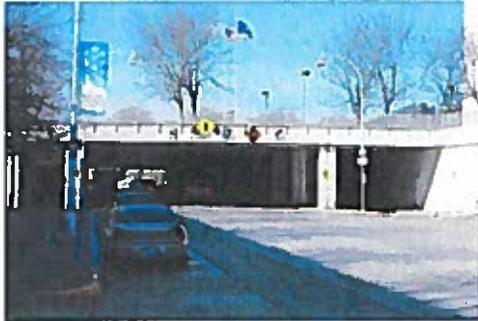
Both Plazas require major remodeling with costs exceeding 50% of the total replacement cost. The low assessment score of these plazas almost classifies them as unsatisfactory and requiring replacement.

- Corrosion damage to slab edges affects 15-20 percent of plaza.
- 30-40 percent of joints are wider than code allows.
- Majority of expansion joints have failed.
- Concrete pedestals have failed.
- Structural wearing slab is deteriorating.
- Flashing and membrane at planters are beyond useful life.
- There are accessibility issues throughout the Plaza.

- Remove and replace all plaza wearing surface with new design.

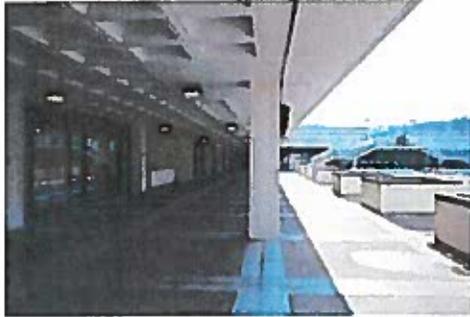
SHOPS: The shops and offices require major remodeling with the estimated cost exceeding 50% of the replacement cost. The evaluation score is 39.7 and is near the score that would classify these areas as unsatisfactory and requiring replacement.

- Replace all store front systems.
- Repair and provide new accessible restrooms.
- Provide new finishes throughout.
- Provide a new HVAC and control system.
- Replace the electrical distribution system.
- Replace lighting, fire alarms, and electrical distribution systems.

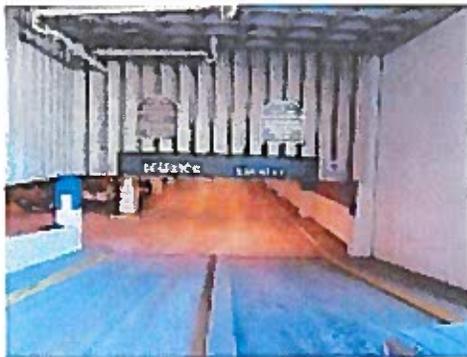
The overall structural condition of the garage is good, however the deterioration noted during our field investigation combined with the results of the chloride testing is indicative of a growing threat to the structure over the long term.

The investigation showed that the garage requires major modernization costing between 25-50 percent of replacement costs.

- The concrete is showing considerable spalling and delamination.
- Chloride levels are sufficient to support corrosion.
- Precast fins are deteriorating.
- Drainage and ponding are an issue.
- Inadequate stormwater drainage system.
- Lighting does not meet current recommended levels.
- Stairs do not meet code.

- Pedestrian and vehicular wayfinding needs to be improved.
- Spalling of waffle slabs/joist/beams needs to be repaired.

We suggest implementing a repair program coupled with installation of a protective overlay topping to stop the deterioration.

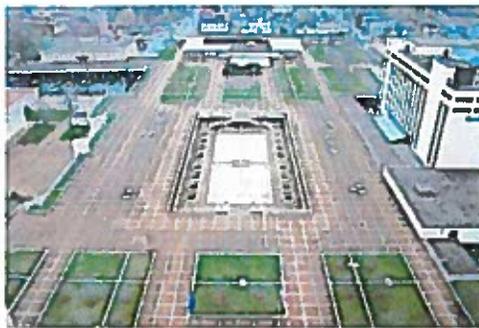
PLAZA: The Plaza requires major remodeling with costs exceeding 50% of the total replacement cost. The low assessment score almost classifies these plazas as unsatisfactory and requiring replacement.

- Corrosion damage to slab edges affects 15-20 percent of plaza.
- 30-40 percent of joints are wider than code allows.
- Majority of expansion joints have failed.
- Concrete pedestals have failed.
- Structural wearing slab is deteriorating.
- Flashing and membrane at planters are beyond useful life.
- There are accessibility issues throughout the Plaza.
- The tree planters are no longer functional and near the end of their useful service life.

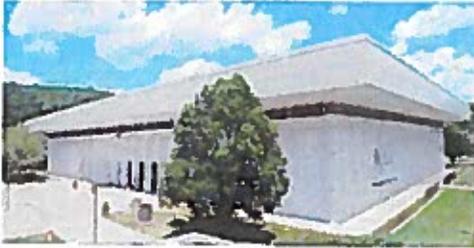
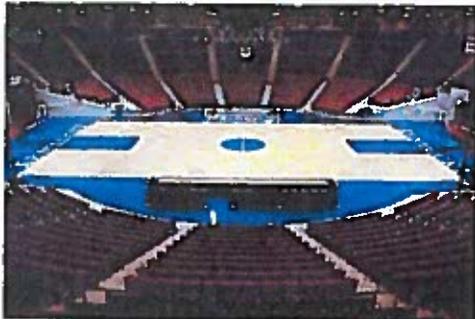
The Frankfort Convention Center scored a total of 51.9 out of a possible maximum of 100 points. This score means this facility required major remodeling with costs exceeding 50% of the replacement cost.

- Finishes are worn and dated.
- No sprinkler system in the building.
- HVAC and electric are at end of useful life.
- Hot water heating is from the Office Tower.
- Outdated fire alarm, data, voice, A/V system.
- List of code deficiencies:
 - Ramps serving the upper concourse are non-compliant
 - No toilets on concourse level
 - No smoke evacuation system
 - Seating aisles width and guardrails do not meet current code.
 - Inadequate accessibility to restrooms, ramps, locker rooms and upper level
 - No elevators
- List of functional deficiencies:
 - Exhibit Hall needs to be larger
 - Inadequate size prefunction space
 - Limited breakout space
 - Lack of upper concourse concessions and restrooms
 - Kitchen facilities are inadequate
 - Lack of storage rooms.

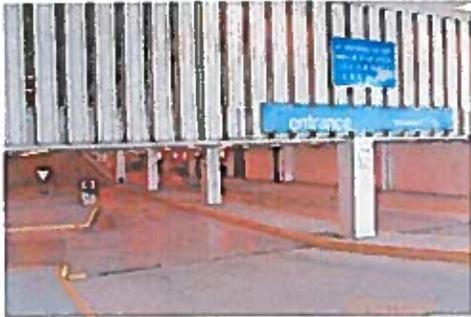
The overall structural condition of the garage is good, however the deterioration noted during our field investigation combined with the results of the chloride testing is indicative of a growing threat to the structure over the long term.

The investigation showed that the garage requires major modernization costing between 25-50 percent of replacement costs.

- The concrete is showing considerable spalling and delamination.
- Chloride levels are sufficient to support corrosion.
- Precast fins are deteriorating.
- Drainage and ponding are an issue.
- Inadequate stormwater drainage system.
- Lighting does not meet current recommended levels.
- Stairs do not meet code.
- Pedestrian and vehicular wayfinding needs to be improved.
- Spalling of waffle slabs/joist/beams needs to be repaired.

We suggest implementing a repair program coupled with installation of an overlay topping to stop the deterioration.

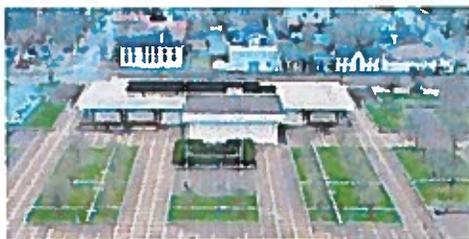
PLAZA: The Plaza requires major remodeling with costs exceeding 50% of the total replacement cost. The low assessment score almost classifies this plaza as unsatisfactory and requiring replacement.

- Corrosion damage to slab edges affects 15-20 percent of plaza.
- 30-40 percent of joints are wider than code allows.
- Majority of expansion joints have failed.
- Concrete pedestals have failed.
- Structural wearing slab is deteriorating.
- Flashing and membrane at planters are beyond useful life.
- There are accessibility issues throughout the Plaza.
