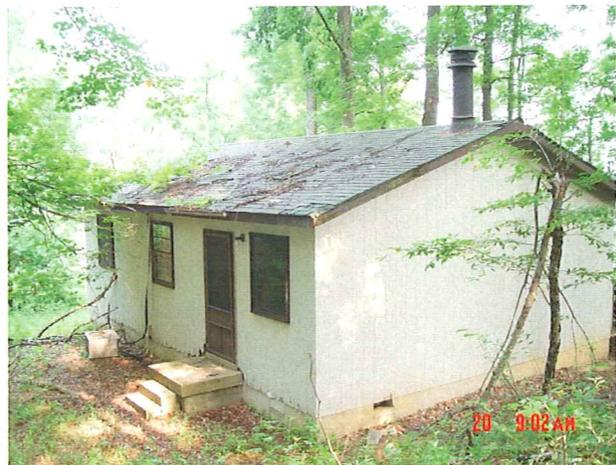
Cabin 5 is located in a more secluded area of the Park east of Cabins 3A-C. This Cabin is identical to Cabins 1 & 2 with regards to the size and floor plan layout. However, this Cabin is not equipped with a stone fireplace. The fireplace in this unit is a metal firebox with a metal chimney. The unit has deteriorated from lack of use and maintenance as well as the perpetual influences of Mother Nature. The condition of the Cabin is rated as poor to fair.

- The roof needs to be replaced and has reached the end of it effective life. Moss is currently growing on areas of the roof.
- The north east corner of the roof is damaged due to decay and the fascia boards at the eave are in

need of replacement. The roof decking in this area as well will need to be replaced.

- The original placement of the Cabin is such that it was placed on what can only be surmised as earth fill. The Cabin foundation is showing signs of differential settlement as a result of inconsistent earth compaction at the time of its construction. The earth at the northwest corner of the Cabin has eroded away to the point where the bottom of the concrete footing is exposed. The concrete masonry foundation wall is cracked in many areas around the building.

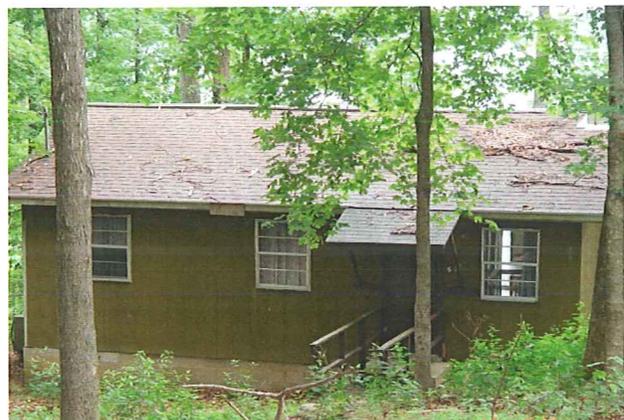
Cabin 6 is located in a secluded area northeast of Cabin 5. This Cabin is identical to Cabins 1 & 2 with regards to the size and floor plan layout. However, this Cabin is not equipped with a stone fireplace. The fireplace in this unit is a metal firebox with a metal chimney. The unit has deteriorated from lack of use and maintenance as well as the perpetual influences of Mother Nature. The condition of the Cabin is rated as poor to fair.

- The roof needs to be replaced and has reached the end of its effective life. Moss is currently growing on areas of the roof.
- The original placement of the Cabin is such that it was placed on what can only be surmised as earth fill. The Cabin foundation is showing signs of differential settlement as a result of inconsistent earth compaction at the time of its construction. The earth at the northwest corner of the Cabin has eroded away to the point where the bottom of the concrete footing is exposed. The concrete masonry foundation wall is cracked in many areas around the building.

- The plywood siding is decaying at the bottom edges due to prolonged exposure to rain water that has splashed onto the siding.
- All of the furnishings need to be discarded. The persistent odor has permeated the fabric of the furniture and bedding to the point where it will have to be replaced.

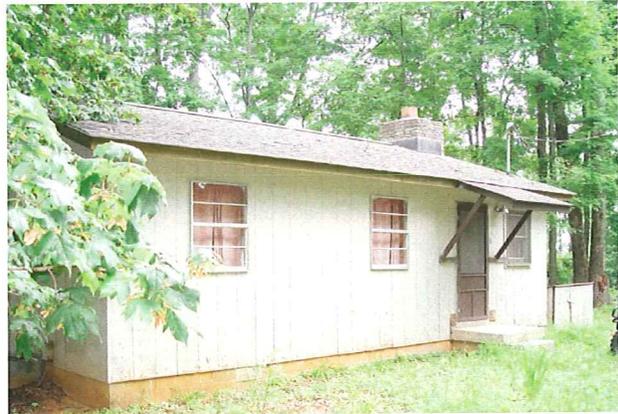
Cabin 7 is located in a secluded area immediately adjacent to Cabin 6. This Cabin is identical to Cabins 1 & 2 with regards to the size and floor plan layout. The unit has deteriorated from lack of use and maintenance as well as the perpetual influences of Mother Nature. The condition of the Cabin is rated as poor to fair.

- The roof needs to be replaced and has reached the end of its effective life. Moss is currently growing on areas of the roof.
- The original placement of the Cabin is such that it was placed on what can only be surmised as earth fill. The Cabin foundation is showing signs of differential settlement as a result of inconsistent earth compaction at the time of its construction. The earth at the northwest corner of the Cabin has eroded away to the point where the bottom of the concrete footing is exposed. The concrete masonry foundation wall is cracked in many areas around the building.

- The plywood siding is decaying at the bottom edges due to prolonged exposure to rain water that has splashed onto the siding.
- All of the furnishings need to be discarded. The persistent odor has permeated the fabric of the furniture and bedding to the point where it will have to be replaced.

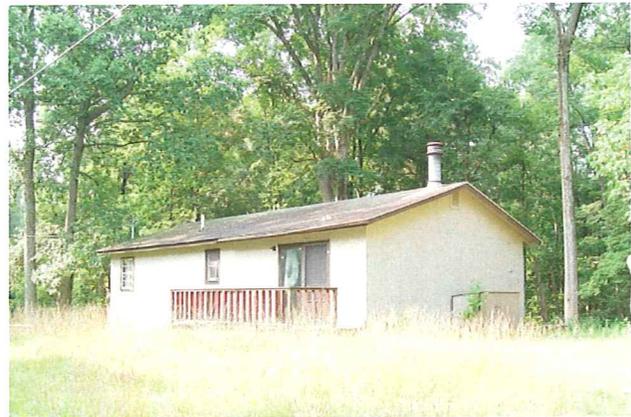
Cabin 9 is situated next to Cabin 10 and is within walking distance of the Van Buren Cabin and Cabins 3 A-3C. Cabins 9 and 10 are identical with the exception of the reverse layout of Cabin 10. Presently, Cabin 9 is in poor condition due to lack of maintenance and decay. The roof of Cabin 9 has decayed to the point that water pours freely into the living area of the building when it rains.

- All of the screens are in poor condition and will need to be replaced.
- A portion of the ceiling in the living area has collapsed due to water infiltration and needs repair.

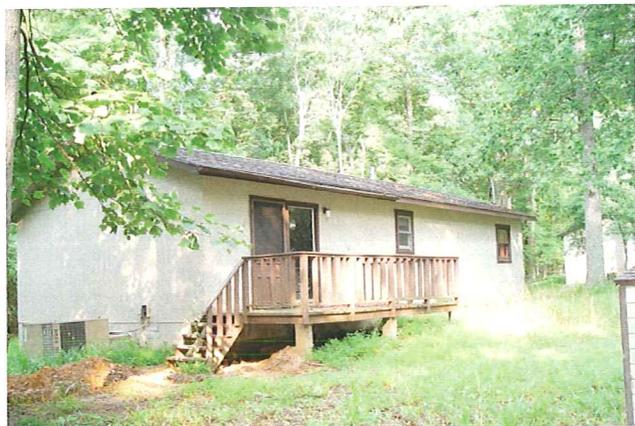
Cabin 10 is situated east of the Van Buren Cabin and south of Cabins 3A-3C, all within walking distance of each other. Cabins 9 and 10 are identical with the exception of the reverse layout of Cabin 9. Presently, Cabin 10 is in poor condition due to lack of maintenance and decay.

- All of the furniture in the building will need to be disposed of due to the mold growth on all of the fabric.
- All of the wood paneled walls in the building are covered with mold. Further investigation will need to be undertaken to determine the full extent of the mold problem.

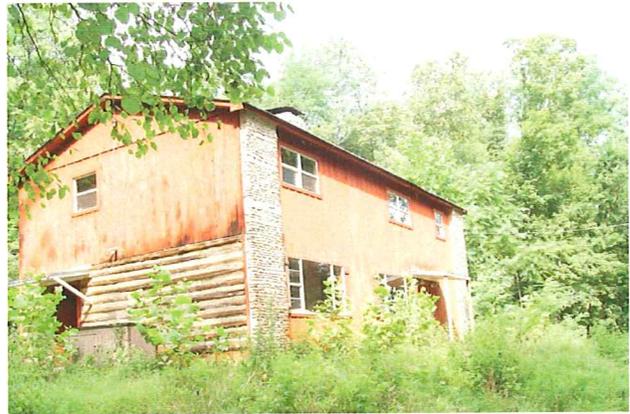
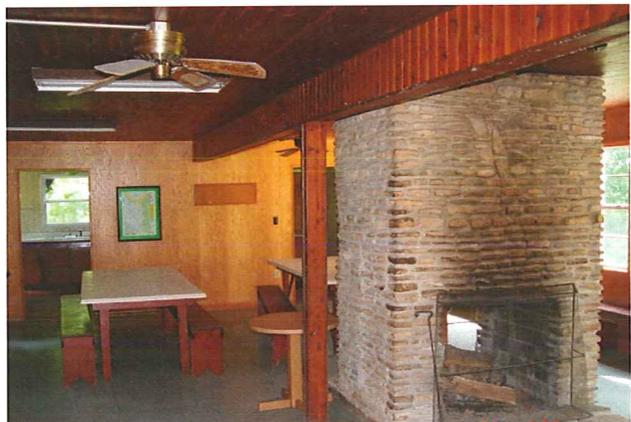
Haven Hill Cabin is located east of the Conference Center approximately 300 yards. It is a two-story building constructed of wood framed and log walls. Each floor has approximately 1188 gross square feet for a total area of 2376 gross square feet. The lower level contains a large living area and dining area with a dual sided fireplace which separates the living area from the dining area. Off of the dining area at the west end of the building is a kitchen. At the northwest and southeast corners of the building are stairways leading to the second floor. The second floor contains three bedrooms and two bathrooms. The building is capable of housing large groups of people. Each of the bedrooms is equipped with bunk beds with a total sleeping capacity of approximately 22 persons. This building is in good condition and there is no reason not to continue on with its use .A review of the building found the following issues that need to be addressed:

- The majority areas of the exterior walls are constructed of vertical board and batten system most likely of red cedar. These walls are in relatively good condition and can be refinished and repaired without much effort.
- The log wall which is confined to the east lower level in good condition and will only need minor repairs.
- The main support beam extends down the center of the building. Near the chimney there is a noticeable sag in
