# **Asbestos Containing Materials Inspection**

**Capital Plaza Office Tower  
500 Mero Street  
Frankfort, Kentucky**

RE: Asbestos Inspection  
Capital Plaza Office Tower  
500 Mero Street  
Frankfort, KY 40601

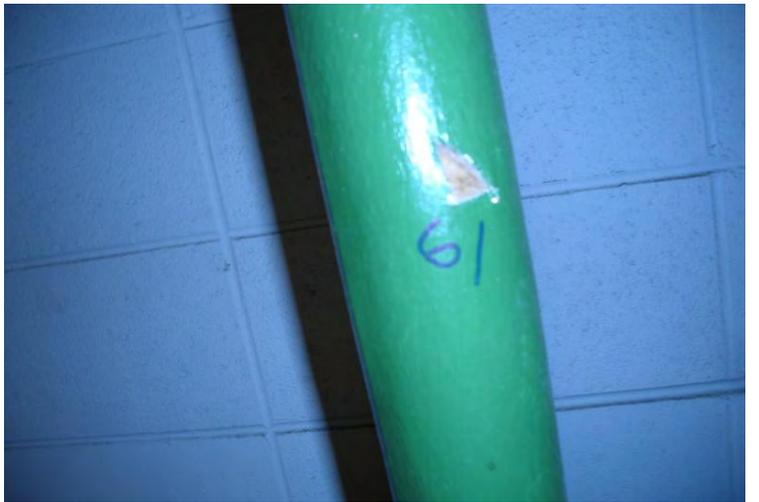
Sample 61  
Pipe wrap  
Ground floor

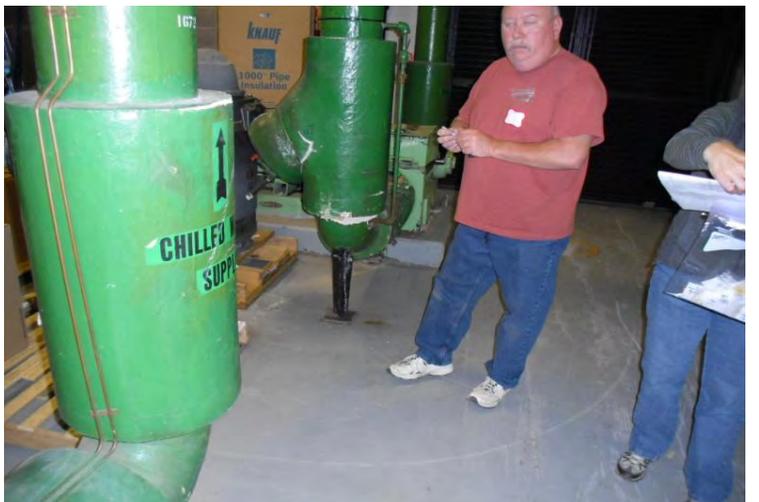
Sample 81  
Valve wrap  
Mechanical Room

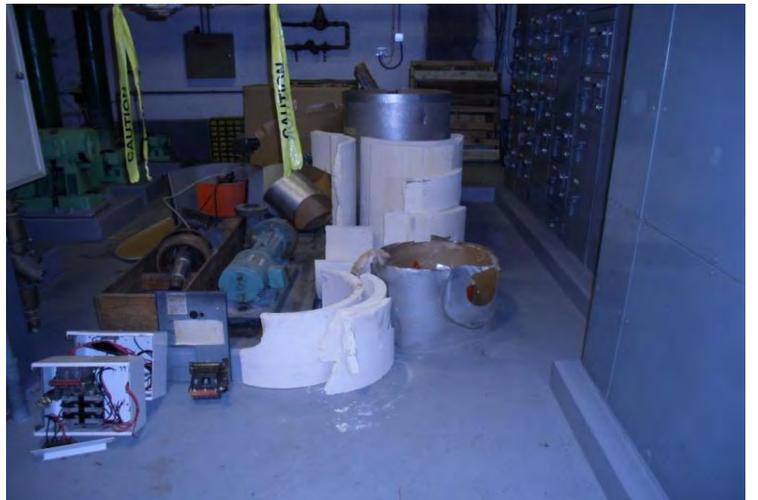
Sample 85  
Loose thermal  
Mechanical Room

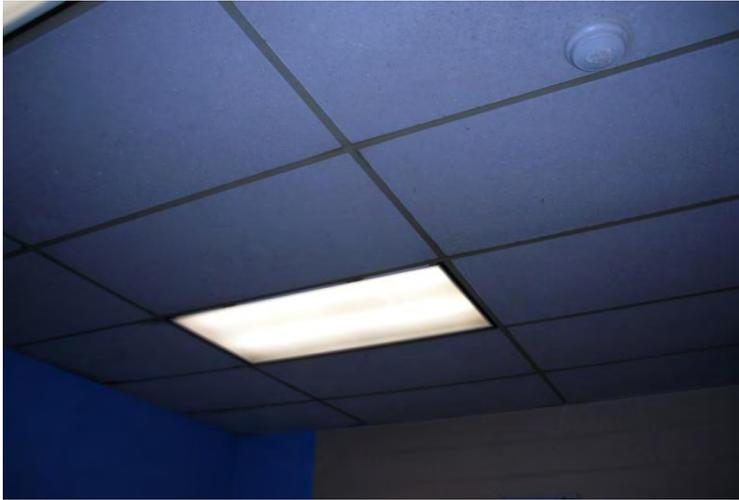
Sample 86  
Ceiling tile  
Ground floor

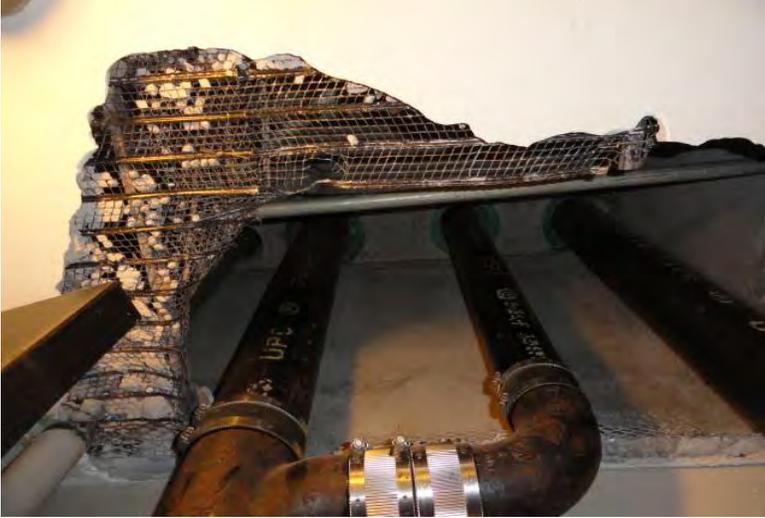
Sample 98  
Ceiling plaster  
Floor 1

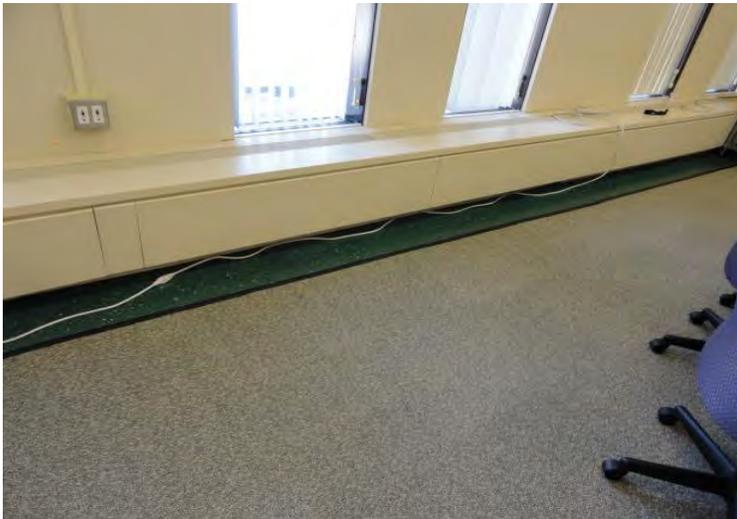
Sample 100  
Floor tile - 12 inch  
Floor 1

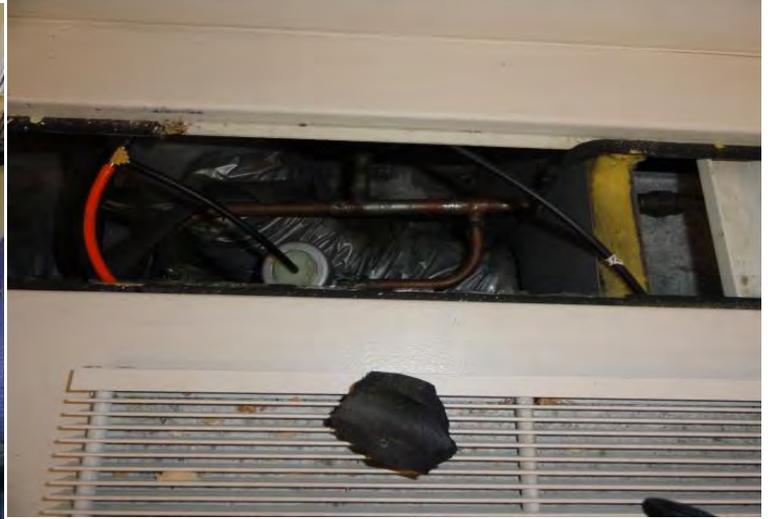
Sample 101  
Water unit insulation  
Floor 1

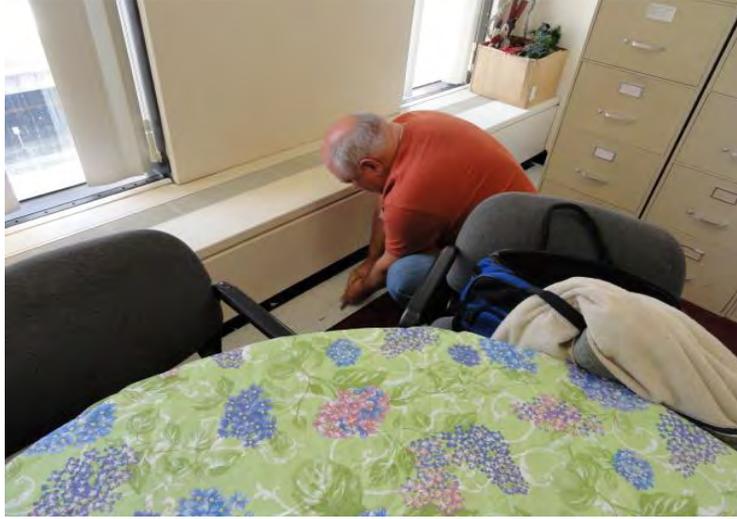
Sample 102  
Floor tile - 12 inch  
Floor 2

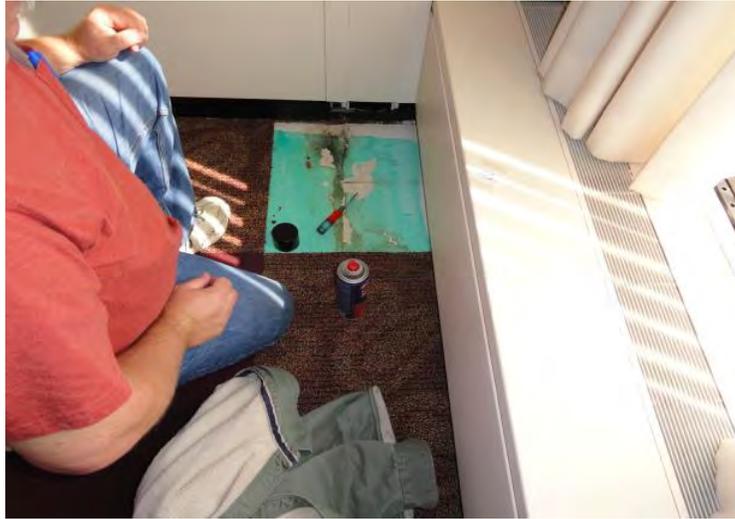
Sample 105  
Floor tile covered with carpet  
Floor 5

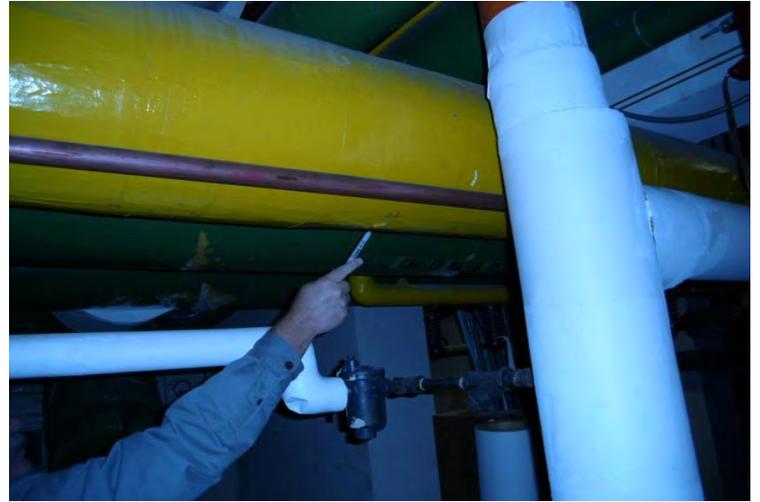
Sample 22  
Pipe wrap  
Floor 13A

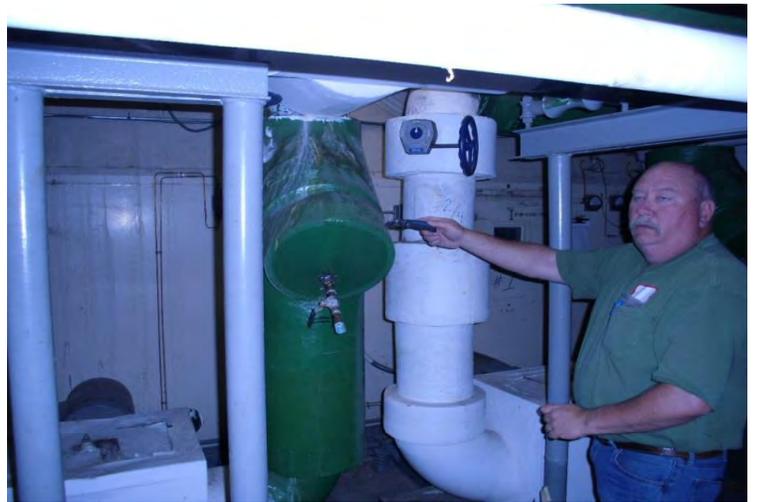
Sample 30  
Pipe wrap  
Floor 13A

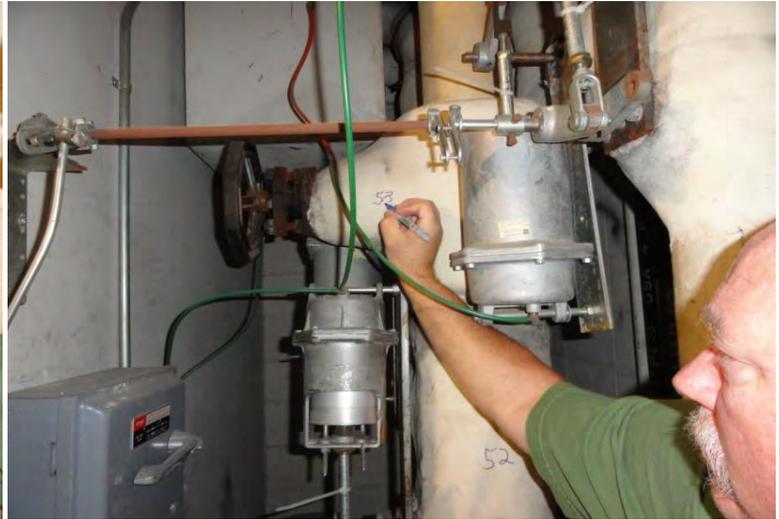
Sample 53  
Pipe Wrap on valve  
Floor 13B

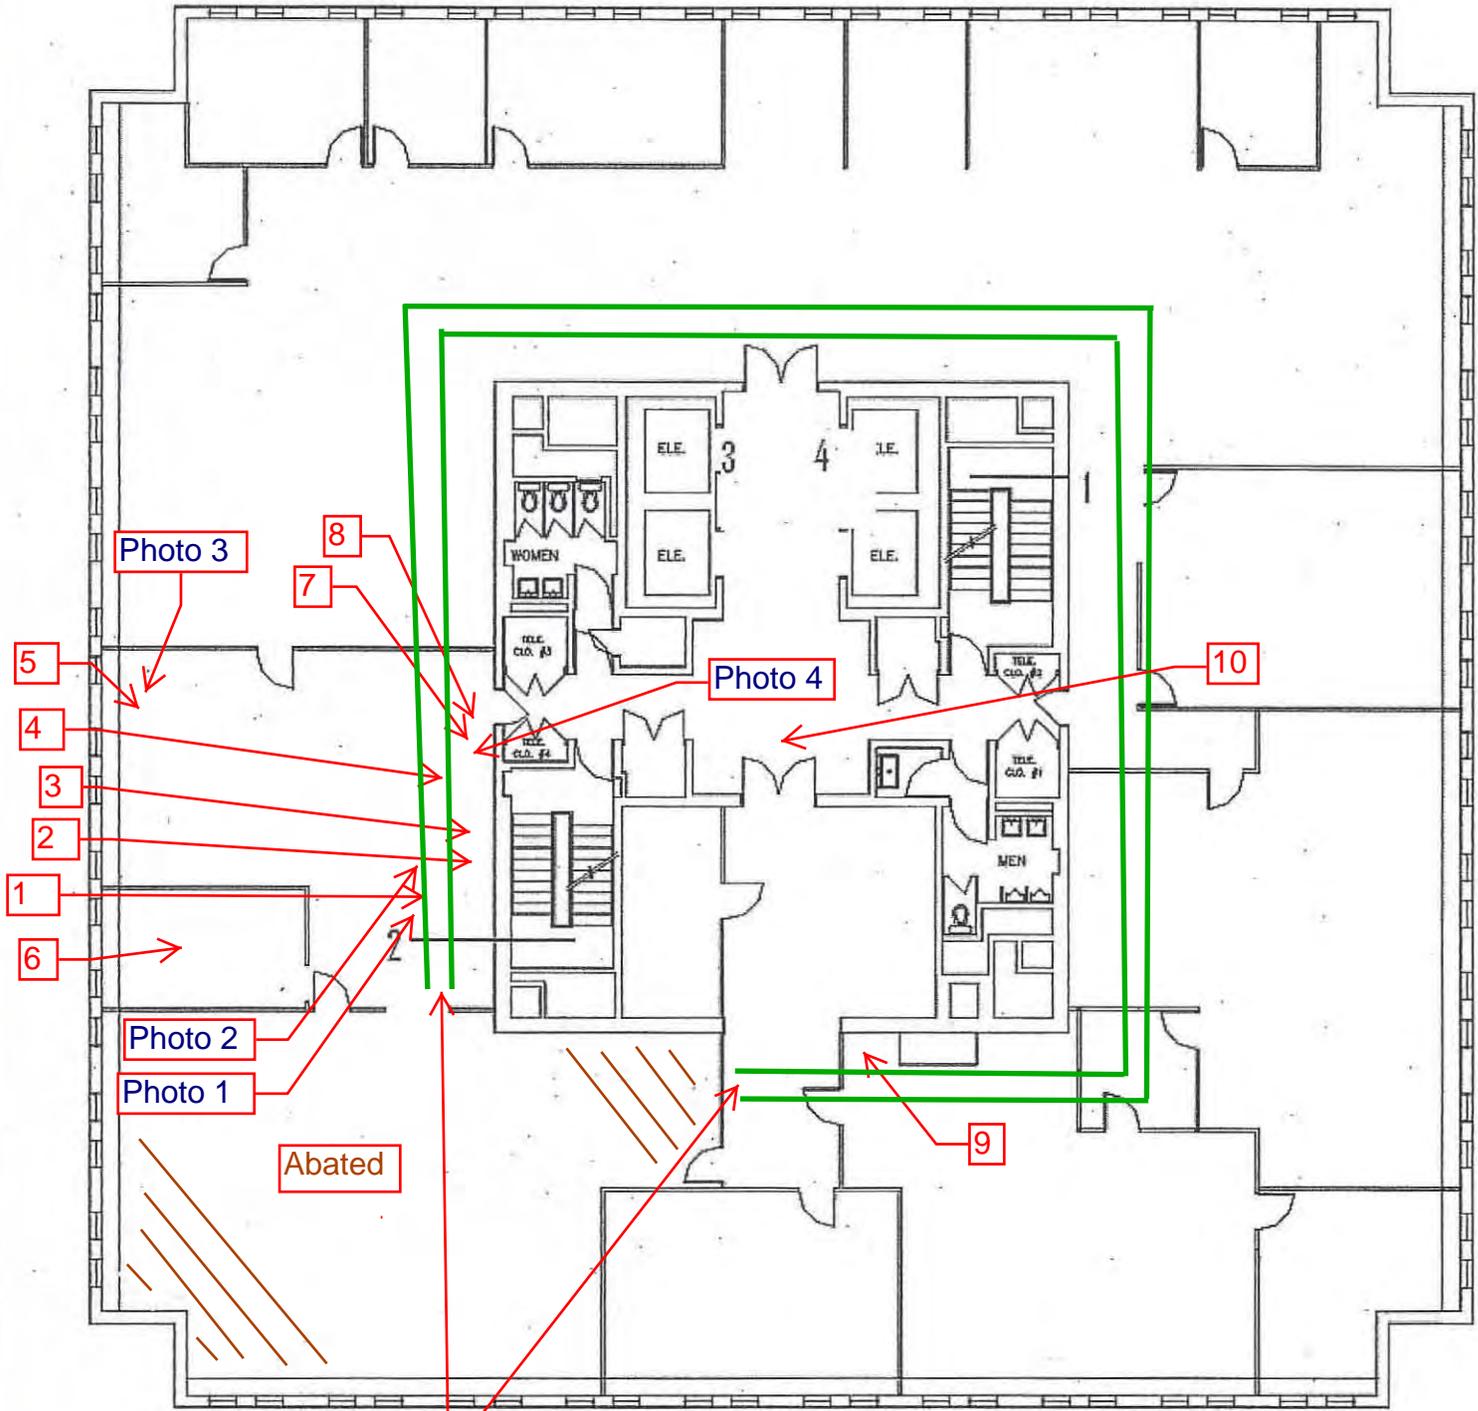
14th FLOOR

Two - 1.5 inch copper pipes with asbestos containing insulation - approximately 300 linear feet
