CPT Replacement Facility - Pass / Fail Evaluation Demolition and New Development

Selection Committee Evaluation

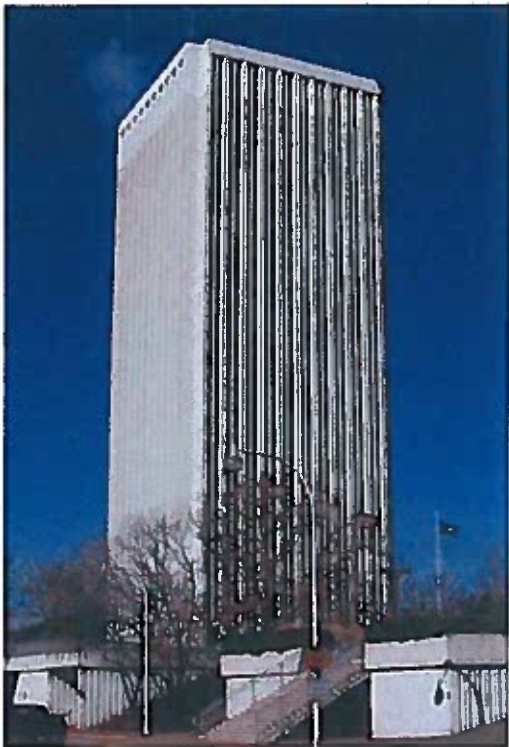
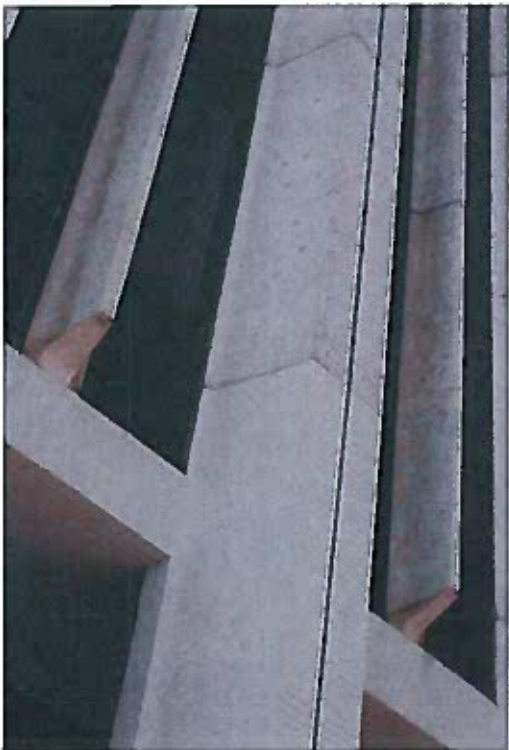
This Section describes field observed deficiencies, which are related to the structure and building envelope.

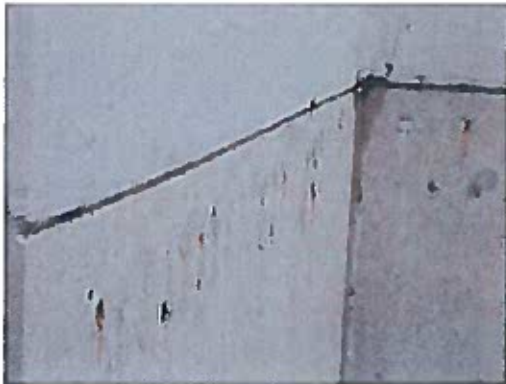
Spalls at Post-Tensioning Anchors

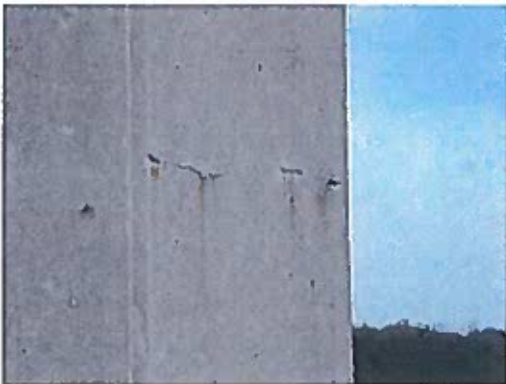
Shallow Concrete Cover.

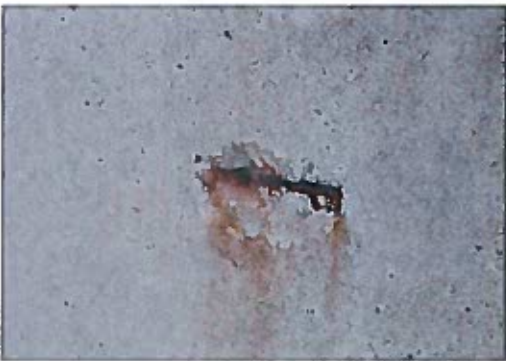
Corrosion Induced Spalls

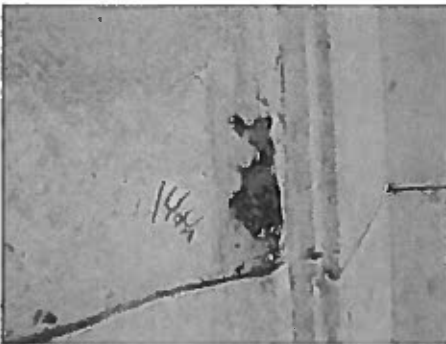
Spalls of Poor Concrete Consolidation.

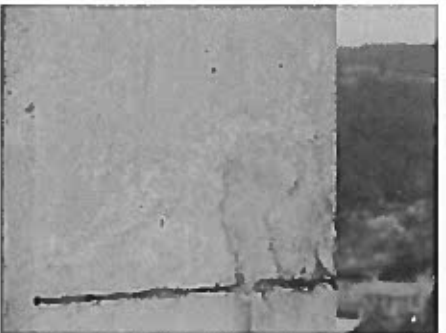
Existing Concrete Patches

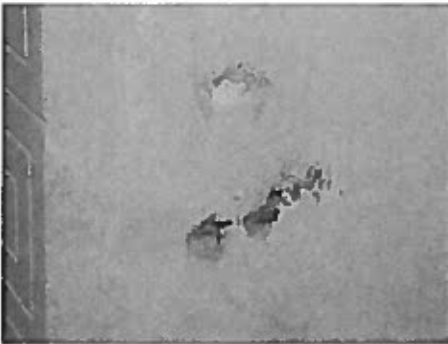
Corrosion Induced Spalls

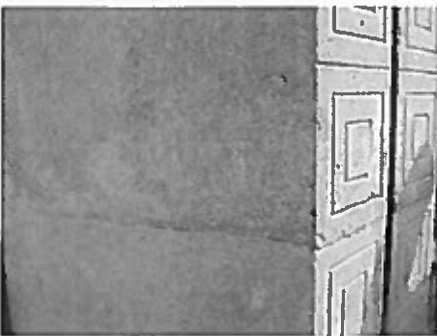
Poor Concrete Consolidation

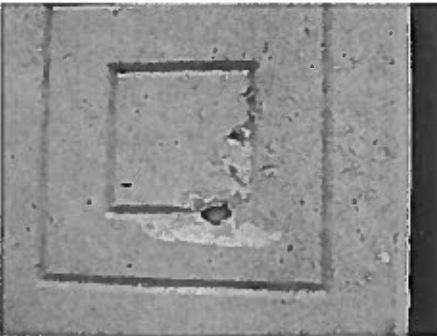
Spalls at Poor Concrete Consolidation

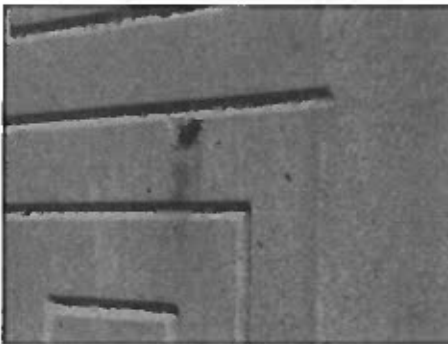
Existing Concrete Patches

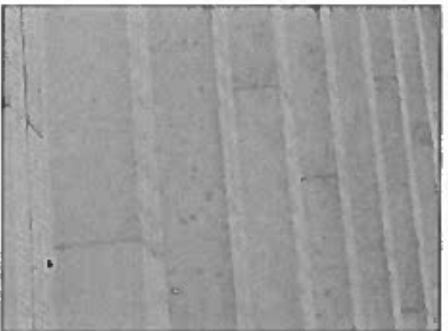
Small Isolated Concrete Patches

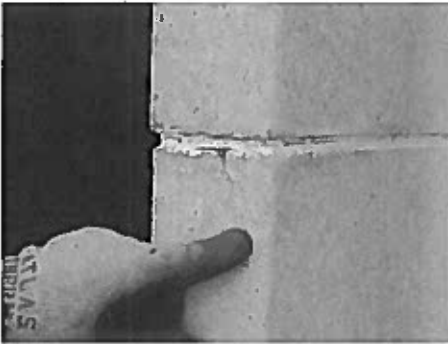
Cracks Within Precast Units

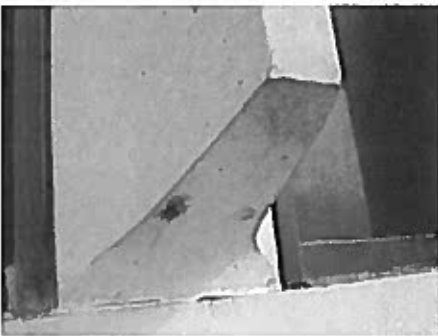
Corrosion Induced Spalls

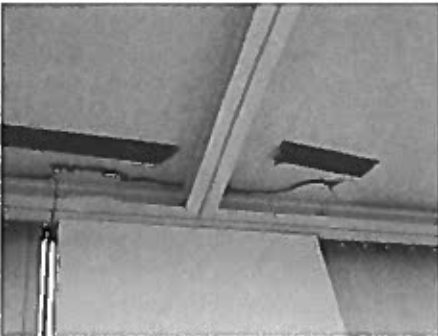
Spalls Within Adjacent Spandrel Beam

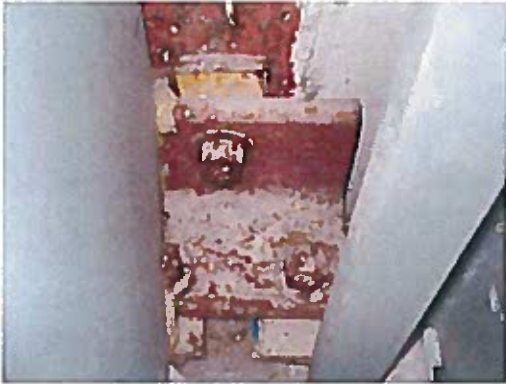
Precast Panel Connections

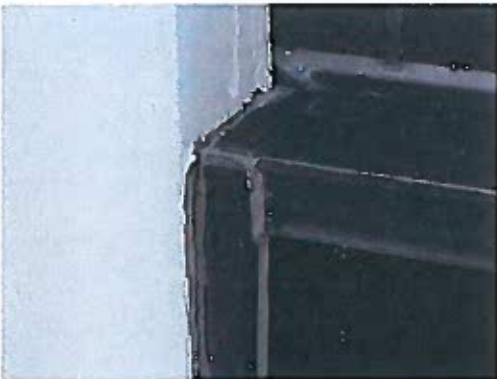
Failed Sealant Joints At Balcony Flashing

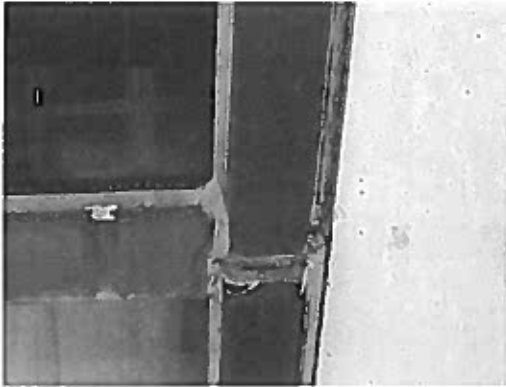
Failed Window Perimeter Joints

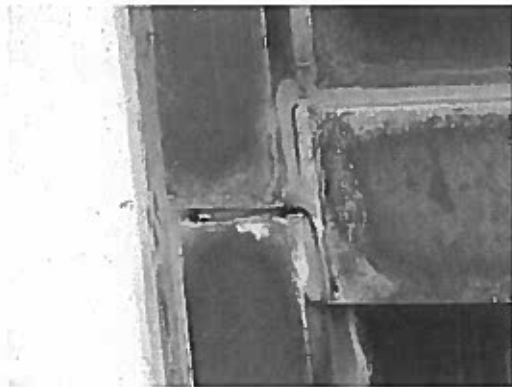
Failed Wet Sealant at Window Joinery

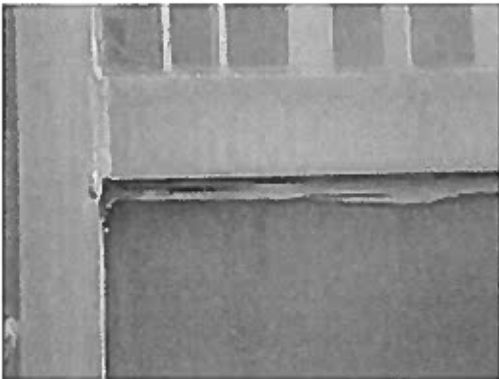
Failed Wet Sealant (Glass-Metal)

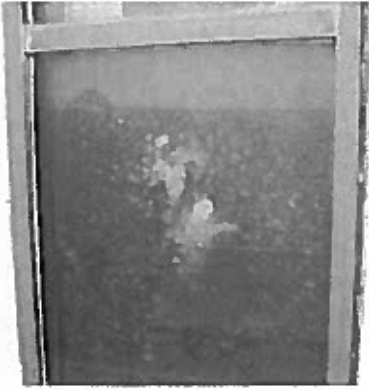
Staining on Interior Surface of Spandrel Glass

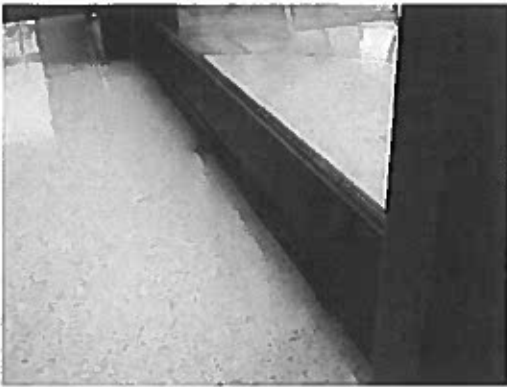
Replacement Windows at Revolving Doors
