Crawford House Preservation and Conservation Easement

Baseline Documentation Report

March 27, 2023

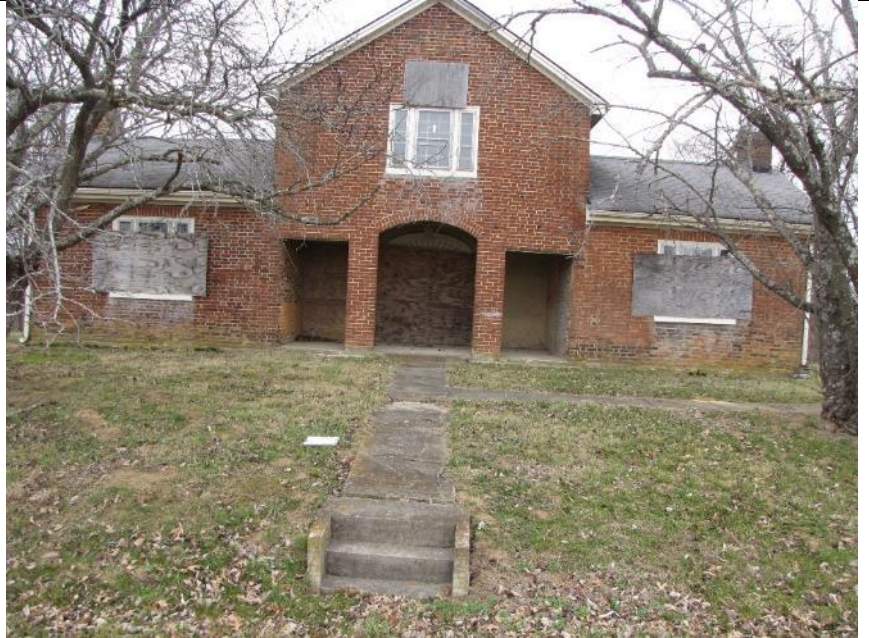
Photo Number: HR-1

Front façade of Crawford House, with walkway to road in foreground

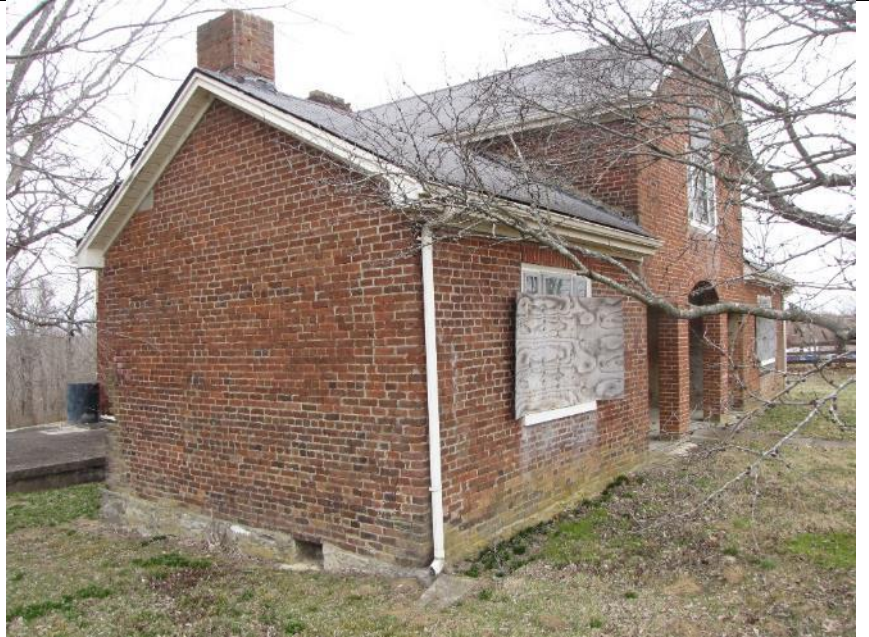
Photo Number: HR-2

Southeast corner of Crawford House, front façade to the right. Note chimney and no fenestration on south side of flanker.

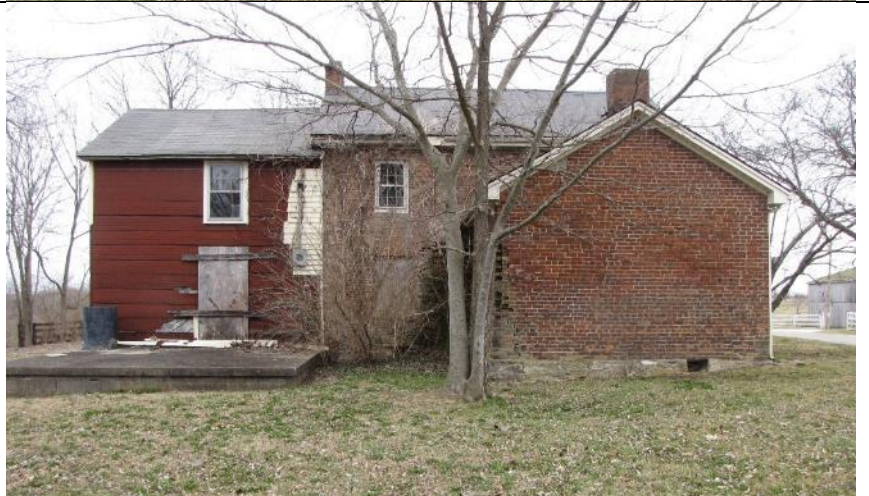
Photo Number: HR-3

Facing south side of Crawford House. Addition is to left, and Harrodsburg Rd at right side of frame.

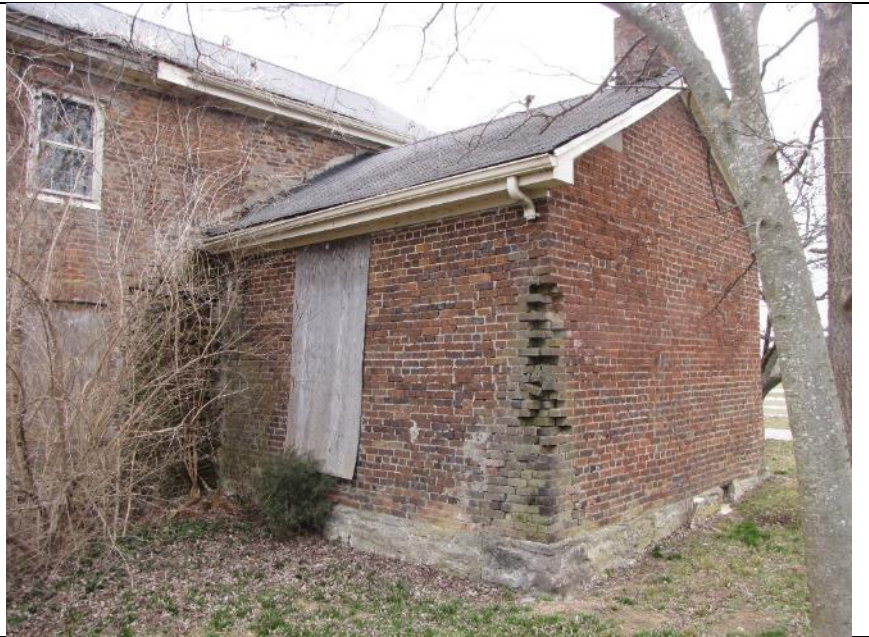
Photo Number: HR-4

Facing significant deterioration of brickwork on southwest corner of the southern flanker of Crawford House. Interior corner at left is also failing with many bricks missing (see below photo HR-22)

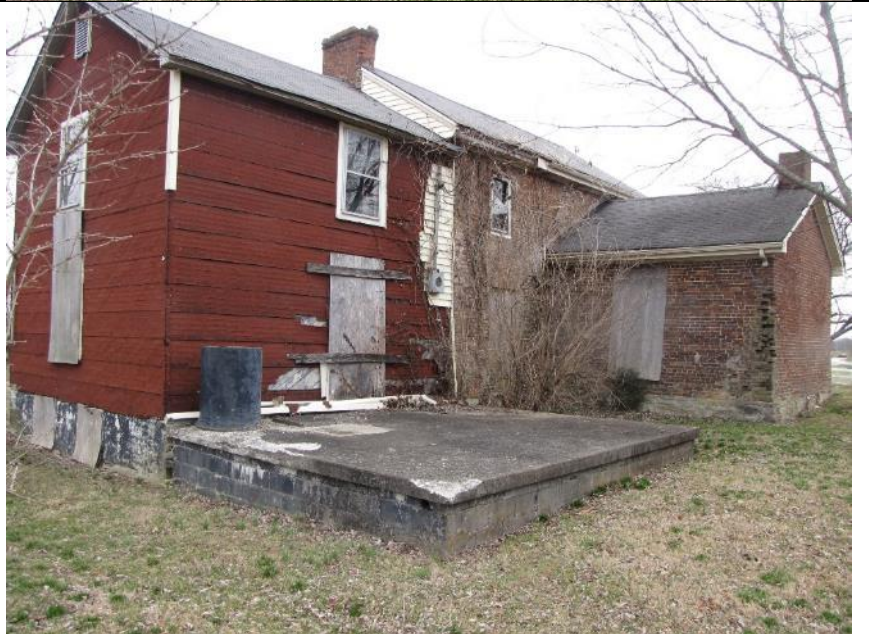
Photo Number: HR-5

There have not been electrical utility lines connected to the house for many years, but there remains an old and disconnected weatherhead on the south side of the rear addition (see photo HR-5). Despite that a sewer line runs through the 4-acre Tract, it is believed that the Crawford House has never been connected to city water and relied on the cistern for water. The house was previously connected to a septic system, but the condition of the system is not known.

Facing southwest corner with addition at left and south flanker at right.

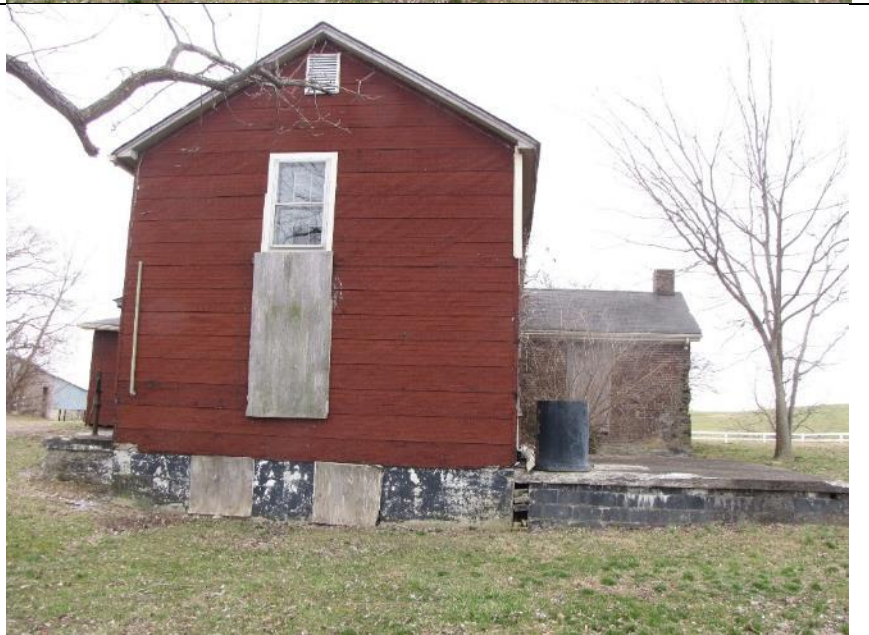
Photo Number: HR-6

Facing rear façade of Crawford House. Red tar paper encloses the addition. South flanker at right

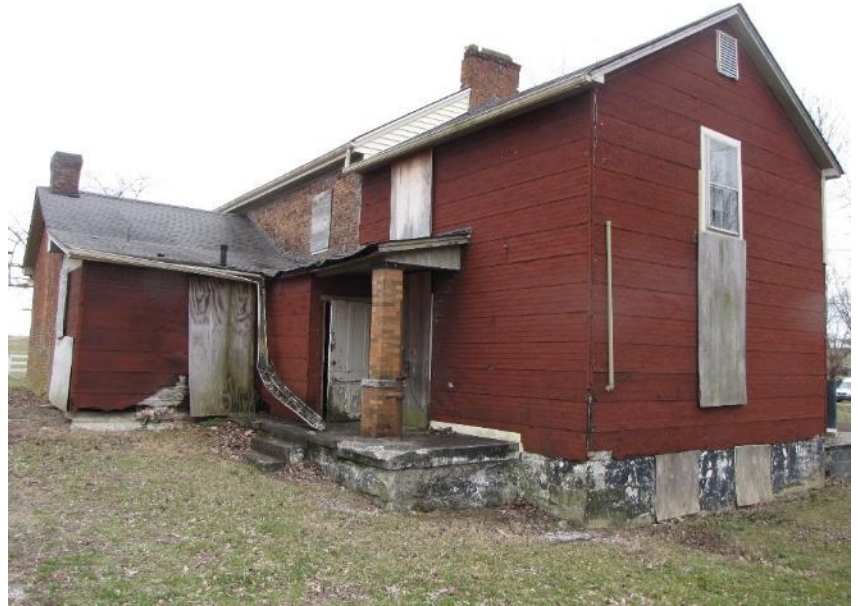
Photo Number: HR-7

Facing northwest corner of the rear addition to the Crawford House.

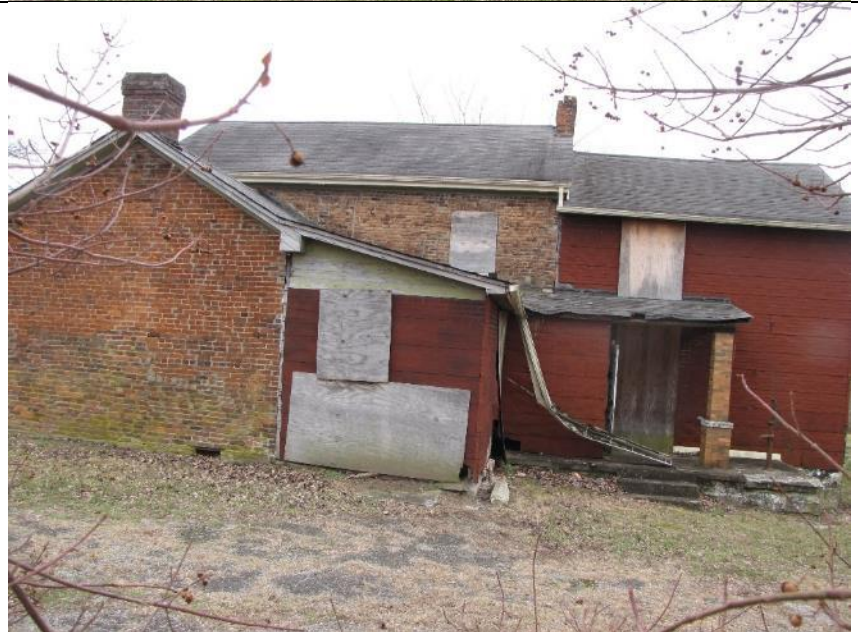
Photo Number: HR-8

Facing north side of Crawford House, showing the additions to the rear of the original structure. Note the gutter on the ground in the center of frame.

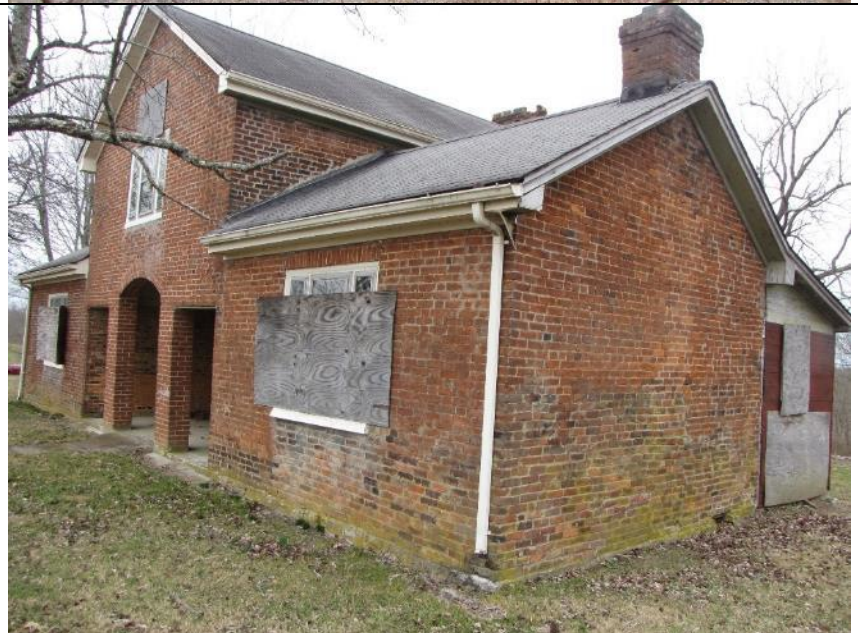
Photo Number: HR-9

Facing northeast corner of the Crawford House, front façade at left and northern end of north flanker without fenestration.

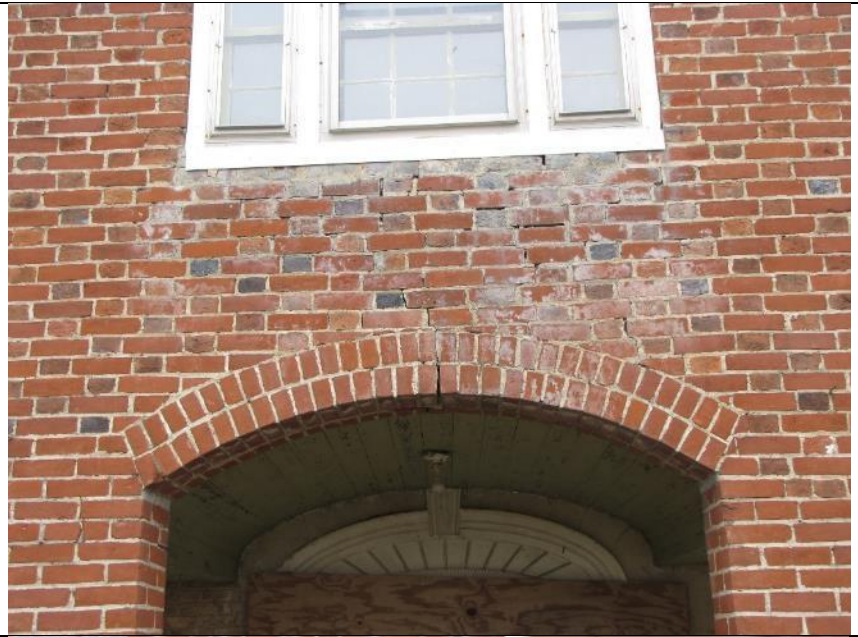
Photo Number: HR-10

Detail of center portion of front façade, showing double row of concentric stretchers in arch over opening of recessed porch, with fanlight above the front door in shadow at bottom, and storm windows over triple windows on second story above.

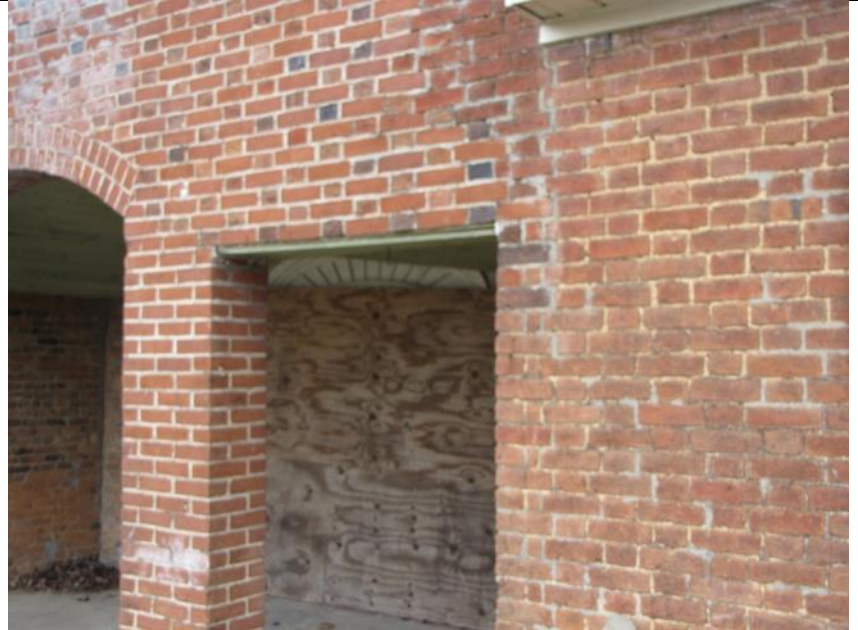
Photo Number: HR-11

Facing northern square-headed opening to the recessed porch on the front façade. Note the apparent different age of bricks and mortar between the north flanker at right, and the central block at left.

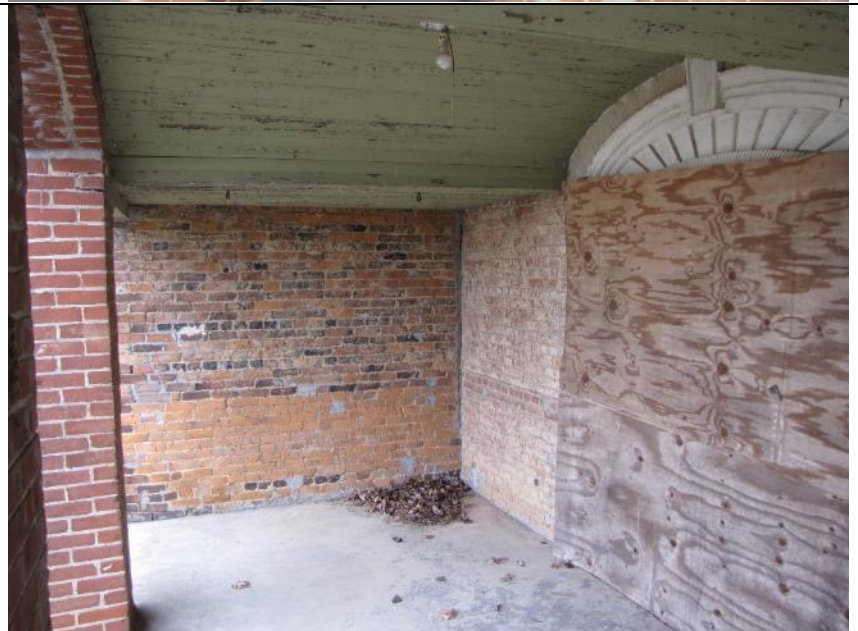
Photo Number: HR-12

Photo taken inside recessed porch, facing apparently older bricks on the north facing wall and fanlight above front door at right. Note the newer bricks of the column at left.

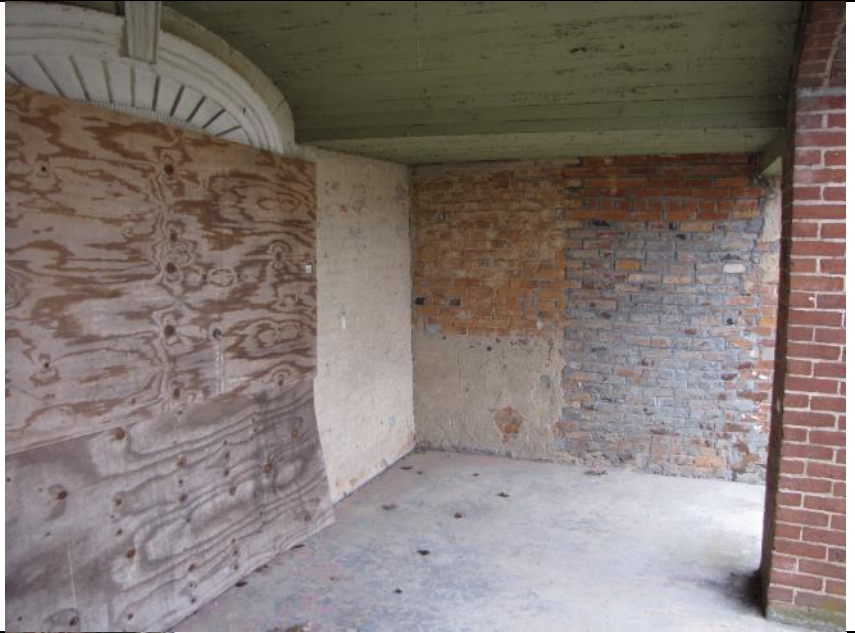
Photo: HR-13

Photo taken inside recessed porch, facing apparently older bricks on the south facing wall and fanlight above front door at left. Note the newer bricks of the column at right.

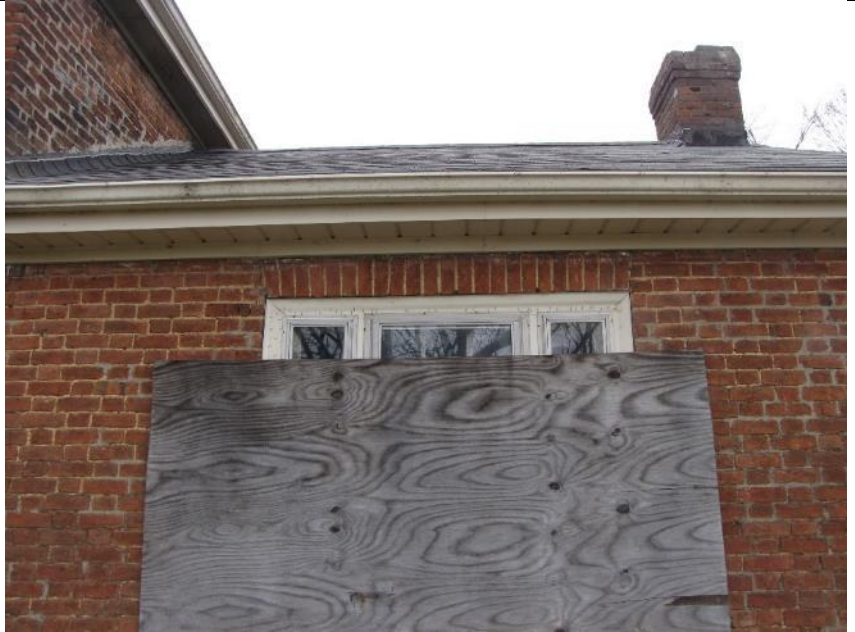
Photo: HR-14

Facing top of the front window on the north flanker, with storm windows visible on each part of the triple window. Note the chimney at top right, at north end of north flanker, is deteriorating.

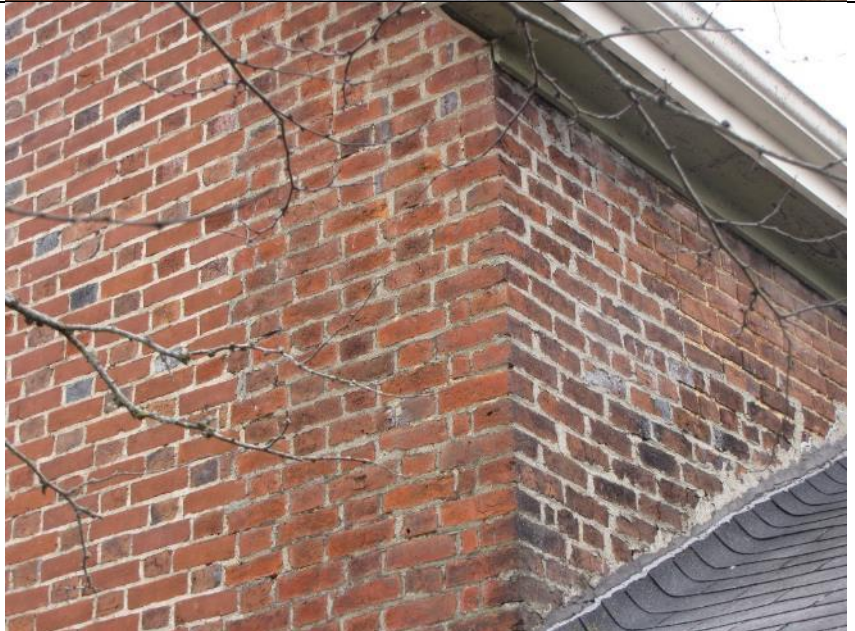
Photo: HR-15

Facing northeast corner of second floor of central block. Note several differences to the apparent age of the bricks and mortar.

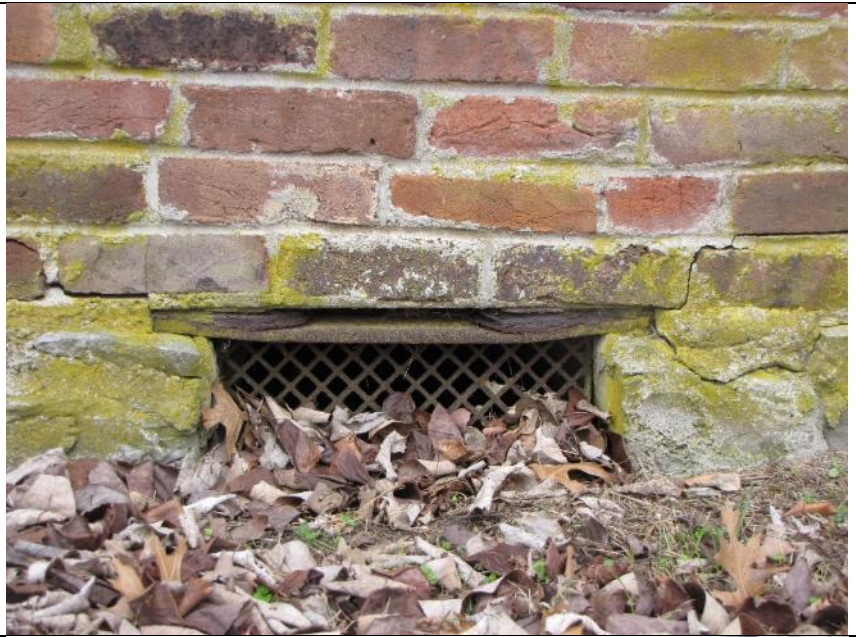
Photo: HR-16

Facing basement vent in center of north end of north flanker.

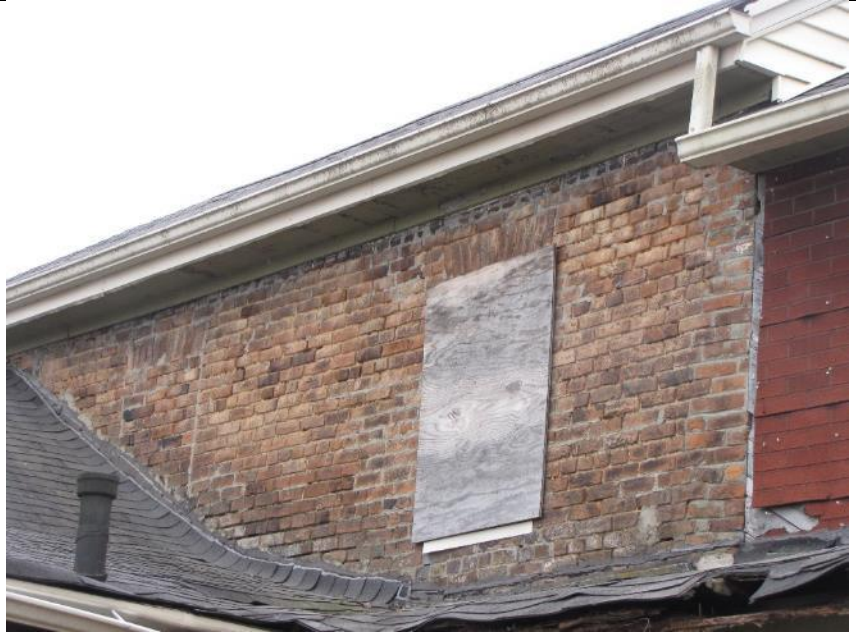
Photo: HR-17

Facing north façade of second floor of central block with boarded up window at center, and bricked in window at left. Rear addition at right edge of frame.

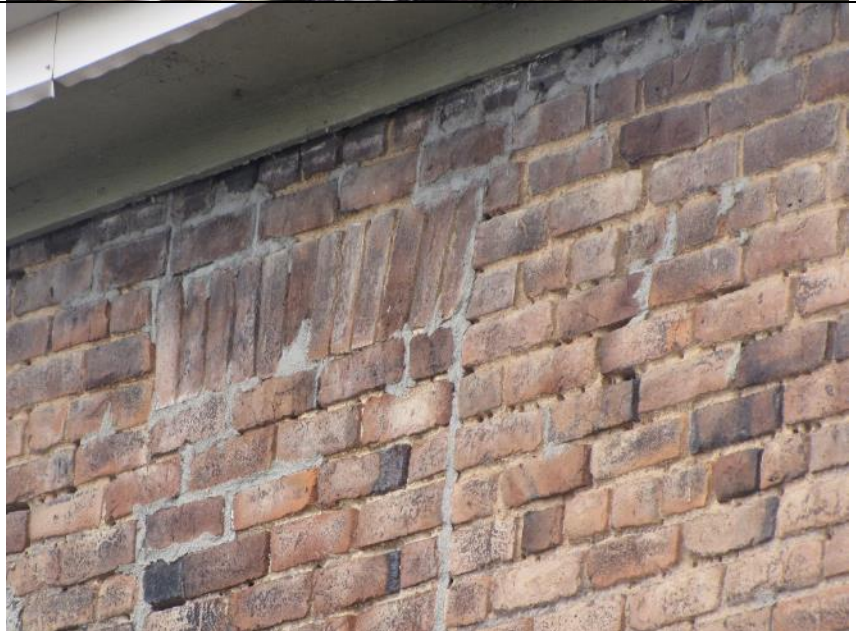
Photo: HR-18

Detail of bricked in window on second floor, north side.

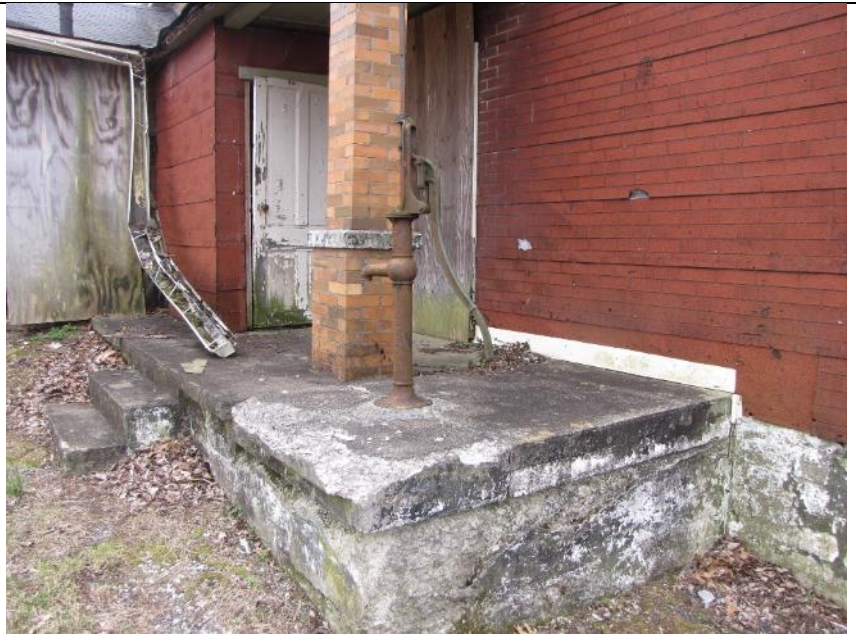
Photo: HR-19

Detail of northwest corner of rear addition, with door into closet at center and pump for water in the cistern.

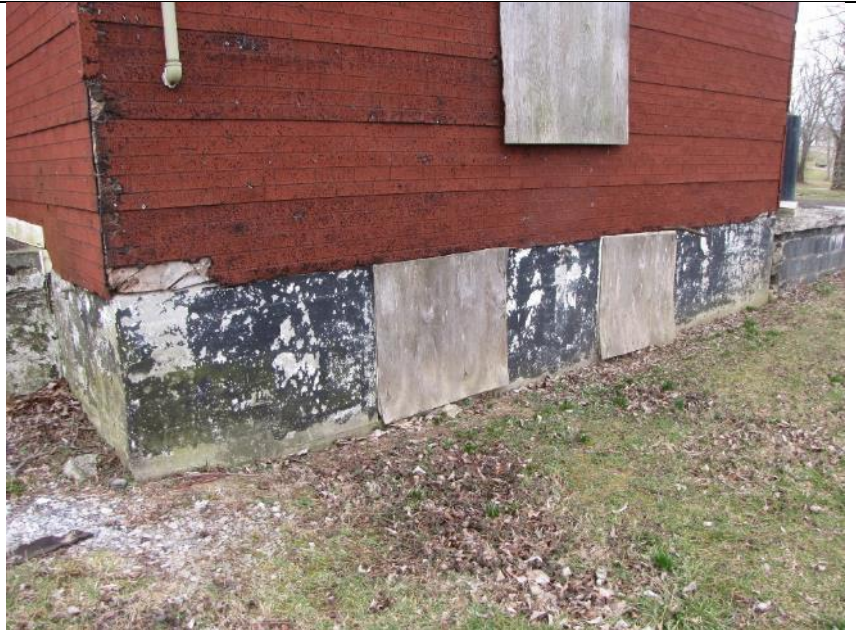
Photo: HR-20

Detail of boarded up foundation on rear addition on Crawford House.

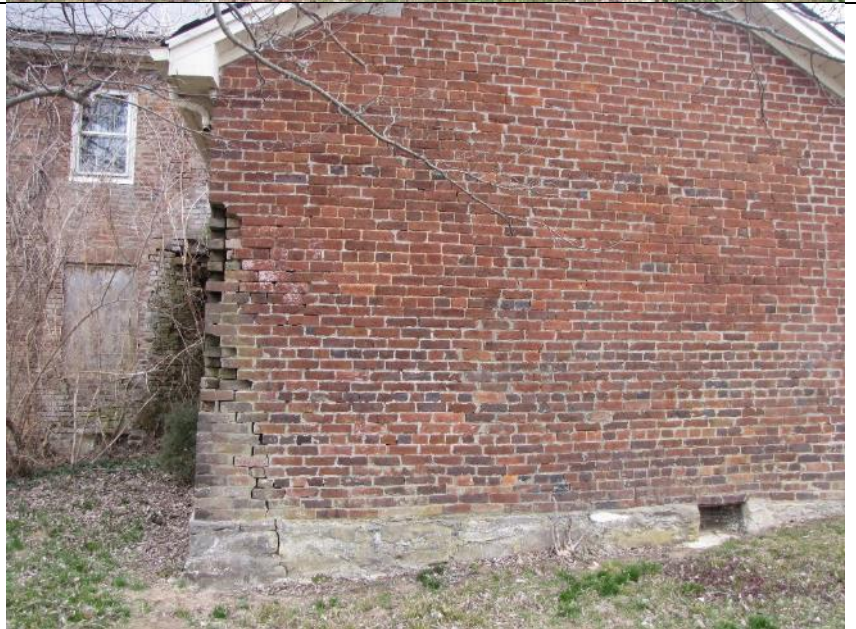
Photo: HR-21

Facing south end of south flanker, with bricks missing from corner.

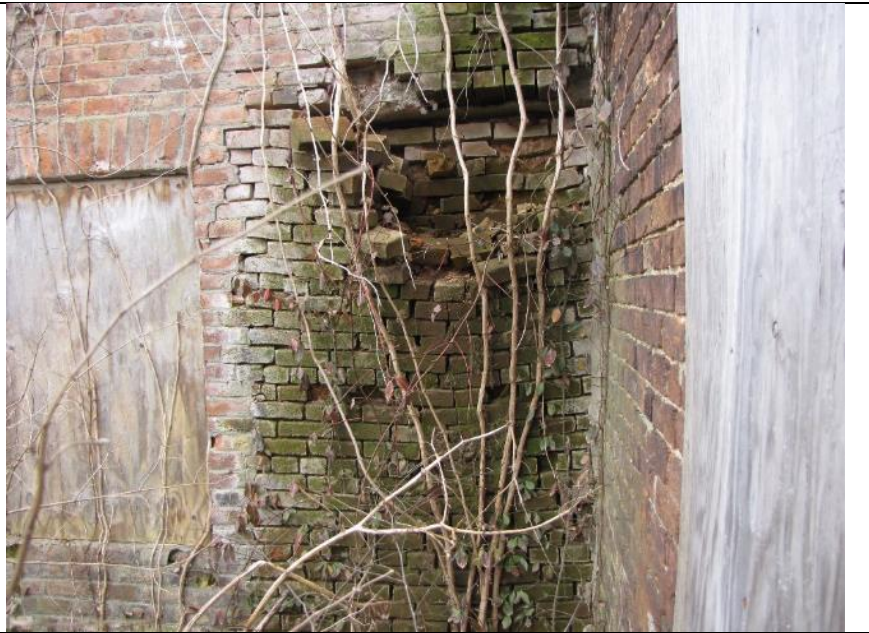
Photo: HR-22

Facing south side of original central block portion of Crawford House. Severe deterioration is evident in this interior corner, with wall collapsing and many bricks missing. Note boarded up window at left.

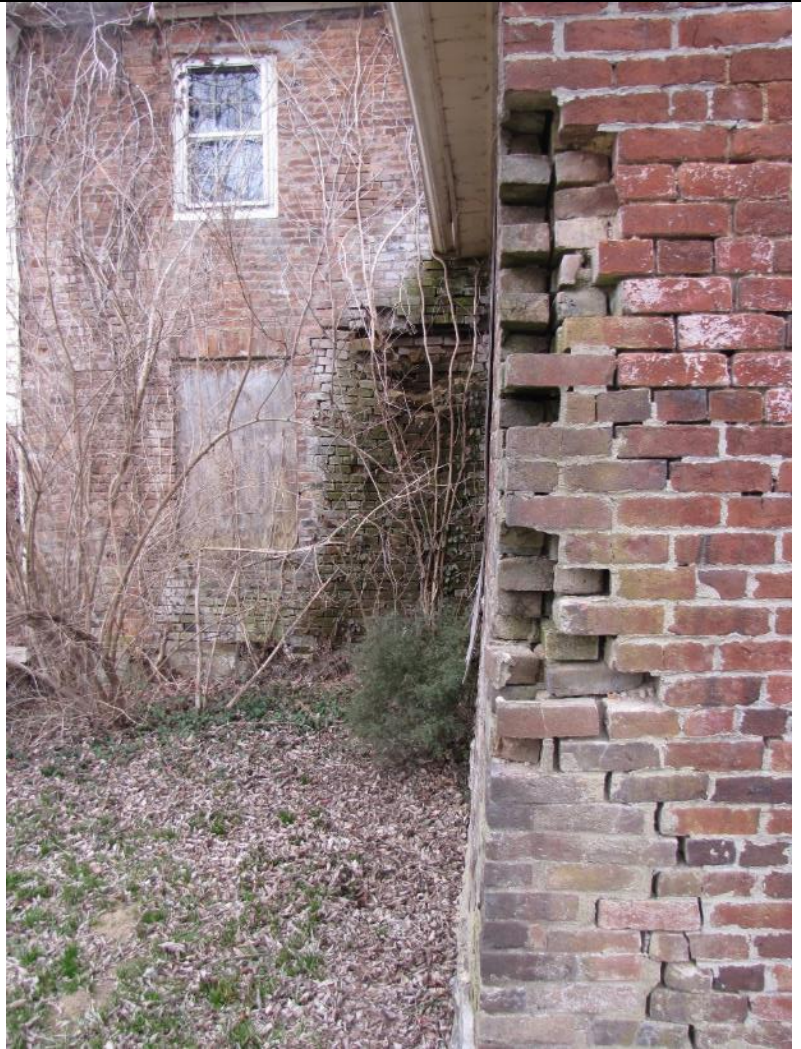
Photo: HR-23

Detail of southwest corner of original portion of Crawford House. Note bricks missing in corner and the severely deteriorating interior corner at center. The gutter at the top of this photo was completely failed as recently as 2020.

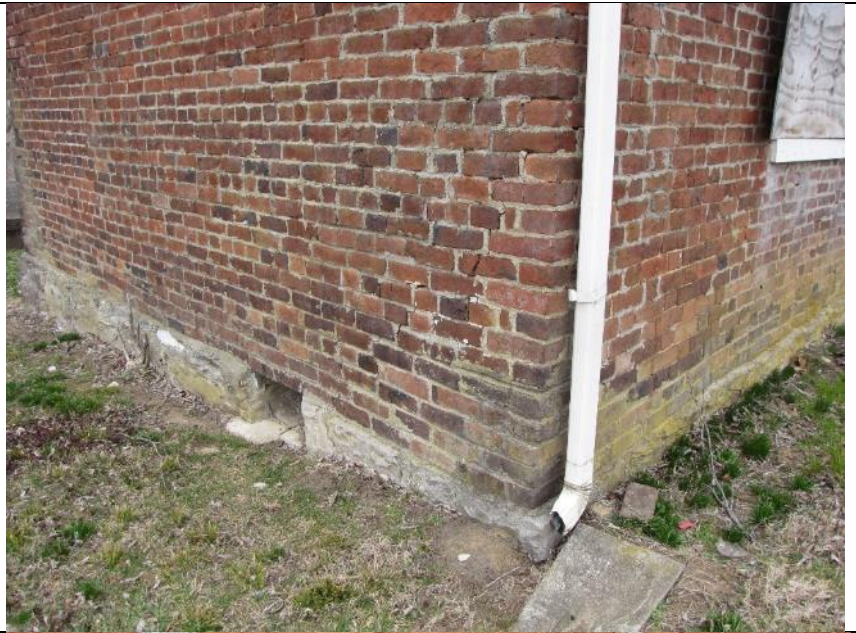
Photo: HR-24

Detail of southeast corner of Crawford House, front façade at right. Note downspout out of alignment.

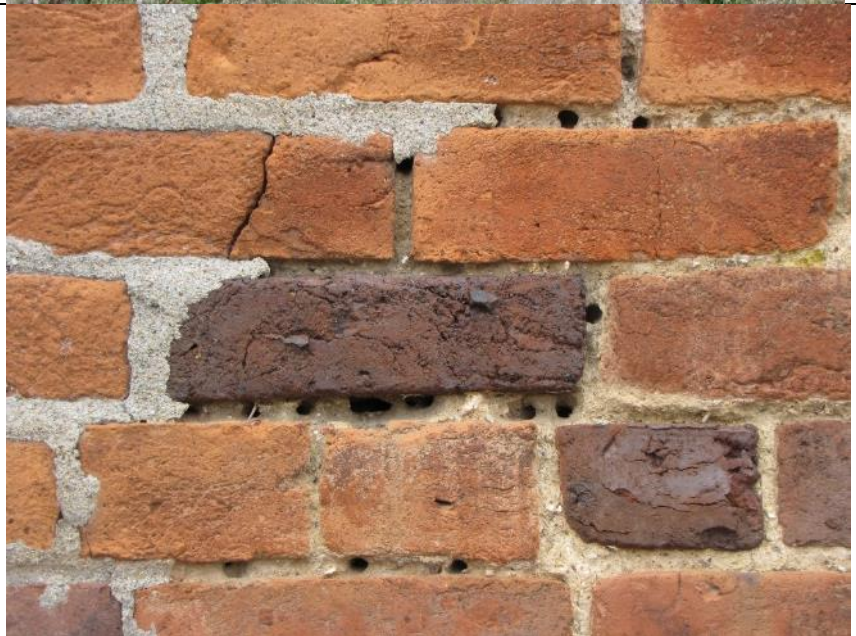
Photo: HR-25

Detail of brickwork on Crawford House, showing inexpert tuck pointing at left, and showing representative mortar bee holes. This less skillful tuckpointing is common across the house, and the mortar bee holes are numerous and widespread.
