Assessment of Facilities

Conference Center

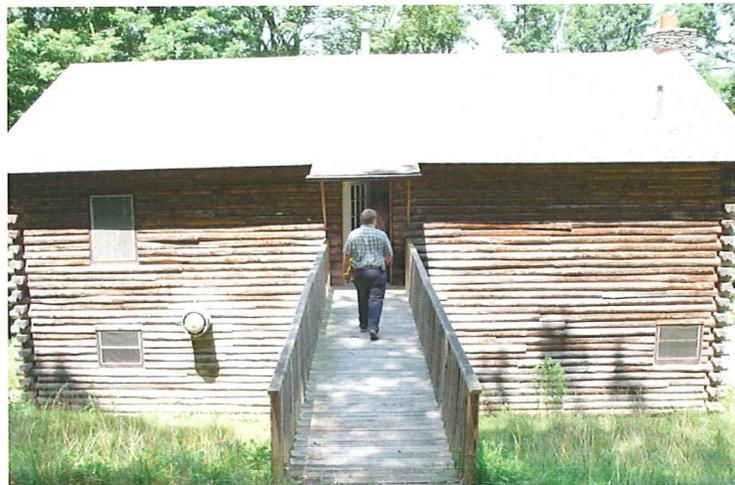
- The south bunk room ceiling appears to have had a leak in the roof as evidenced by the water stain on the ceiling. It is not known at this moment if this condition was repaired in the past.

- The ceiling of the north bunk room at the 2nd floor is showing a sign of failure as it is clearly visible that the ceiling is sagging down approximately 2" from its original position. Further inspection noted that the roof rafters are failing and it is very noticeable at the exterior of the building at the stone chimney. (See Fig. 1)

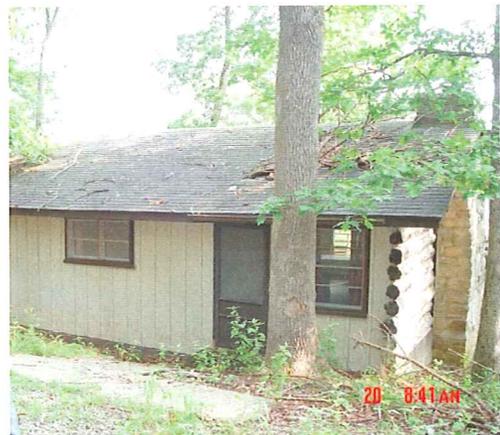
- The roof needs to be replaced and has been damaged as a result of the tree branch falling and penetrating the roof structure, causing not only roof damage but also consequential damages to the interior ceiling, floor and floor structure.

- The original placement of the Cabin and the down slope of the bluff has allowed for years of water from rains and snow to drain directly towards the building foundation, thereby causing for differential settlement of the Cabin.

- The rear door leading to the deck can no longer be opened as a result of settlement issues.
- The floor at the main entry to the Cabin has rotted to the point that it can no longer sustain foot traffic without the fear of failure.

- The vinyl tile flooring is in poor condition and many of the tiles have become dislodged from their position, especially at door openings.
- The log walls appear to be coated with mold in several areas.

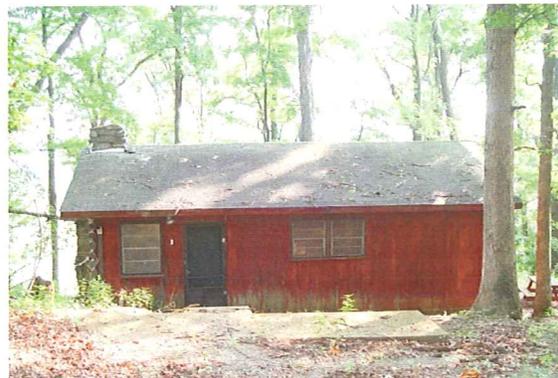
- The roof needs to be replaced, as it has reached the end of its life. Moss is presently growing on the roof.
- The roof structure has begun to settle near the stone chimney. There is noticeable sag in the roof in this area. The roof leaks water into the interior at this area.

- The original placement of the Cabin and the down slope of the bluff has allowed for years of water from rains and snow to drain directly towards the building foundation, thereby causing for differential settlement of the Cabin.

- The log walls appear to be coated with mold in several areas.
- The vinyl tile flooring is in poor condition and many of the tiles have become dislodged from their position, especially at door openings.

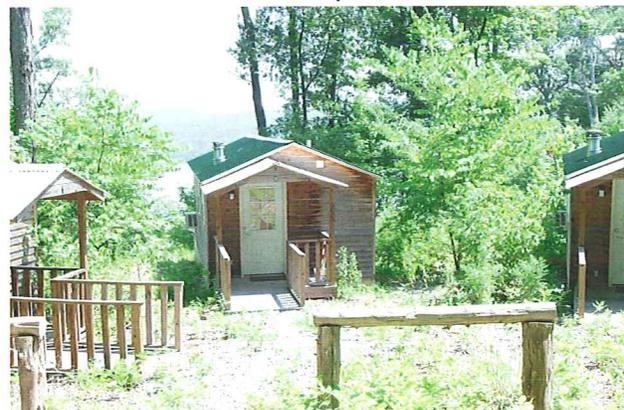
Cabins 1 & 2, these Cabins have a commanding view of the Ohio River and the valley below the bluff. These Cabins are relatively new in comparison to the other Cabins noted in this study. The Cabins are in good condition and with a general cleaning and inspection can continue to be used. The Cabins are of an efficiency type much like a small hotel room. Each of them contains a small bathroom, kitchenette, closet and sleeping area. A porch is located on both the front and rear sides of the building.

- The Cabins are equipped with a through-the-wall heat pump which provides both heating and air-conditioning. An inspection of these units is warranted to determine if there are any deficiencies that need to be addressed.
- There is a slight musty odor within the Cabins but it is believed that that can be eliminated with consistent use and maintenance.
- The bedding may need to be discarded and new bedding provided if these Cabins are to be used in the future. The sanitary sewer septic system needs to be inspected for continued use.
- The site immediately surrounding the Cabins needs to be cleaned up and trees need to be pruned to allow a better view of the valley below.
