# **Asbestos Containing Materials Inspection**

**Capital Plaza Office Tower  
500 Mero Street  
Frankfort, Kentucky**

RE: Asbestos Inspection  
Capital Plaza Office Tower  
500 Mero Street  
Frankfort, KY 40601

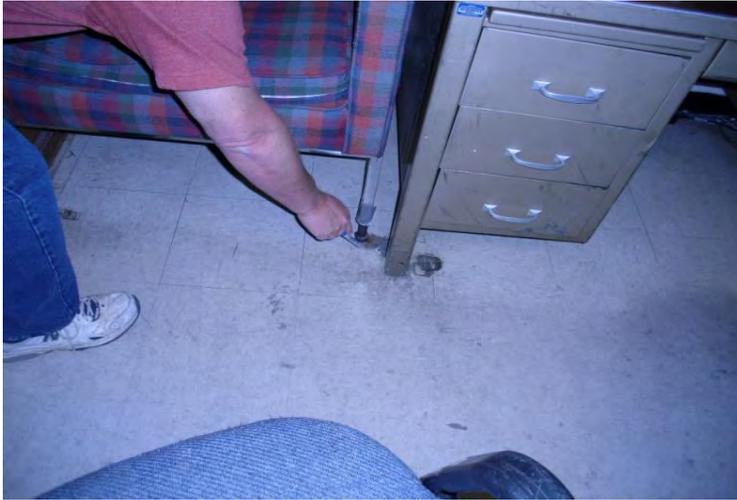
Sample 54  
Floor tile  
Ground floor

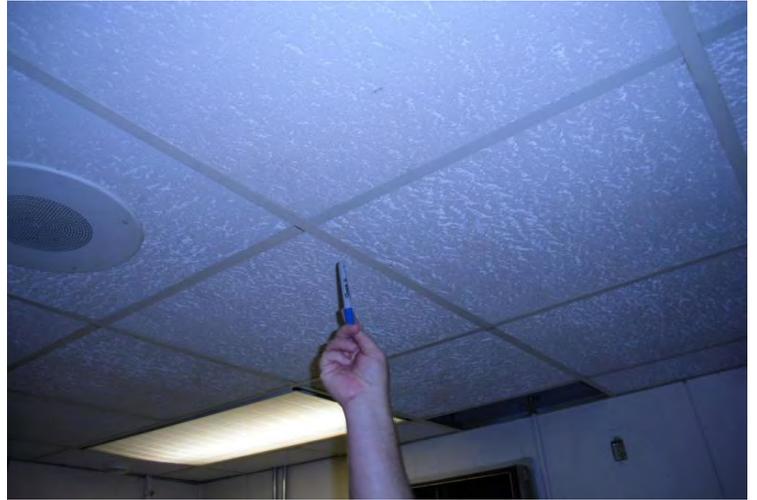
Sample 55  
Ceiling tile  
Ground floor

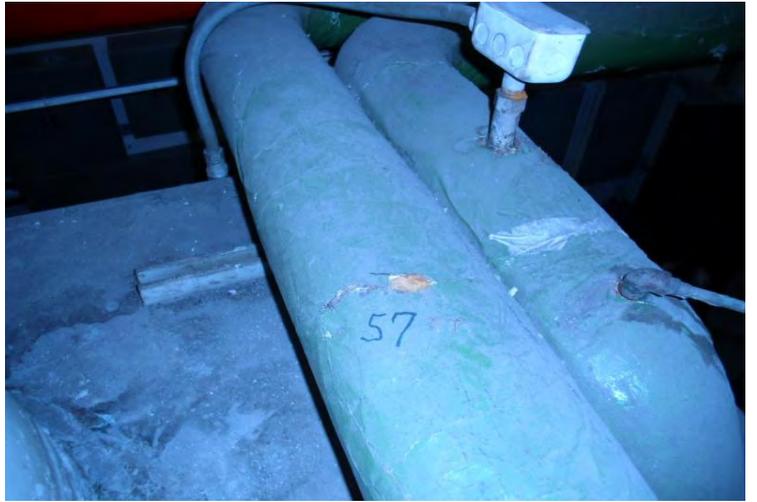
Sample 57  
Pipe wrap  
Ground floor

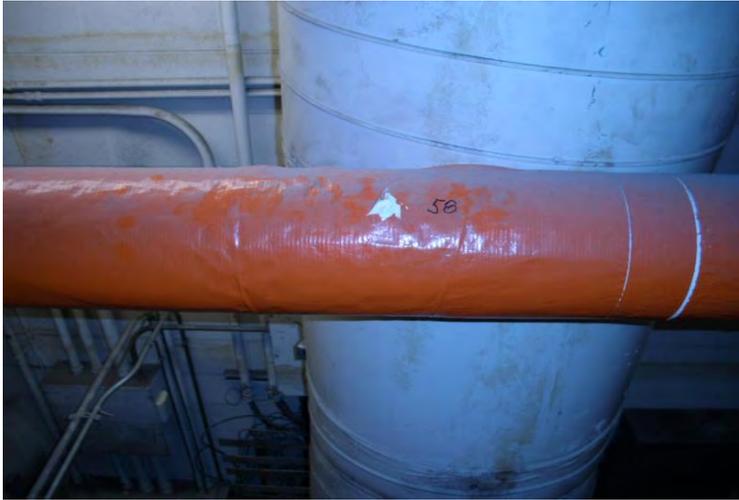
Sample 58  
Pipe wrap  
Ground floor

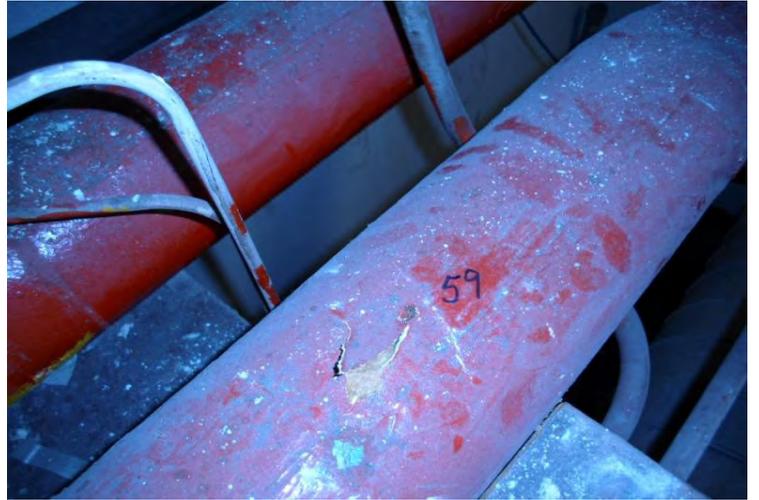
Sample 59  
Pipe wrap  
Ground floor

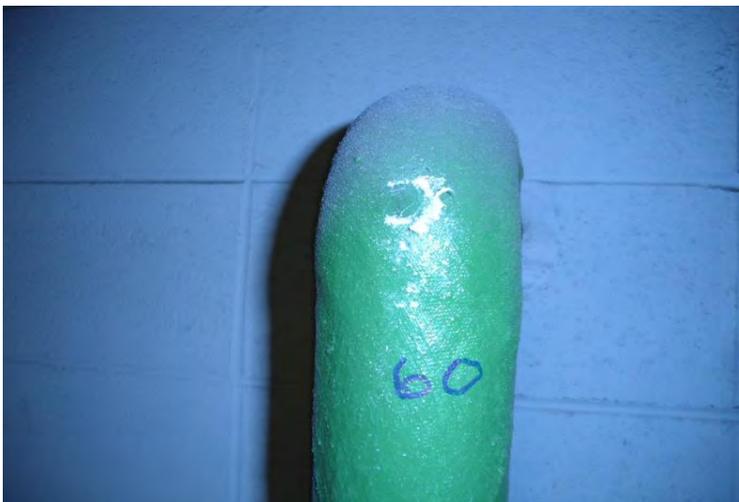
Sample 60  
Elbow  
Ground floor

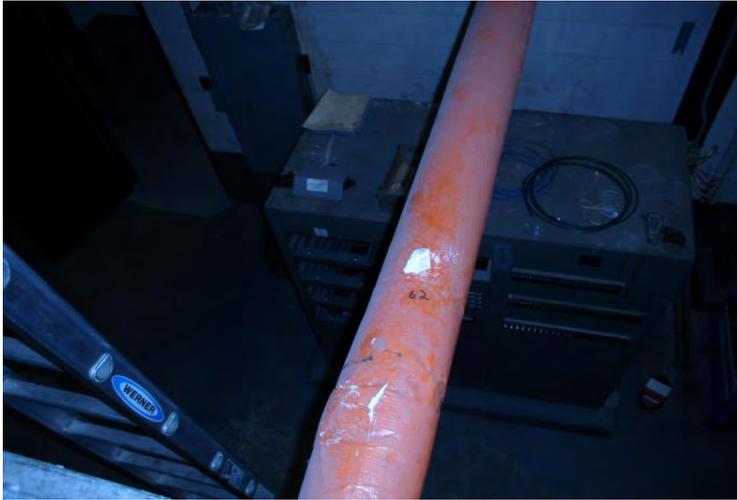
Sample 62  
Pipe wrap  
Ground floor

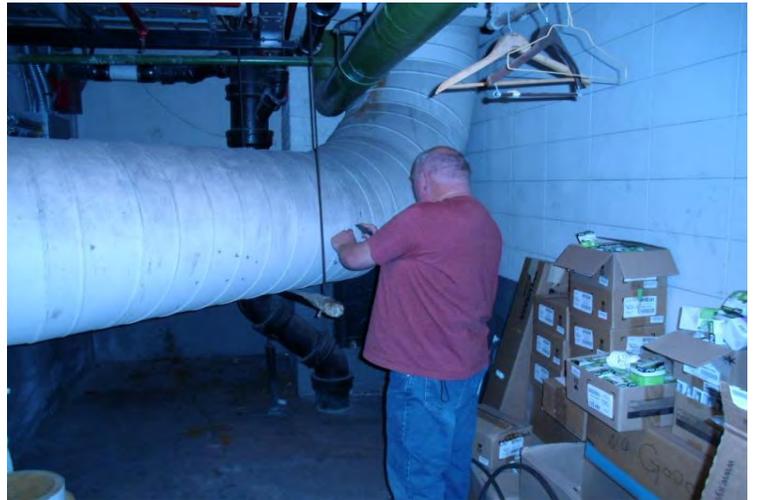
Sample 63  
Vent tape  
Ground floor

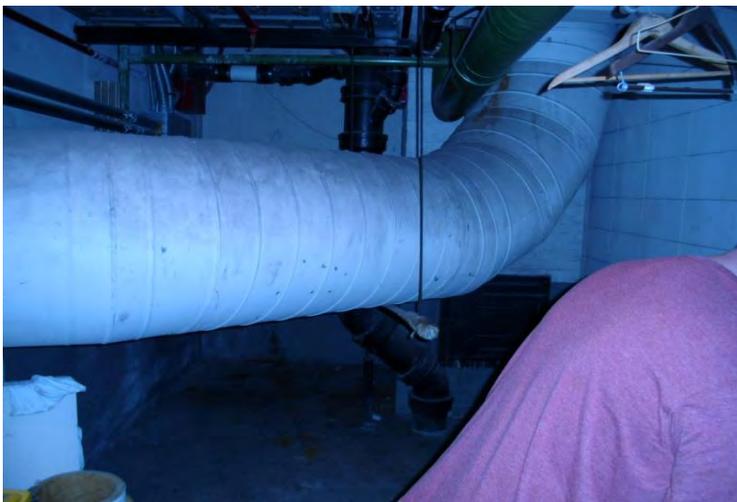
Sample 64  
Tape mud  
Ground floor

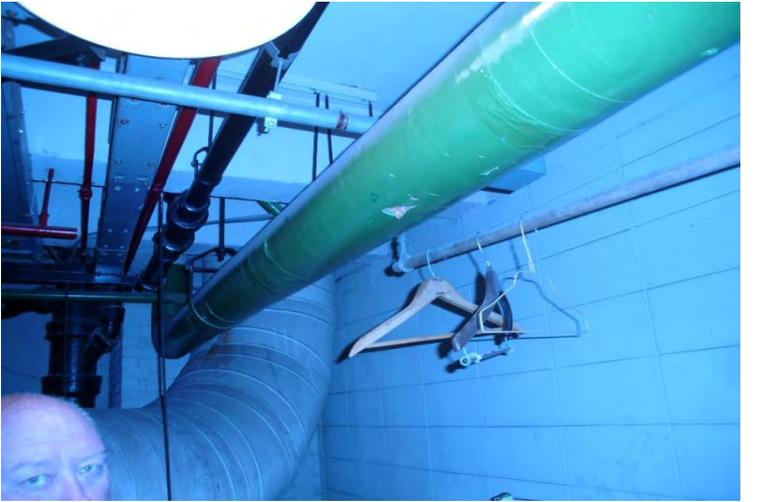
Sample 65  
Pipe wrap  
Ground floor

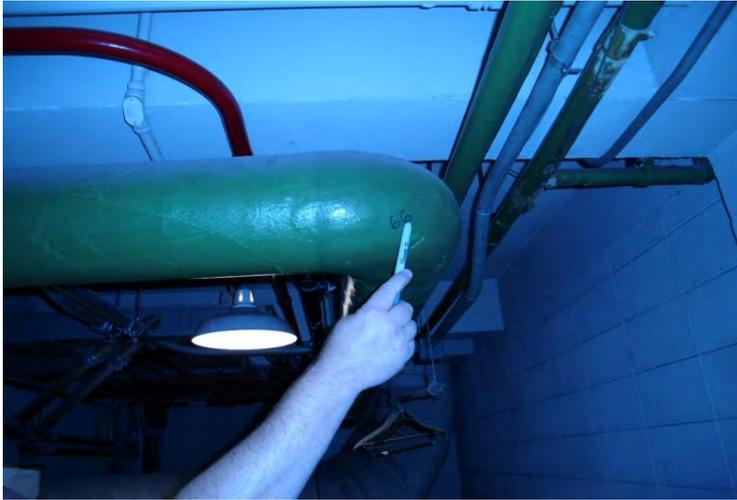
Sample 66  
Elbow  
Ground floor

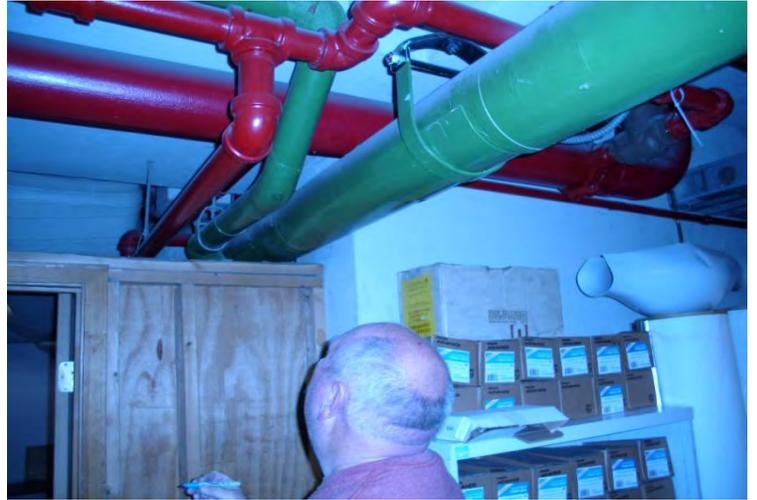
Sample 67  
Elbow  
Ground floor

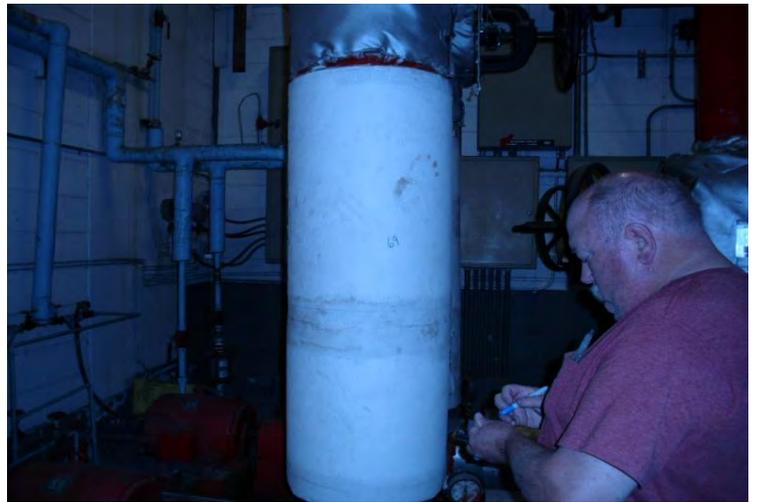
Sample 69  
Pipe wrap  
Boiler Room

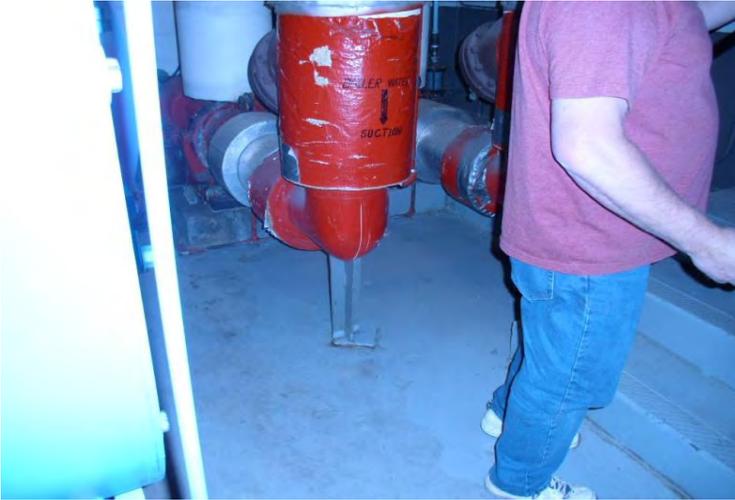
Sample 70  
Elbow  
Boiler Room

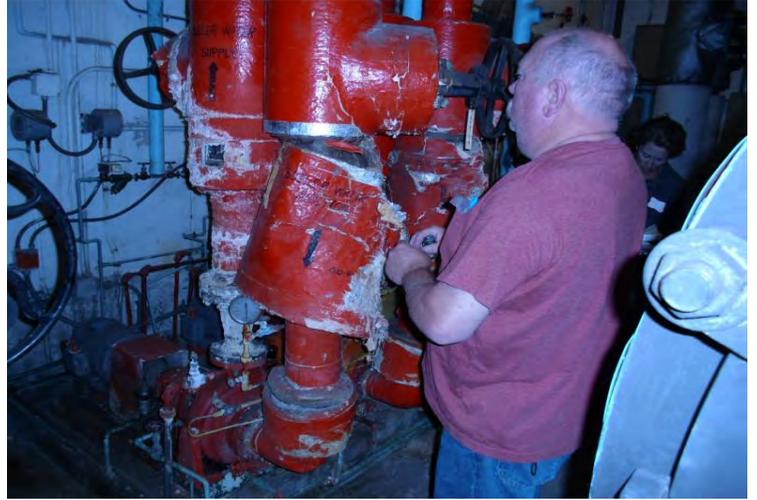
Sample 71  
Pipe wrap  
Boiler Room

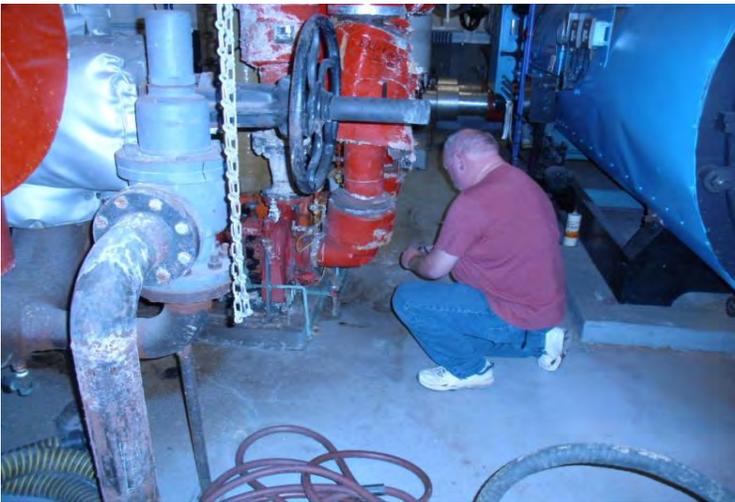
Sample 72  
Elbow  
Boiler Room

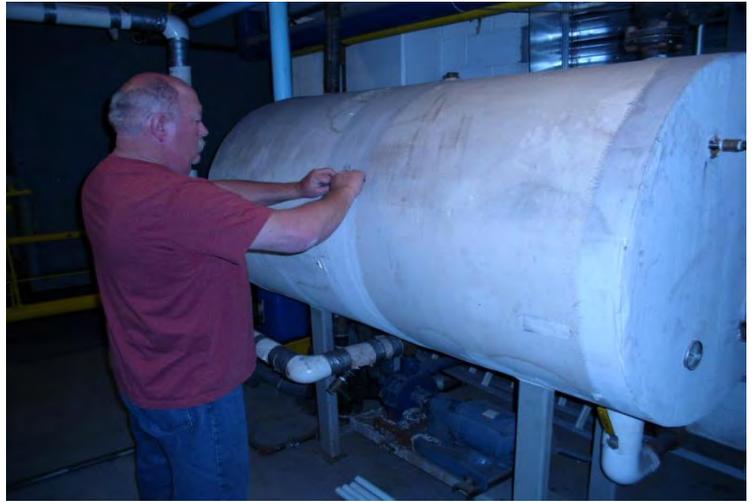
Sample 73  
Tank insulation  
Boiler Room

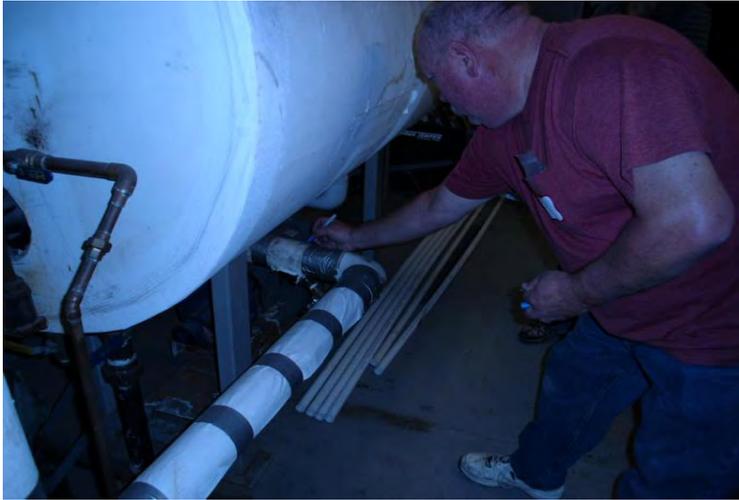
Sample 74  
Pipe wrap tank  
Boiler Room

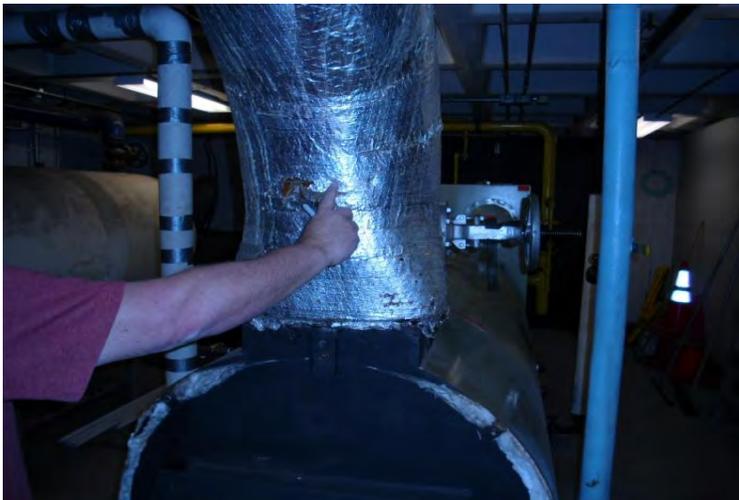
Sample 76  
Pipe wrap tank  
Boiler Room

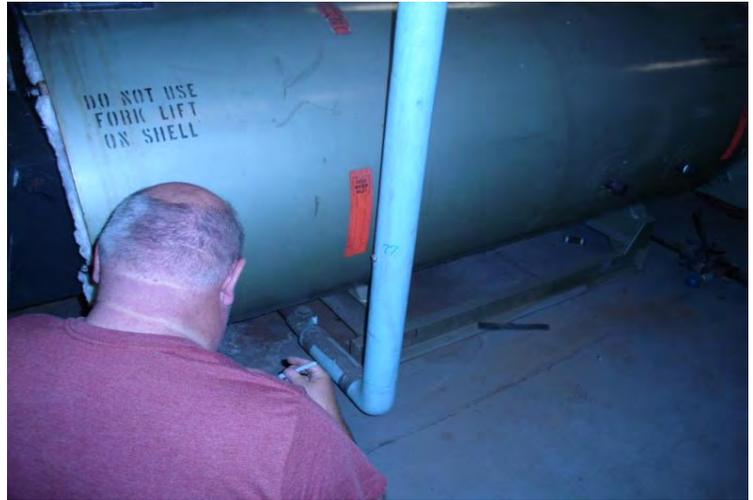
Sample 77  
Pipe wrap  
Boiler Room

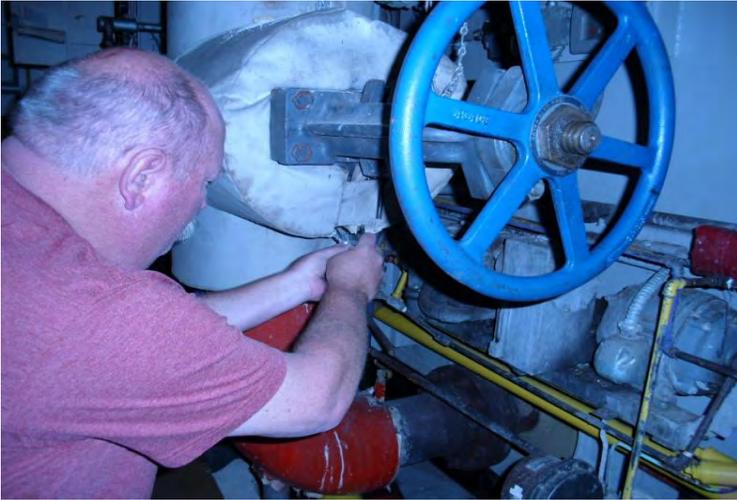
Sample 78  
Over pack  
Boiler Room

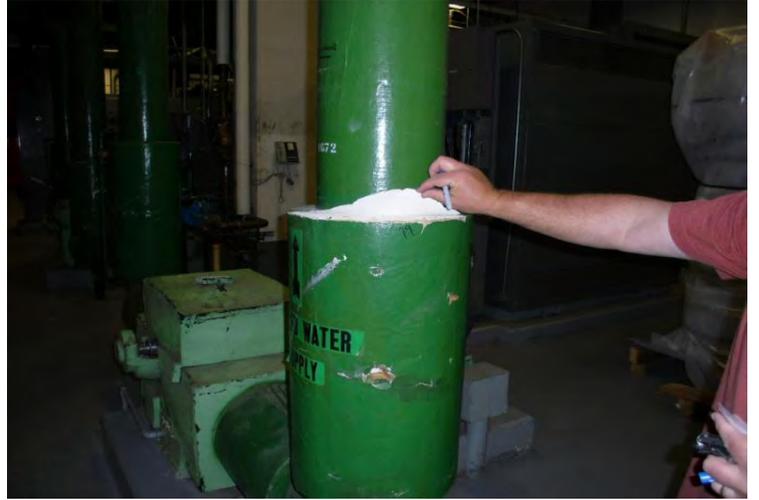
Sample 79  
Valve junction  
Mechanical Room

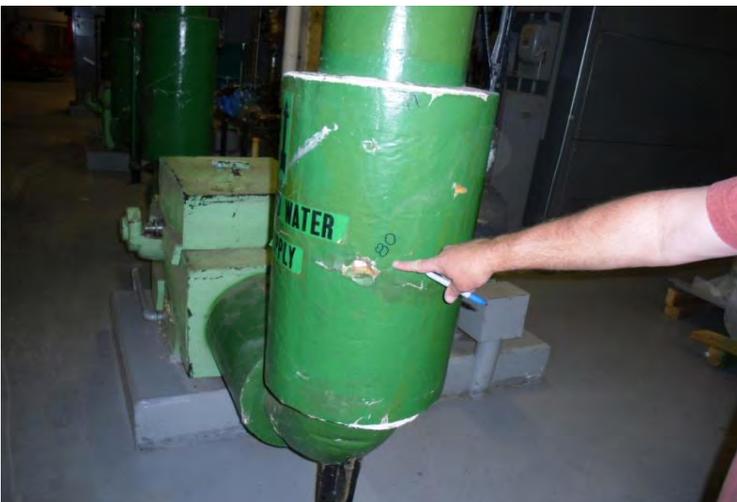
Sample 80  
Pipe insulation  
Mechanical Room

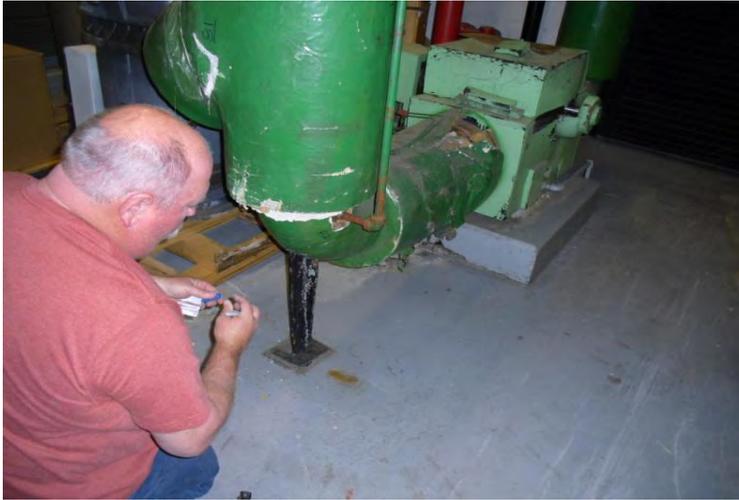
Sample 82  
Elbow  
Mechanical Room

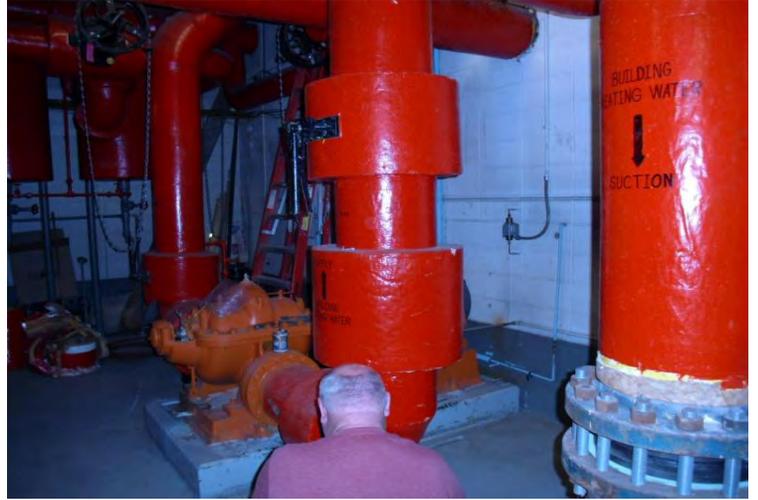
Sample 83  
Pipe insulation  
Mechanical Room

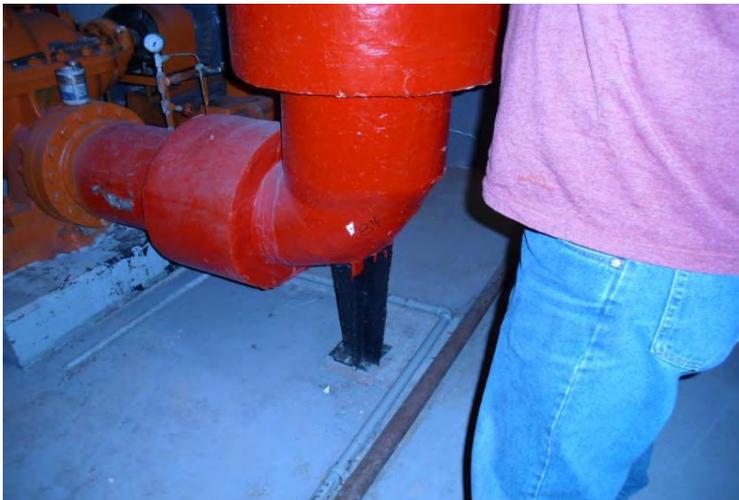
Sample 84  
Elbow  
Mechanical Room

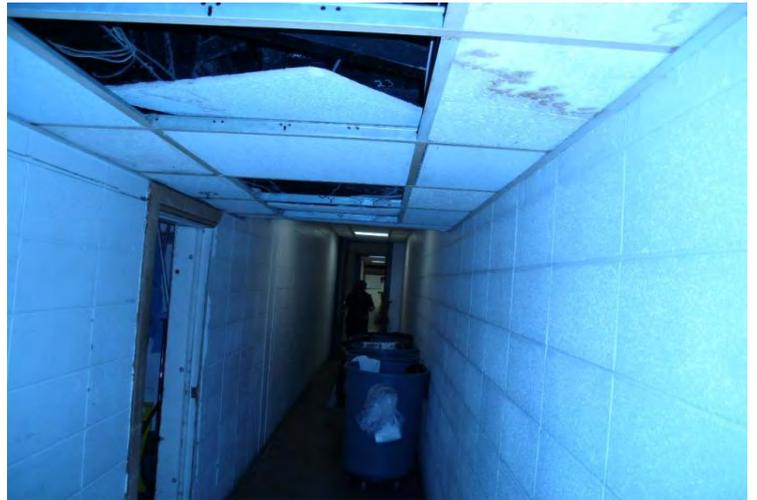
Sample 87  
Ceiling tile  
Ground floor

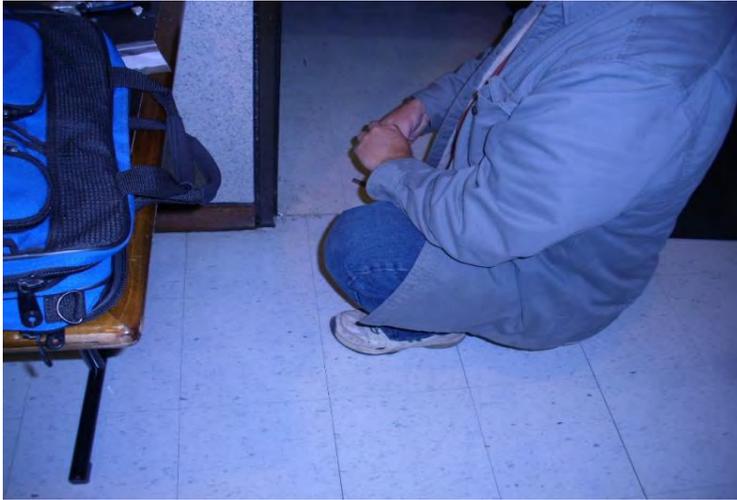
Sample 90  
Floor tile  
Ground floor

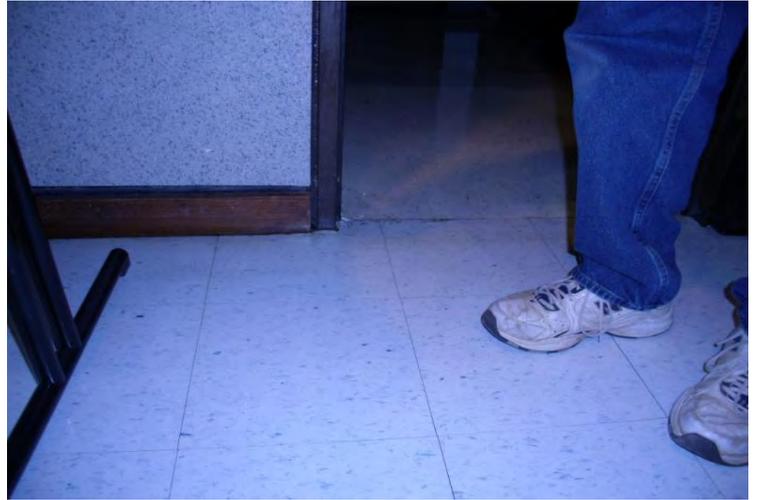
Sample 91  
Floor tile  
Ground floor

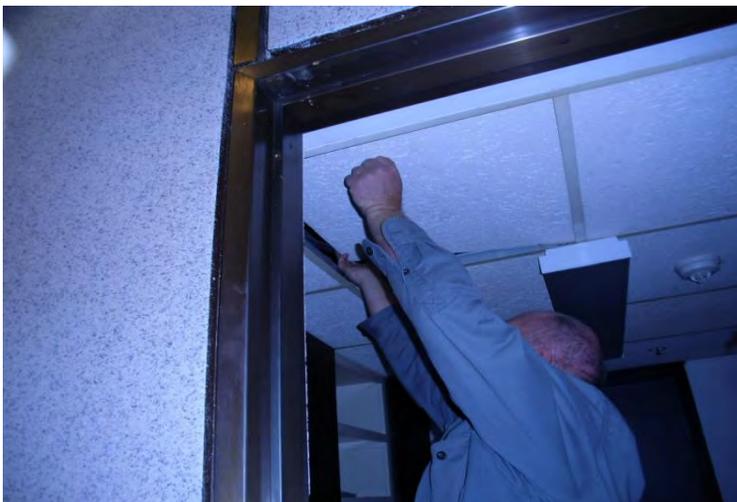
Sample 92  
Ceiling tile  
Ground floor

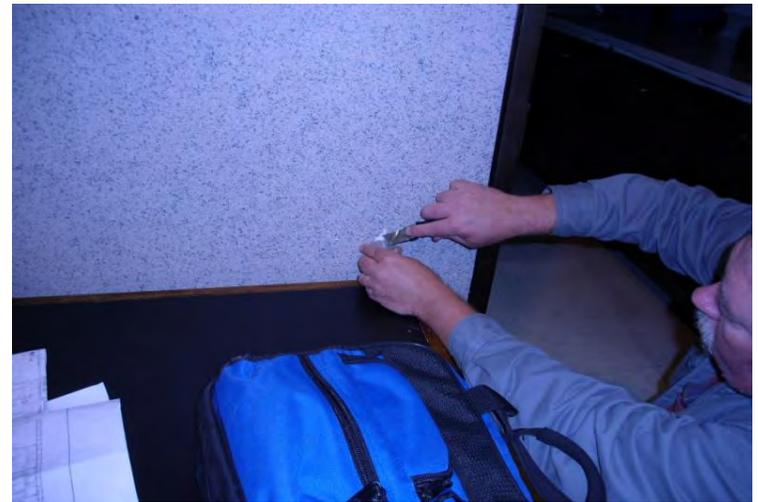
Sample 93  
Wall covering  
Ground floor

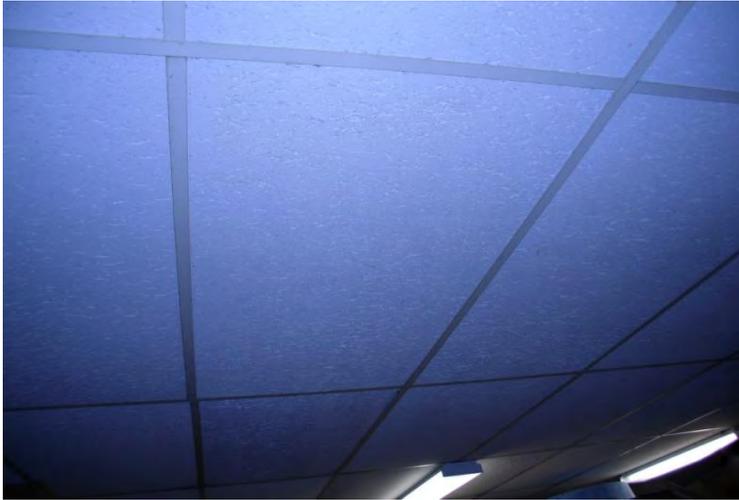
Sample 94  
Ceiling tile  
Ground floor

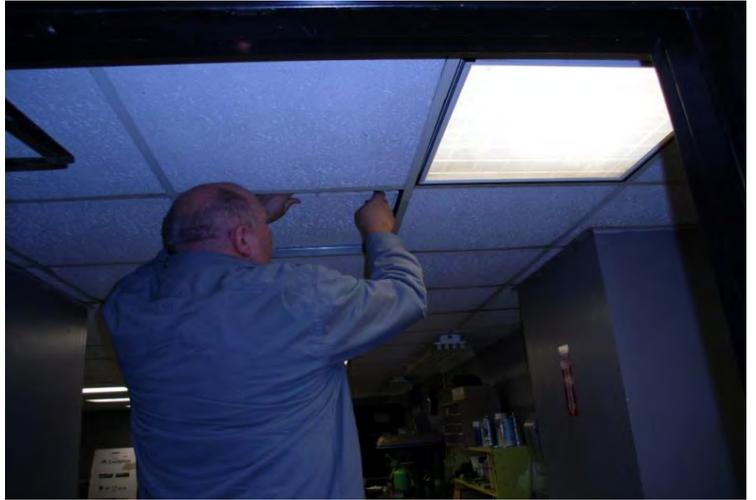
Sample 95  
Ceiling tile  
Ground floor

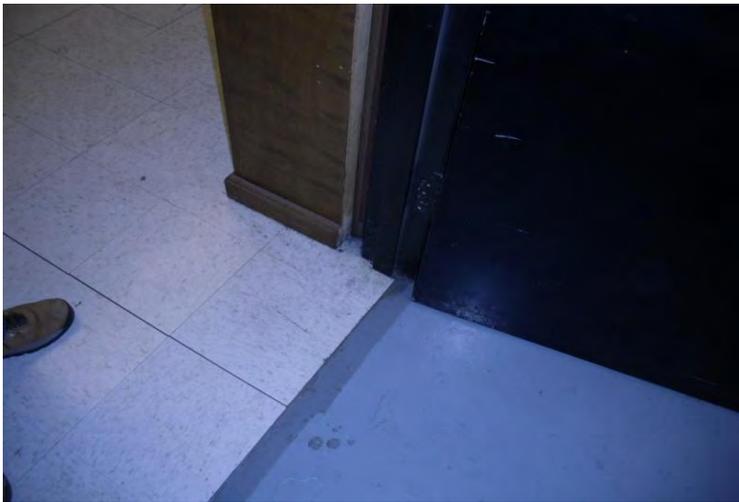
Sample 96  
Floor tile  
Ground floor

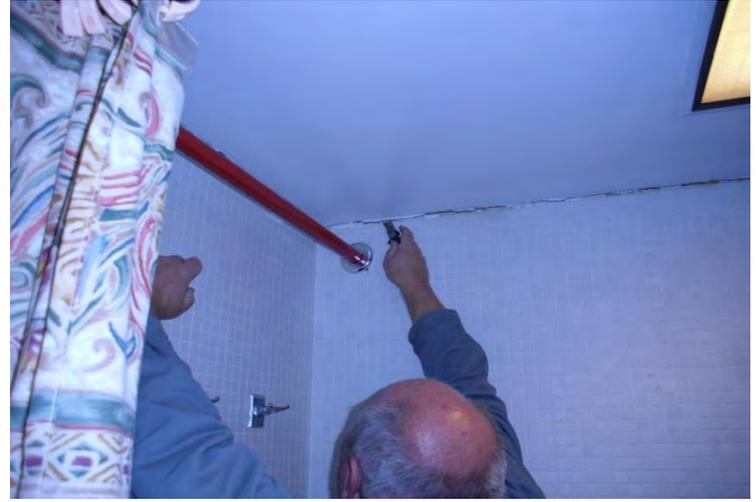
Sample 97  
Ceiling covering  
Ground floor

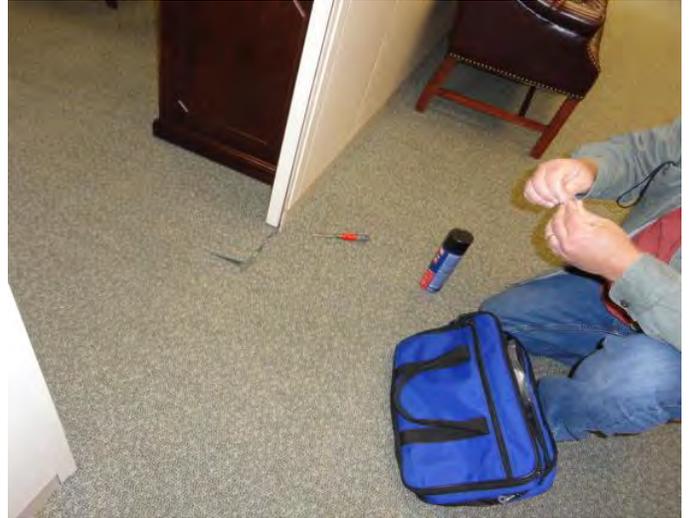
Sample 99A  
Sample 99B  
Floor concrete/mastic  
Floor 1

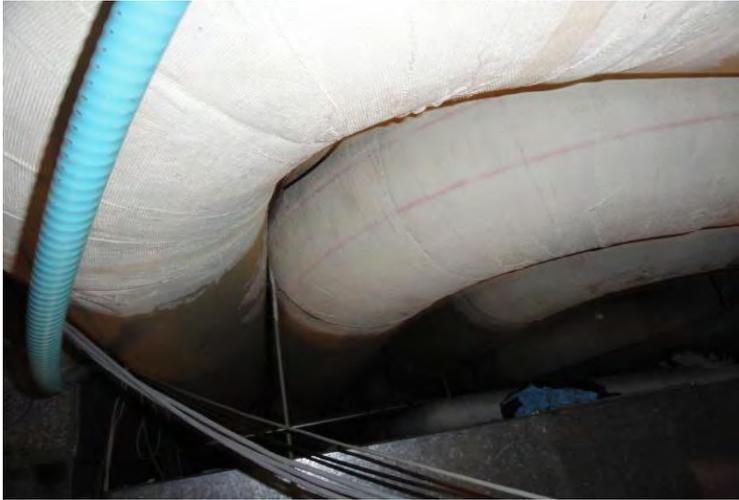
Sample 135  
Pipe wrapping  
Crawl Space

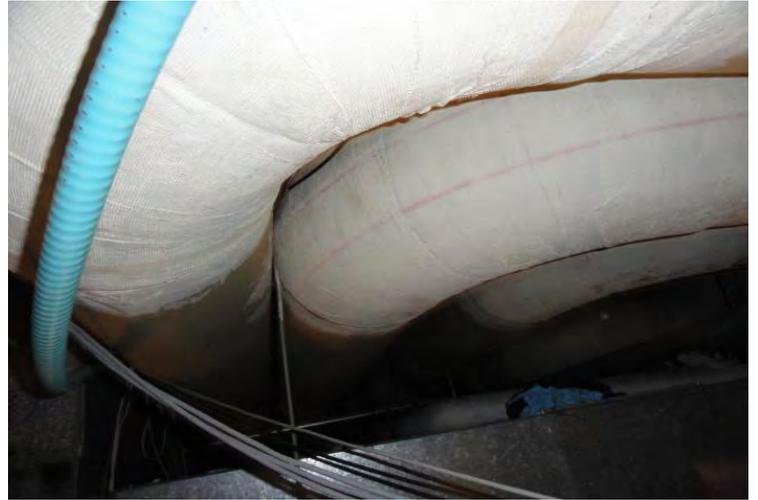
Sample 136  
Piping insulation  
Crawl Space

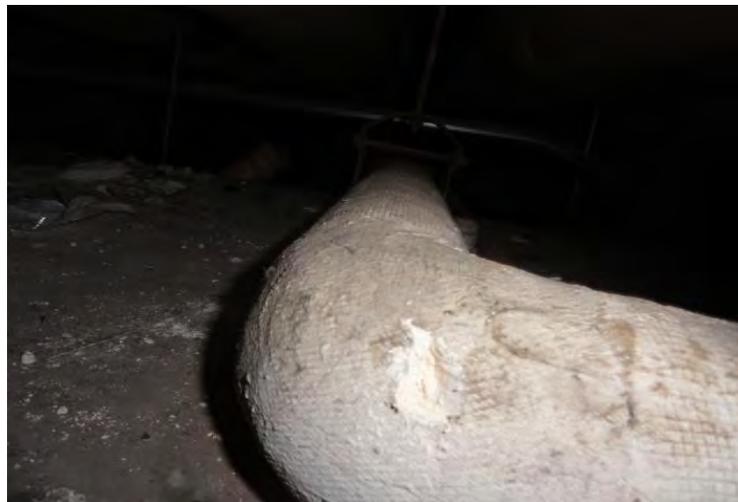
Sample 137  
Elbow  
Crawl Space

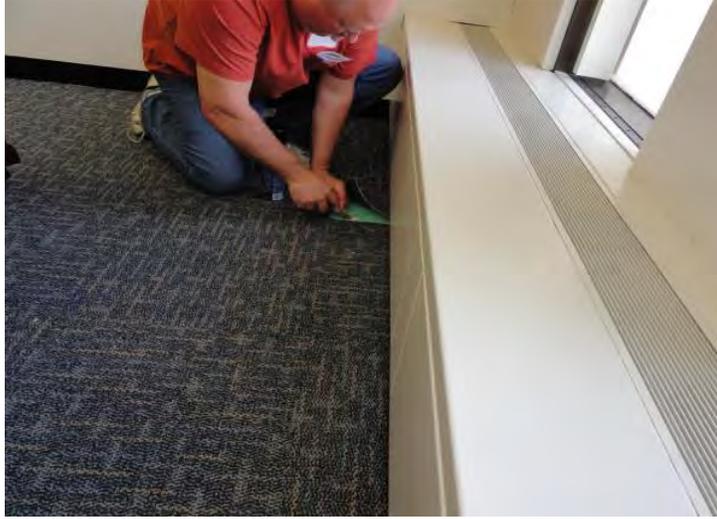
Sample 104  
Floor tile covered with carpet  
Floor 4

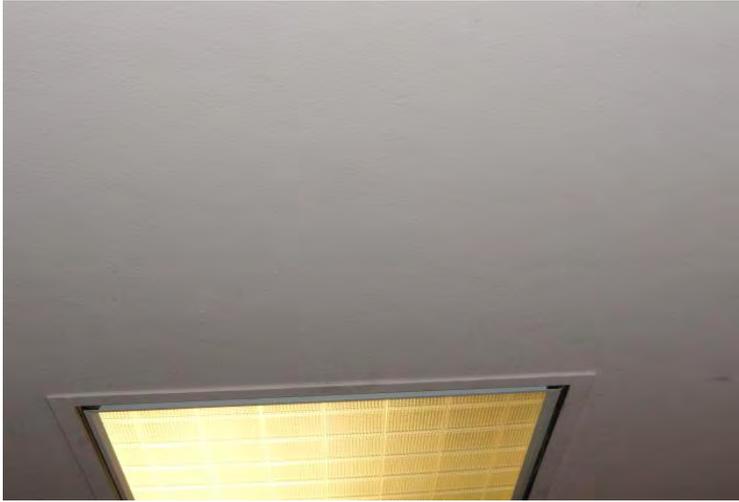
Sample 133  
Ceiling texture  
Floor 6

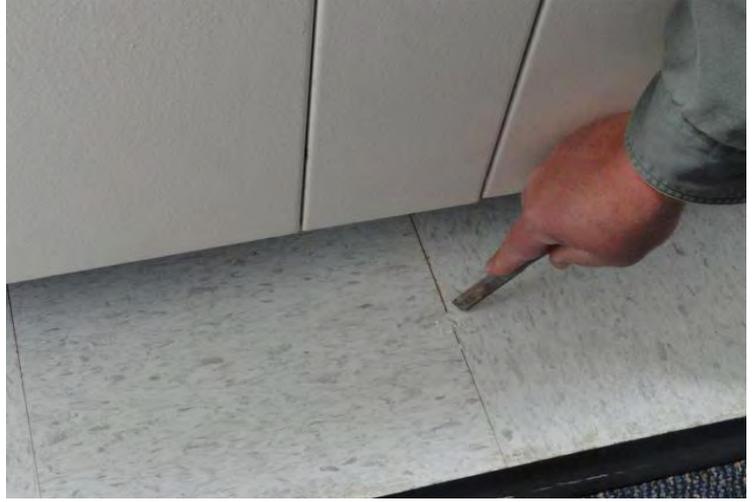
Sample 134  
Floor tile  
Floor 6

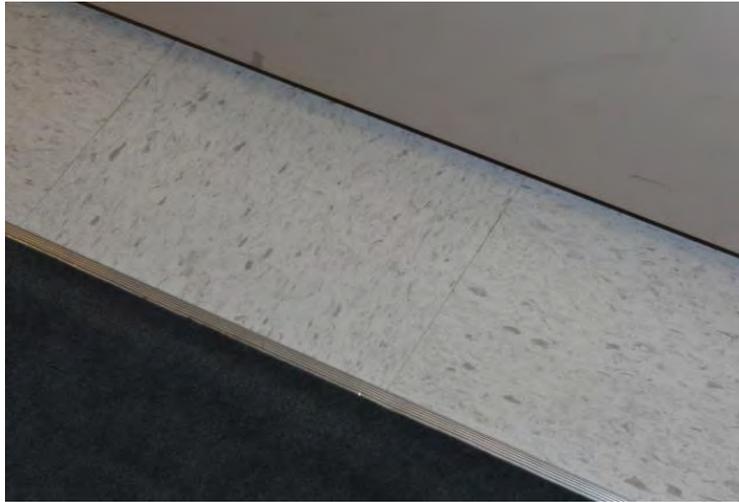
Sample 132  
Floor tile  
Floor 7

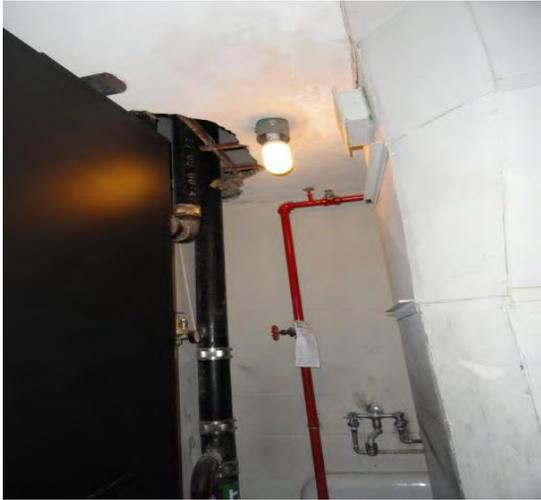
Sample 130  
Ceiling tile  
Floor 8

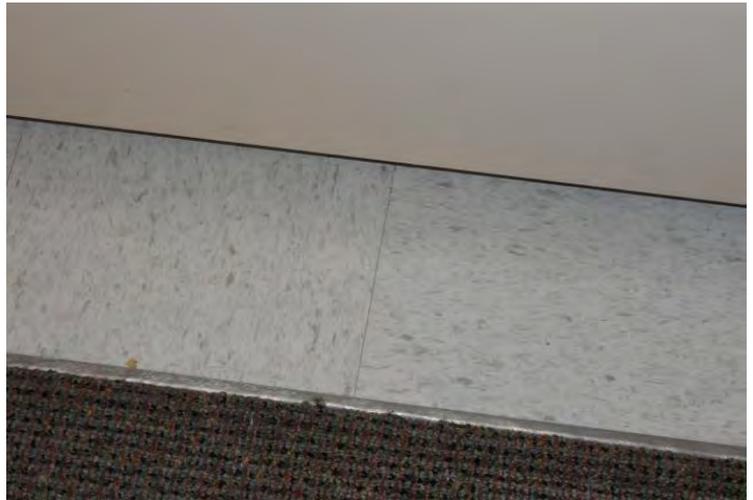
Sample 131  
Floor tile  
Floor 8

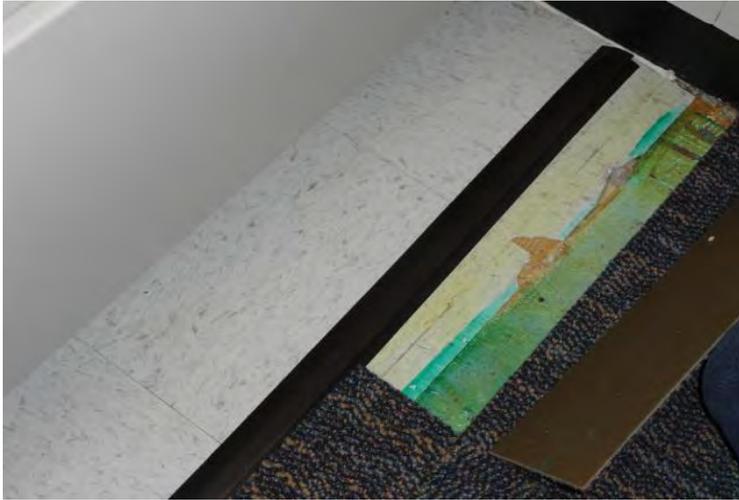
Sample 128  
Floor tile  
Floor 9

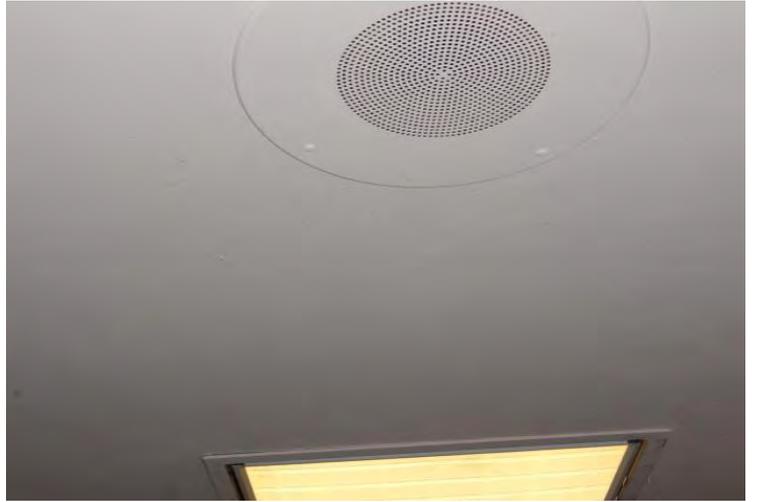
Sample 129  
Ceiling texture  
Floor 9

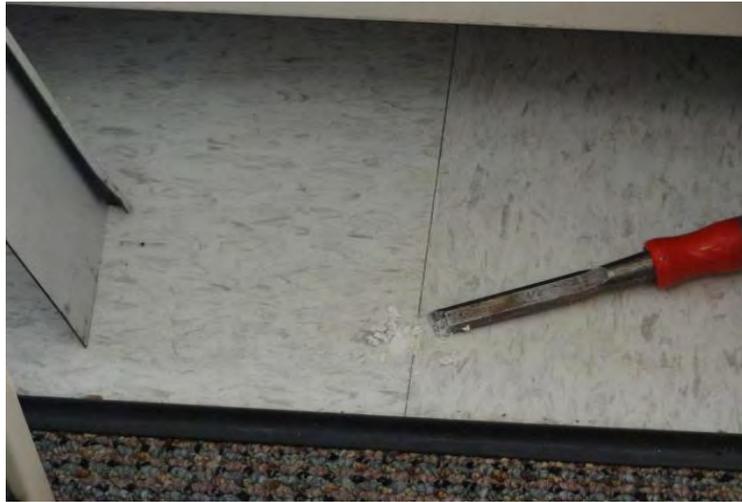
Sample 127  
Floor tile  
Floor 10

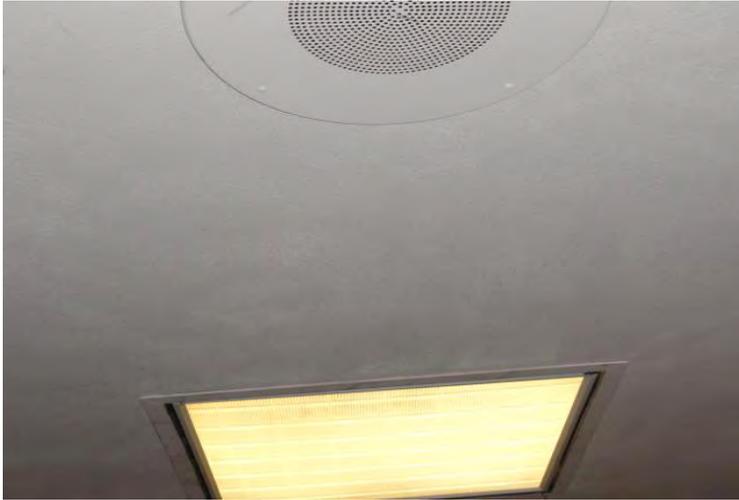
Sample 125  
Ceiling plaster  
Floor 11

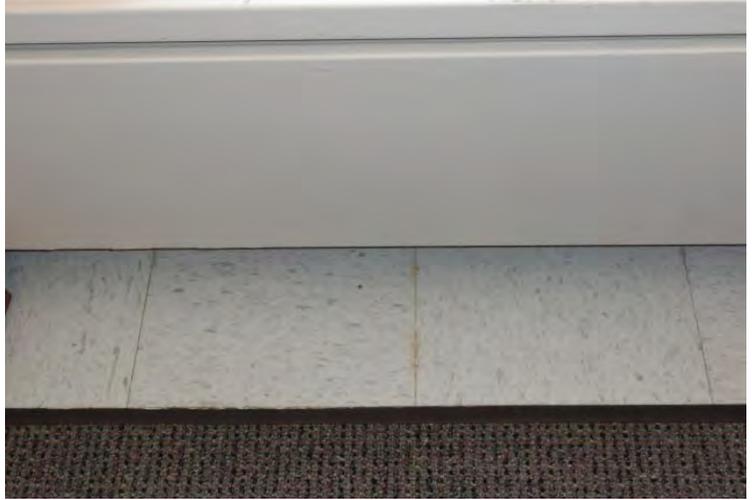
Sample 126  
Floor tile  
Floor 11

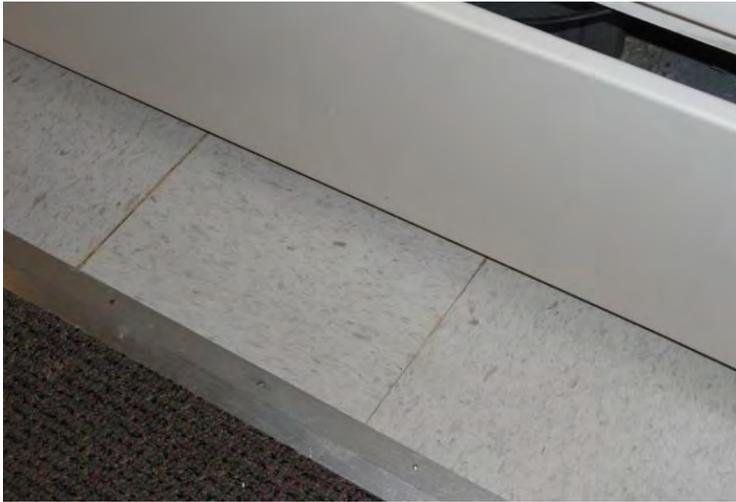
Sample 124  
Floor tile  
Floor 12

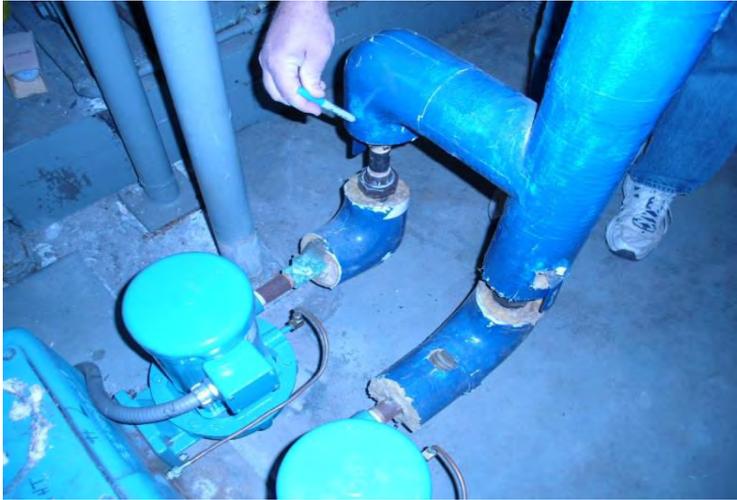
Sample 11  
Elbow pipe insulation  
Floor 13A

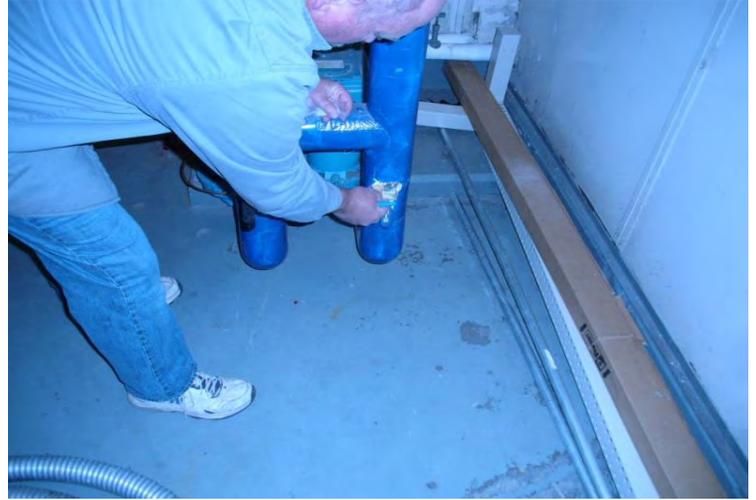
Sample 12  
Pipe wrap  
Floor13A

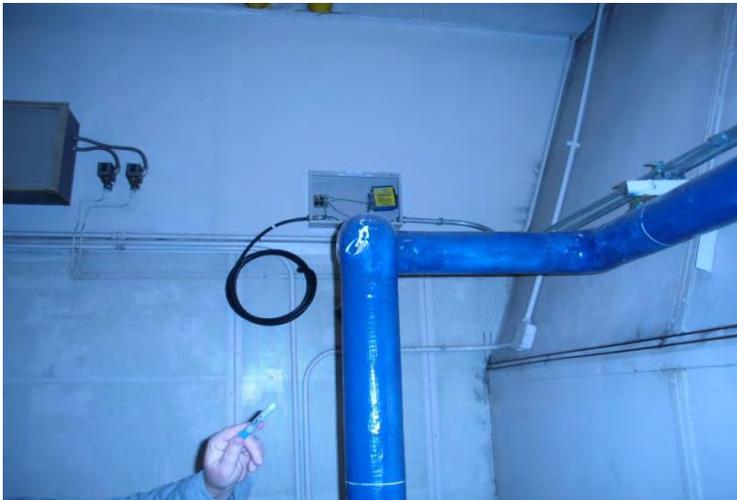
Sample 13  
Elbow insulation  
Floor 13A

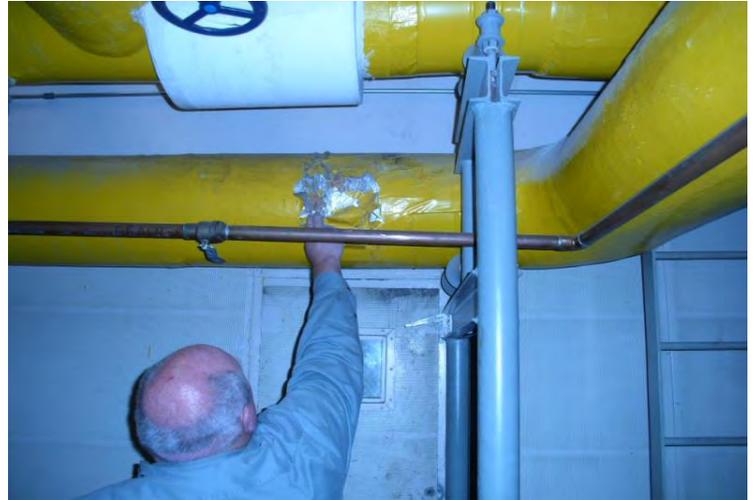
Sample 14  
Pipe wrap  
Floor 13A

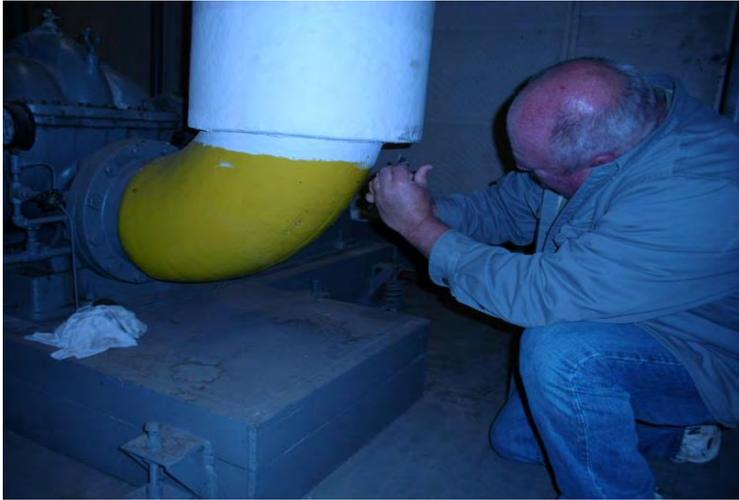
Sample 15  
Pipe wrap  
Floor 13A

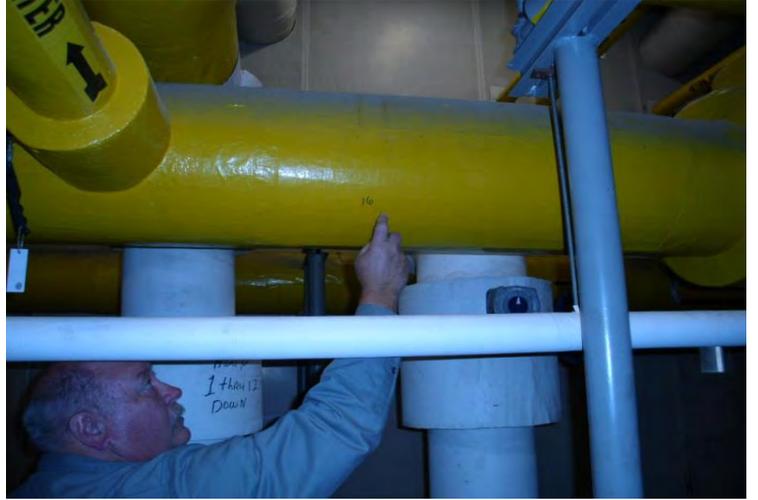
Sample 16  
Pipe wrap  
Floor 13A

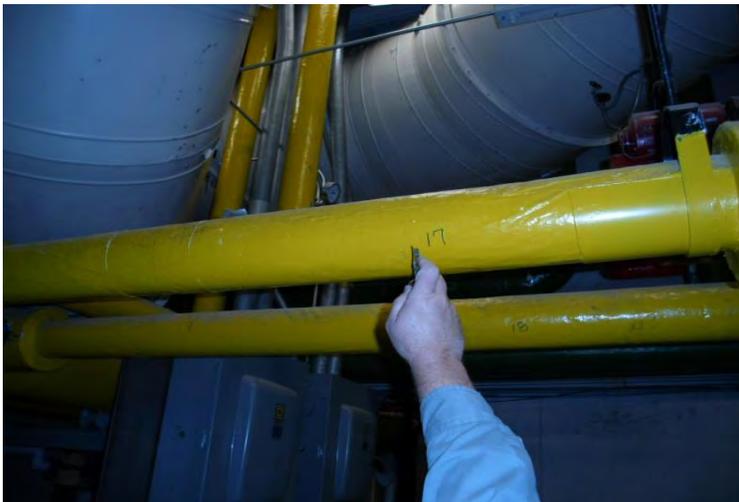
Sample 17  
Pipe wrap  
Floor 13A

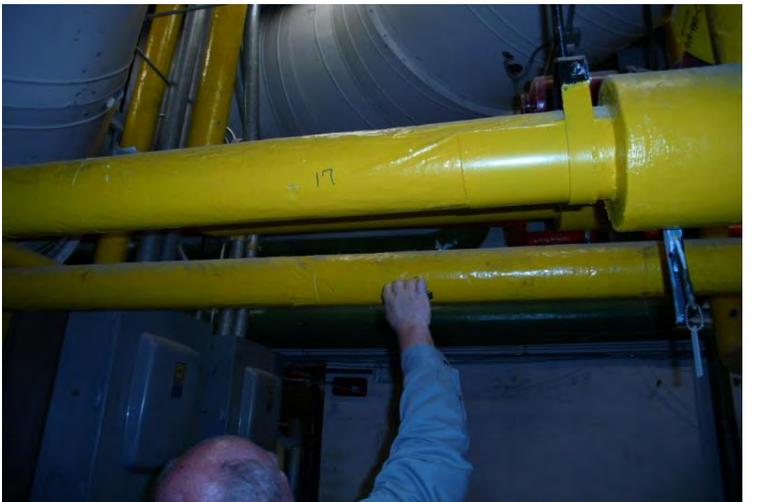
Sample 18  
Pipe wrap  
Floor 13A

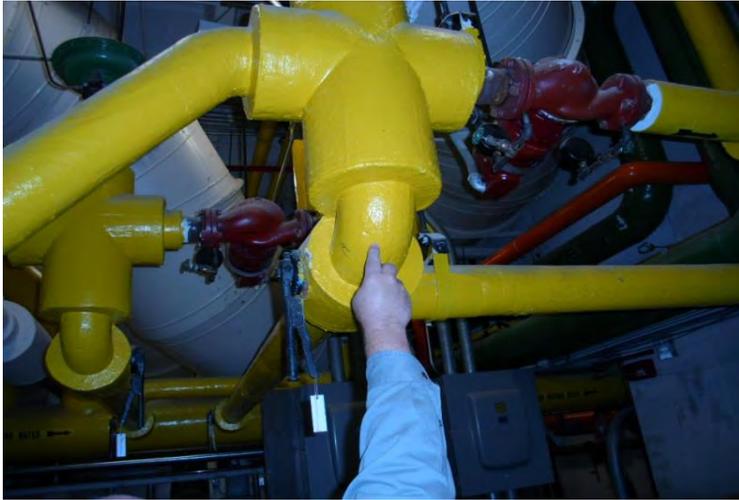
Sample 19  
Elbow  
Floor 13A
