# **Asbestos Containing Materials Inspection**

**Capital Plaza Office Tower  
500 Mero Street  
Frankfort, Kentucky**

RE: Asbestos Inspection  
Capital Plaza Office Tower  
500 Mero Street  
Frankfort, KY 40601

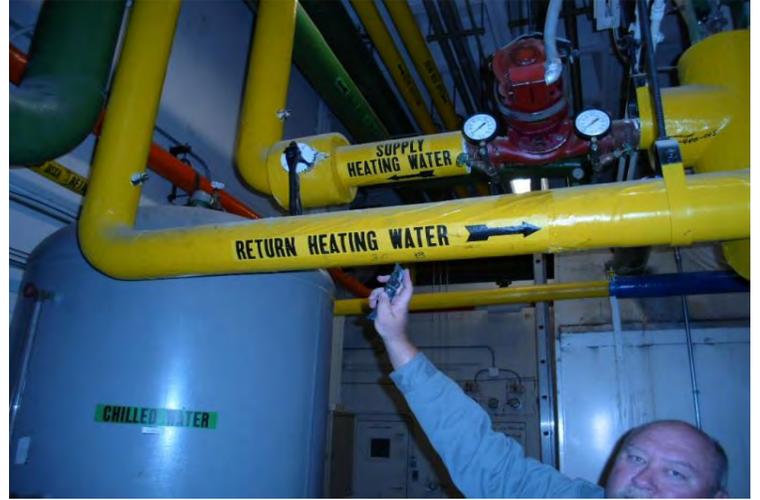
Sample 20  
Pipe wrap  
Floor 13A

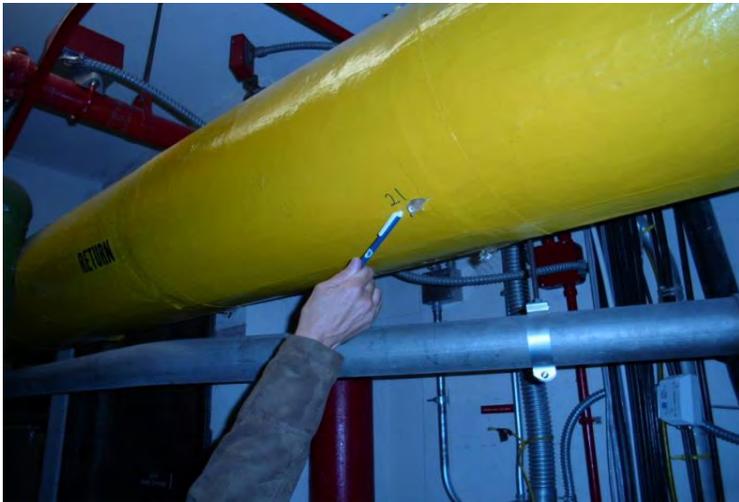
Sample 21  
Pipe wrap  
Floor 13A

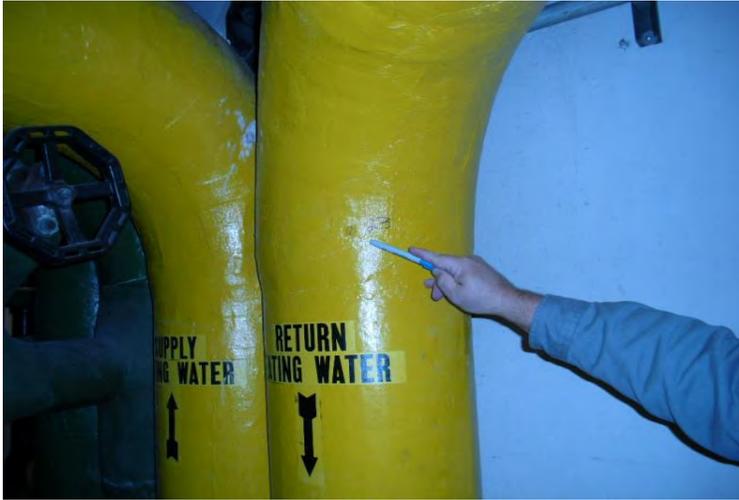
Sample 23  
Elbow  
Floor 13A

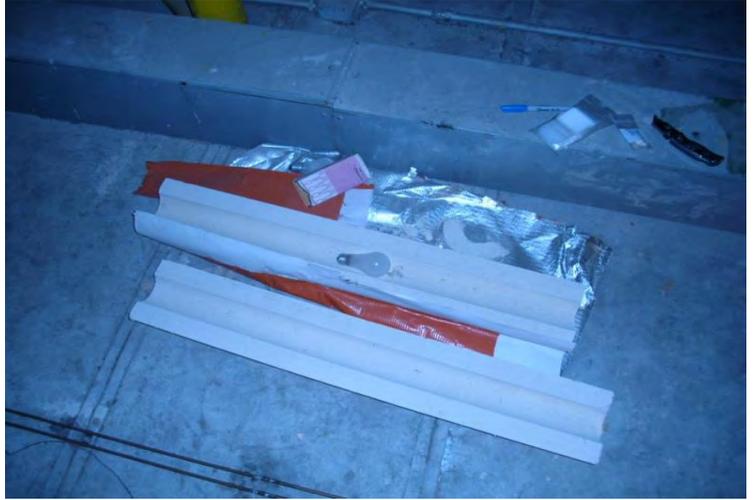
Sample 24  
Debris - laying on top of unit  
Floor 13A

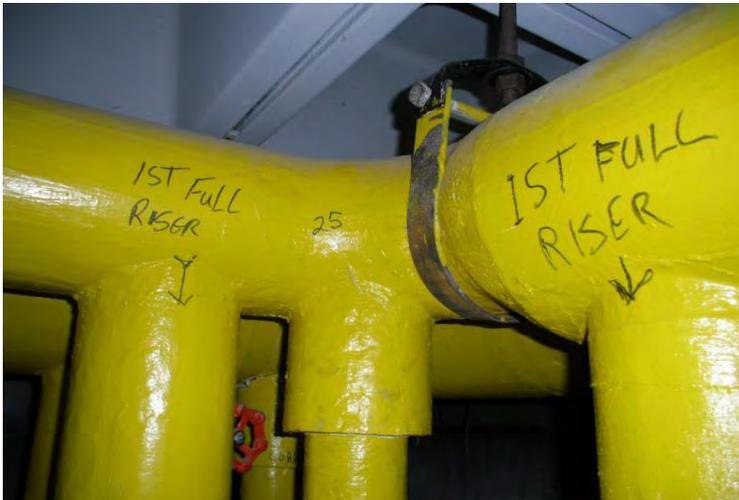
Sample 25  
Joint  
Floor 13A

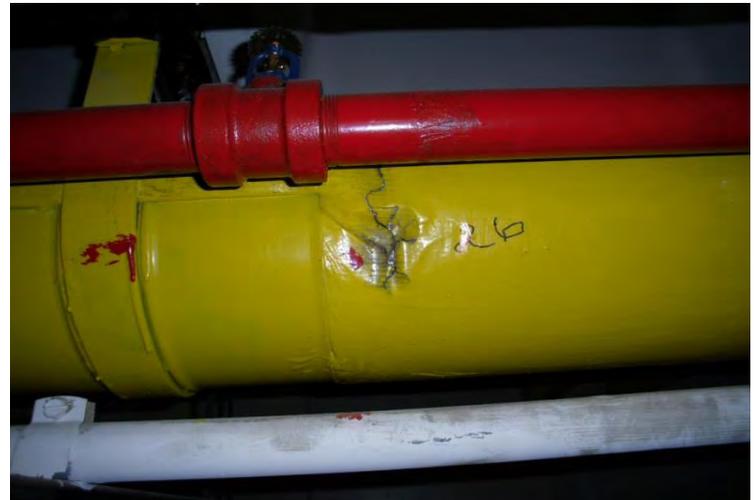
Sample 26  
Pipe wrap  
Floor 13A

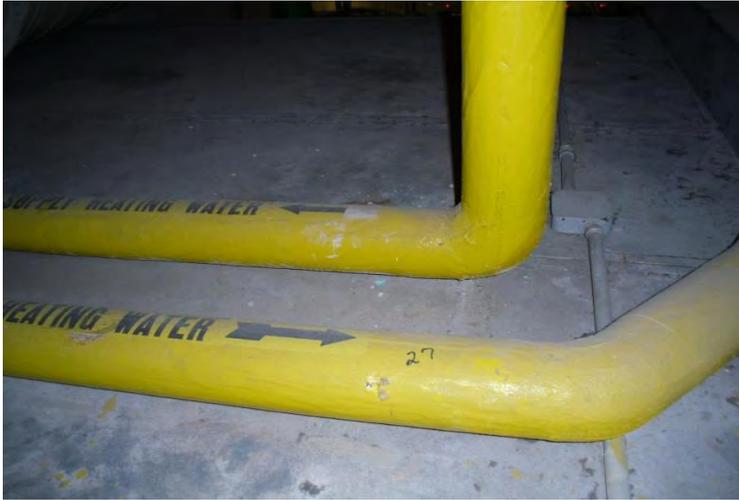
Sample 27  
Pipe wrap  
Floor 13A

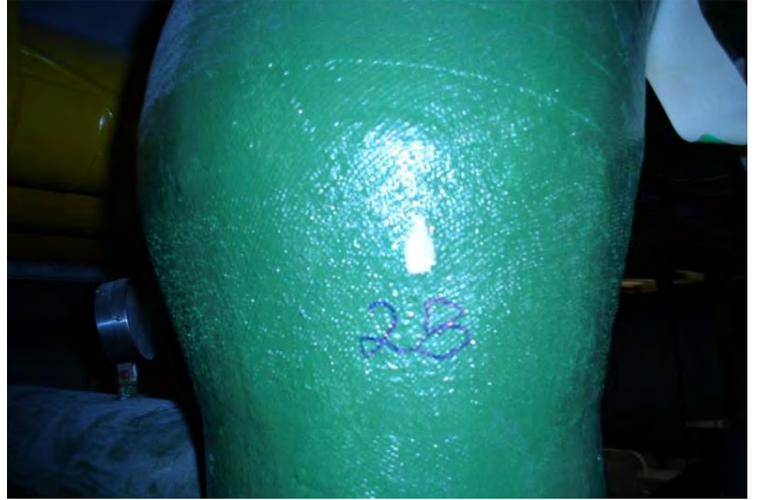
Sample 28  
Joint/elbow  
Floor 13A

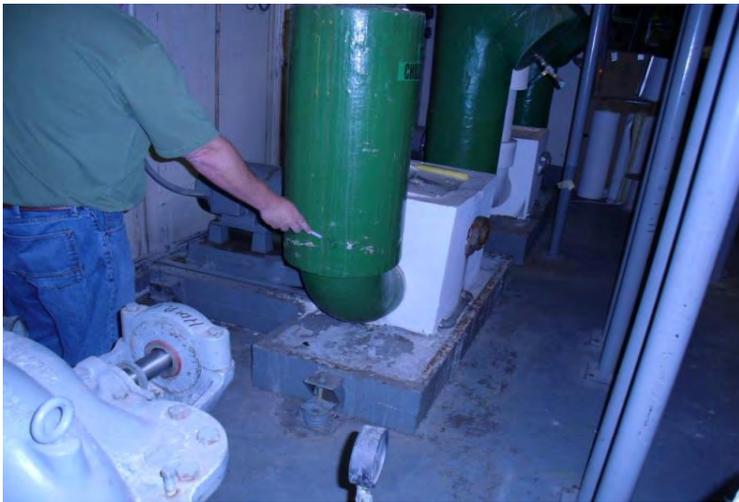
Sample 29  
Pipe wrap  
Floor 13A

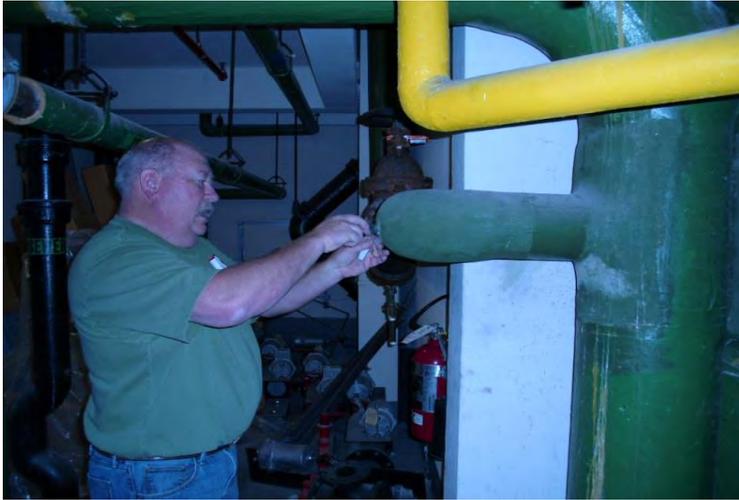
Sample 31  
Pipe wrap  
Floor 13A

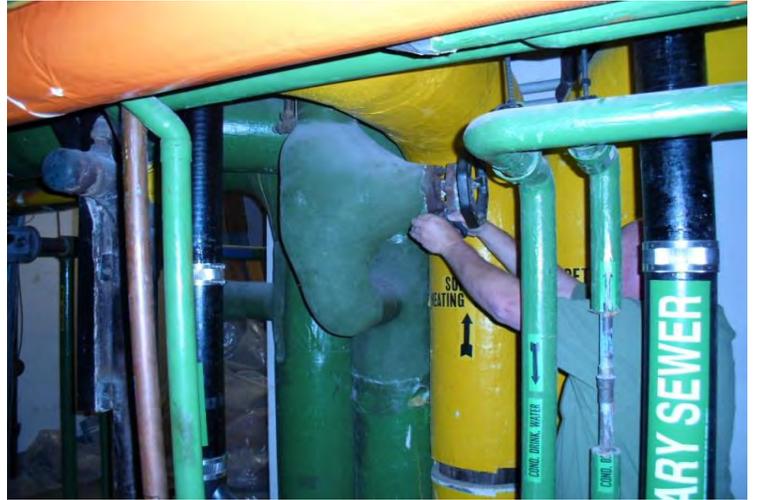
Sample 32  
Valve  
Floor 13A

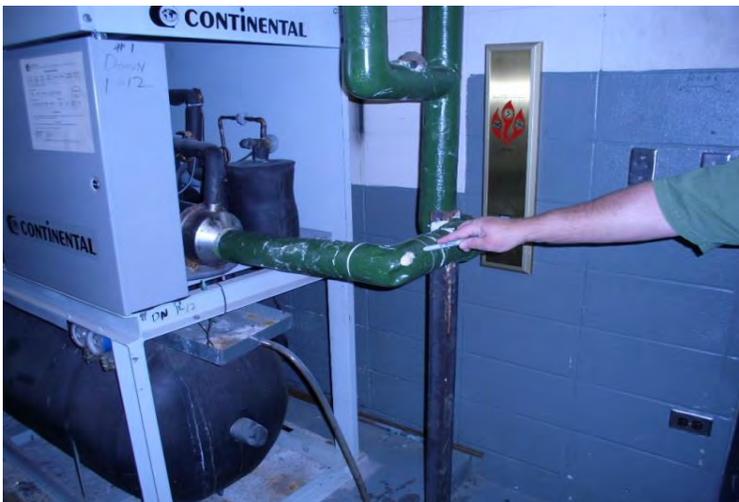
Sample 33  
Elbow  
Floor 13A

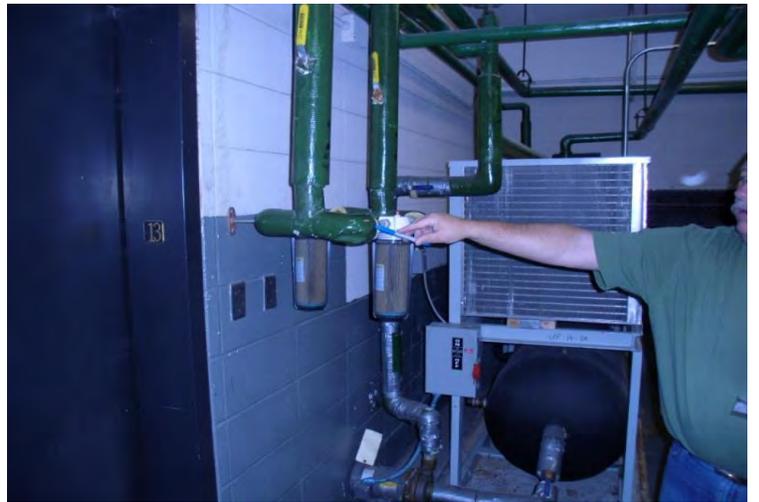
Sample 34  
Joint  
Floor 13A

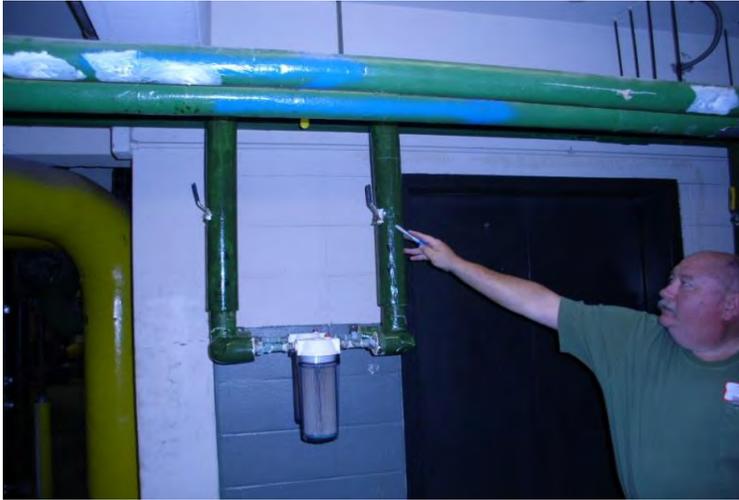
Sample 35  
Pipe wrap  
Floor 13A

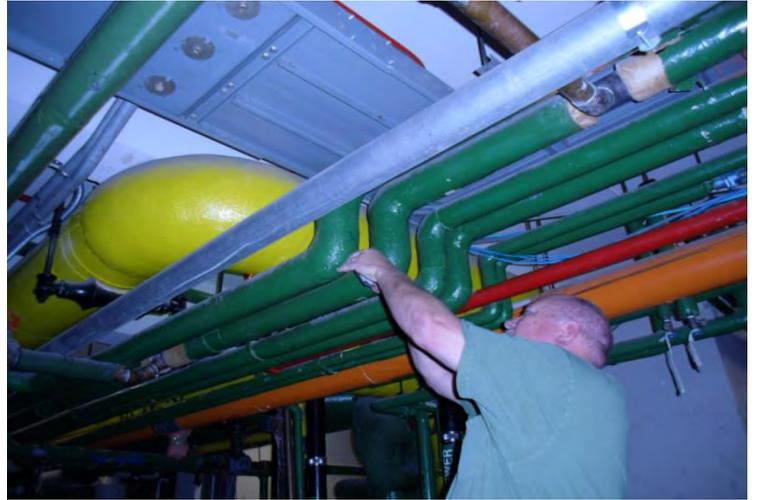
Sample 36  
Elbow  
Floor 13A

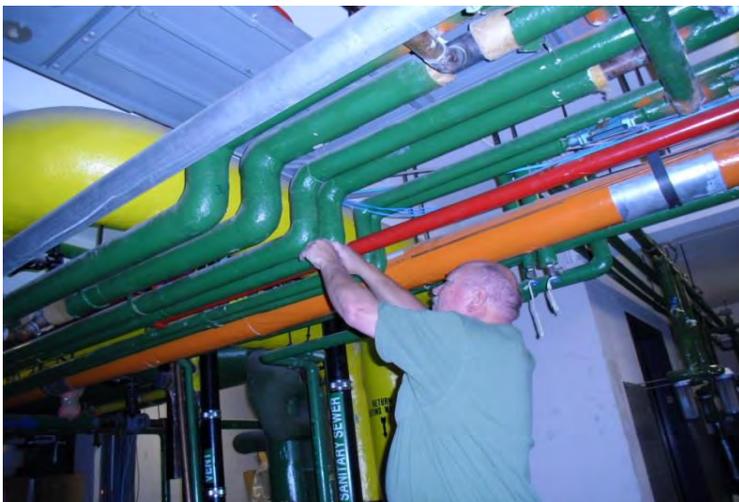
Sample 37  
Elbow  
Floor 13A

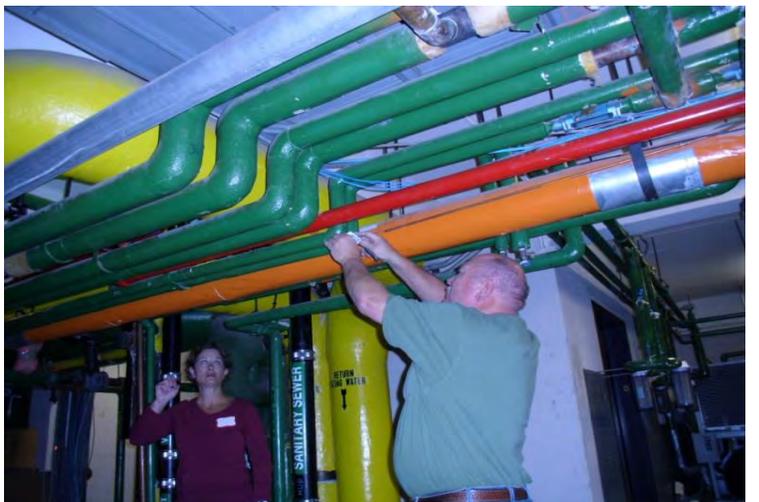
Sample 38  
Elbow  
Floor 13A

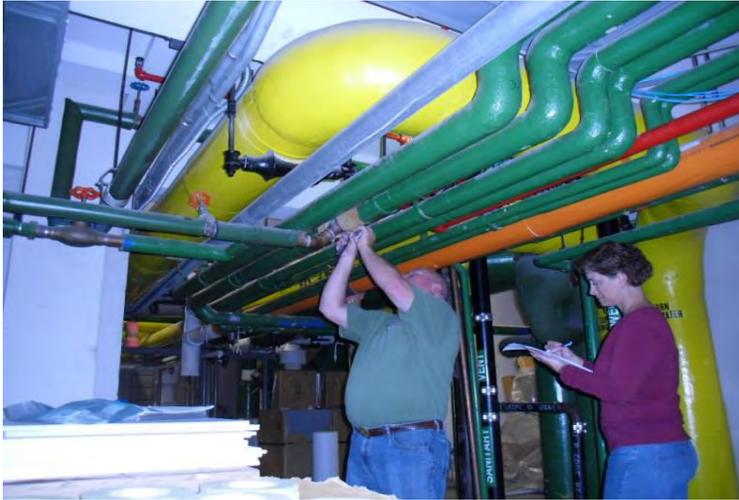
Sample 39  
Pipe insulation  
Floor 13A

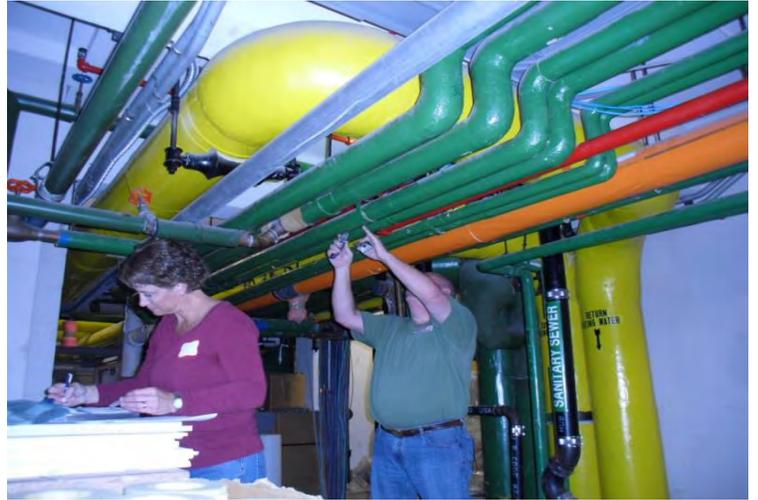
Sample 40  
Pipe wrap  
Floor 13A

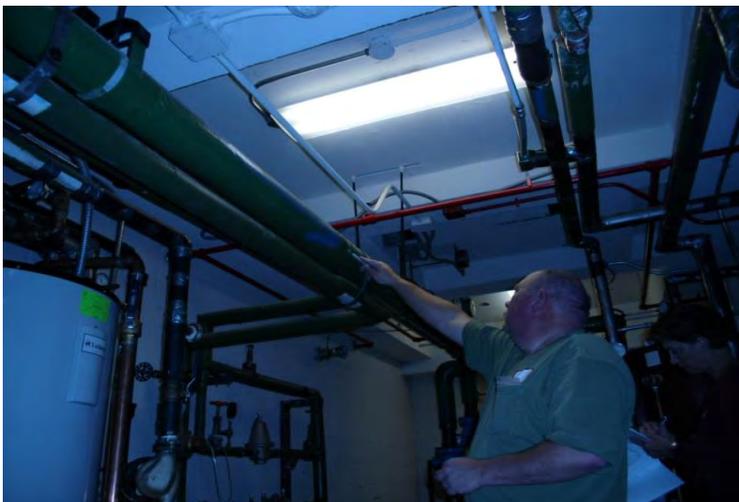
Sample 41  
Pipe wrap  
Floor 13A

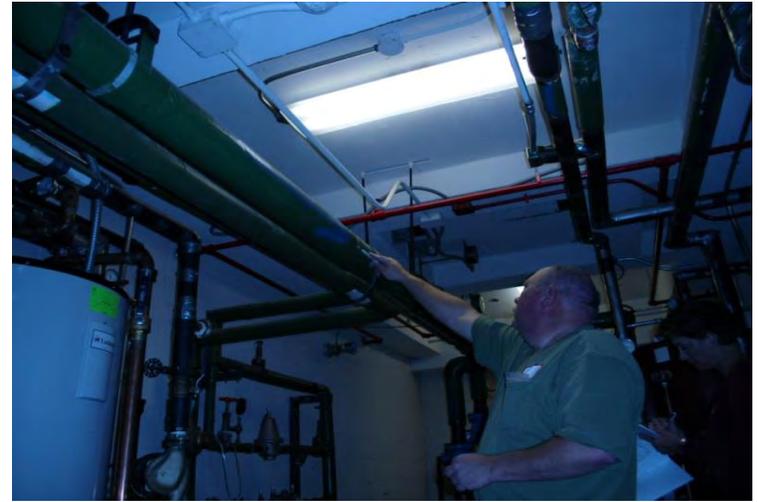
Sample 42  
Pipe wrap  
Floor 13A

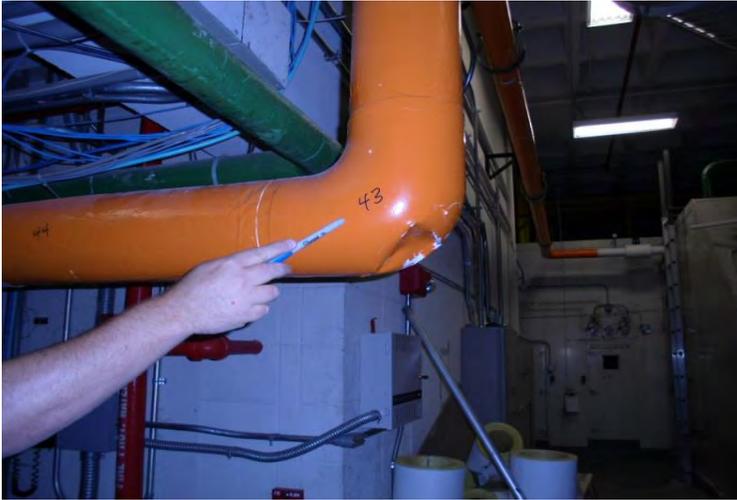
Sample 43  
Elbow  
Floor 13A

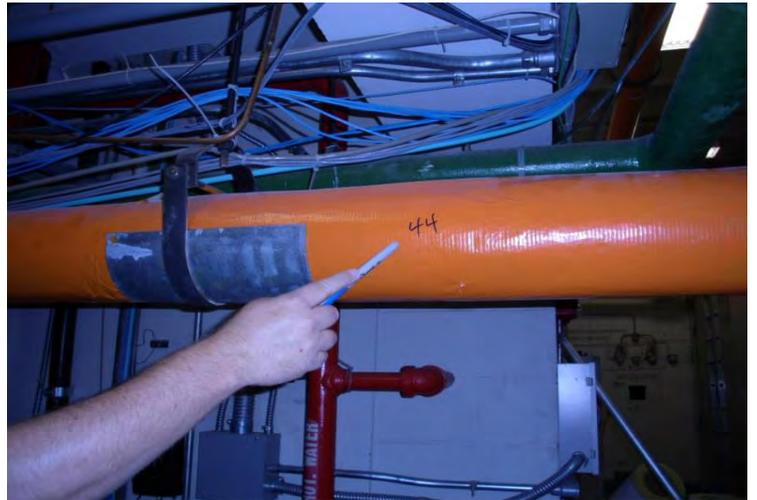
Sample 44  
Pipe wrap  
Floor 13A

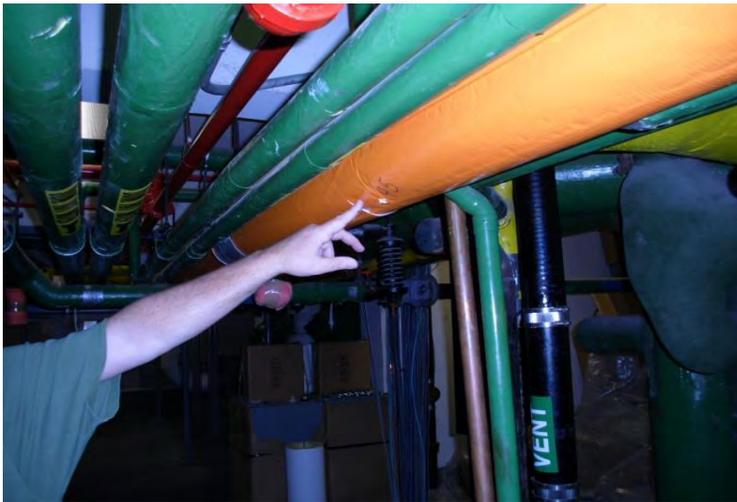
Sample 45  
Pipe wrap  
Floor 13A

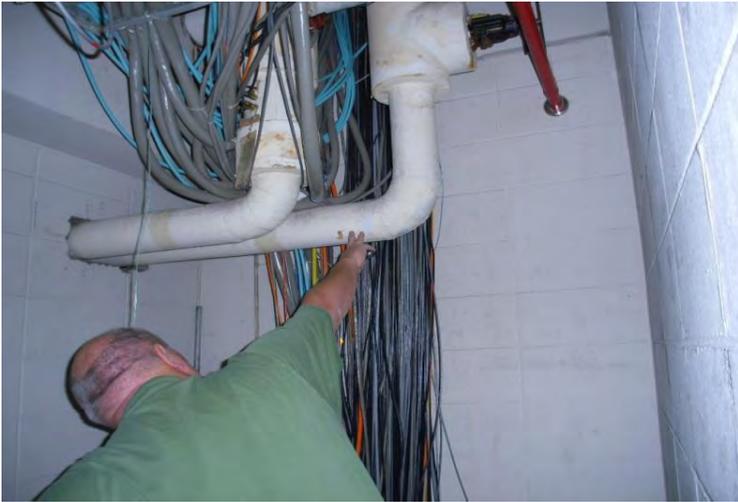
Sample 47  
Pipe wrap  
Floor 13A

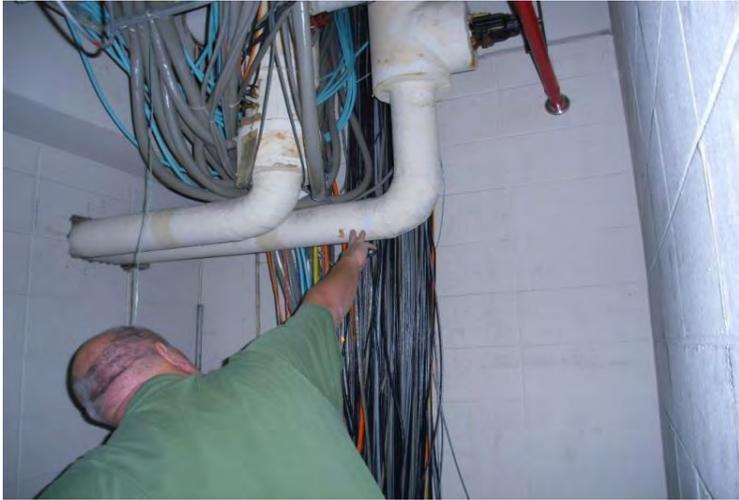
Sample 48  
Pipe wrap  
Floor 13B

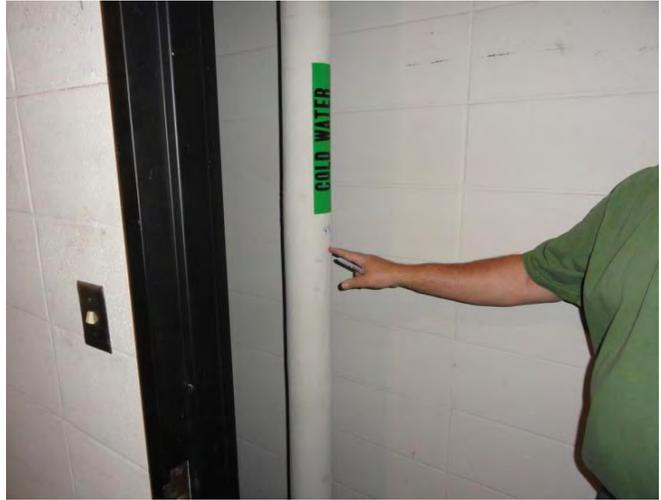
Sample 49  
Pipe Wrap  
Floor 13B

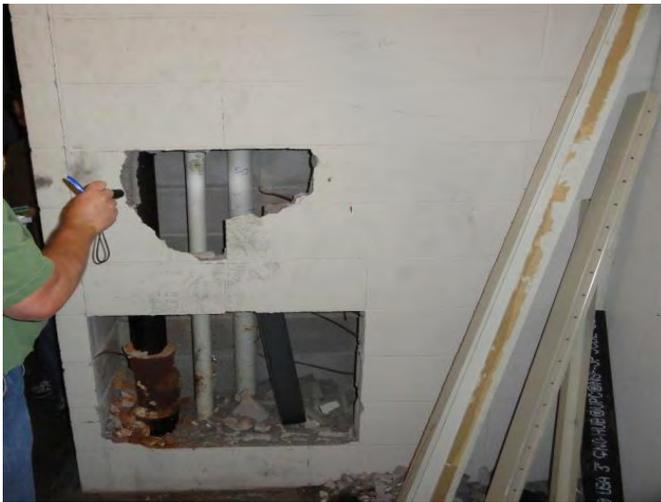
Sample 50  
Pipe Wrap  
Floor 13B

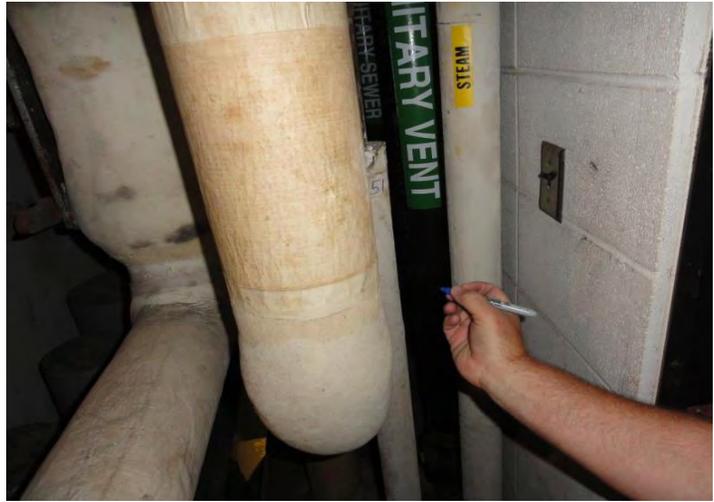
Sample 51  
Pipe Wrap  
Floor 13B

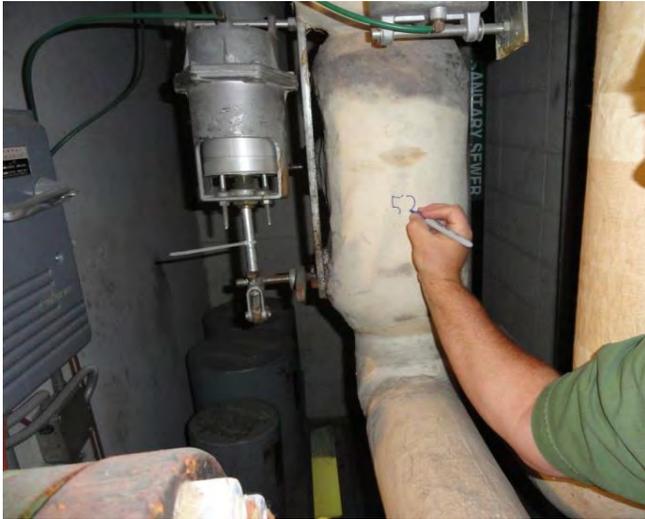
Sample 52  
Pipe Wrap  
Floor 13B

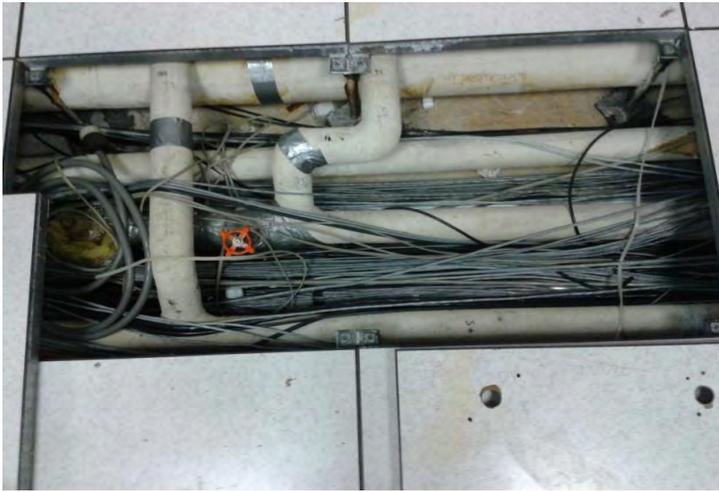
Photo 1  
Pipes under floor tile  
Fourteenth Floor

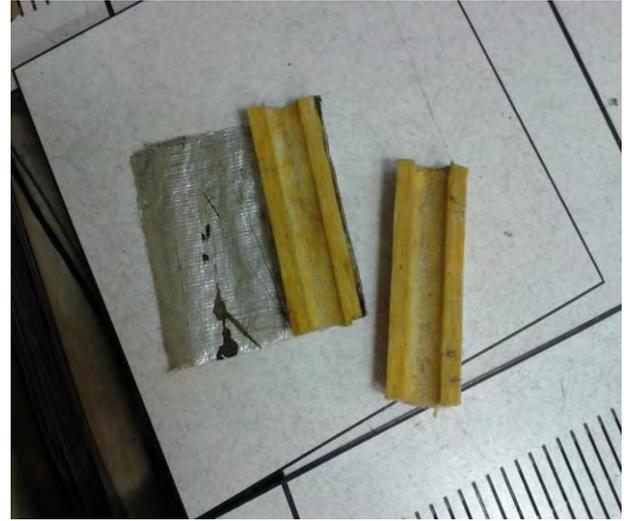
Photo 2  
Insulation foil and pipe insulation  
Fourteenth Floor

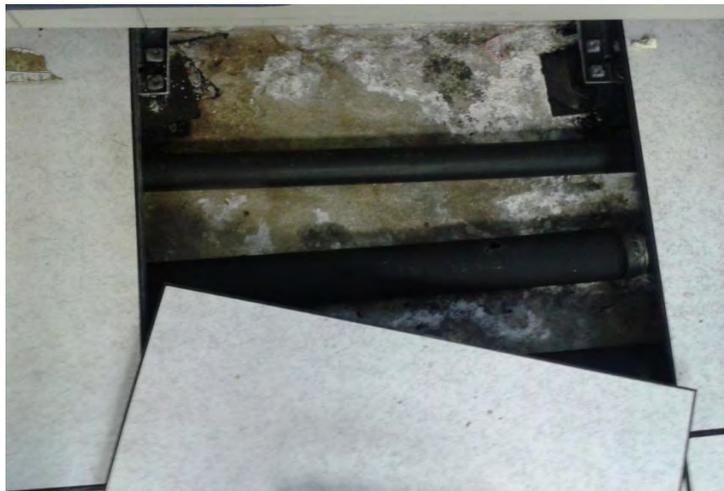
Photo 3  
Black foam insulation  
Fourteenth Floor

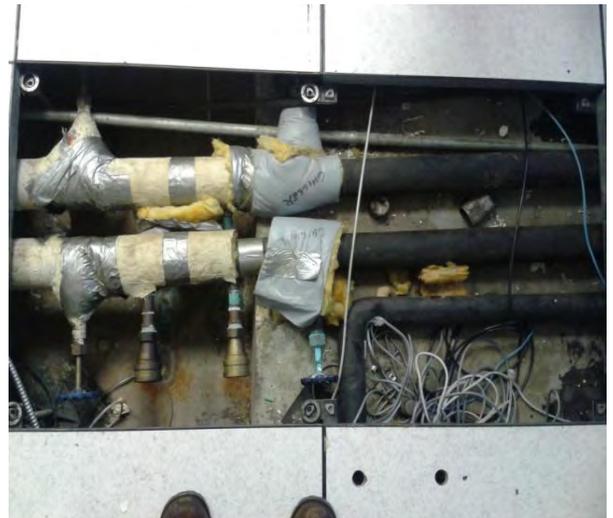
Photo 4  
Joint compound  
Fourteenth Floor

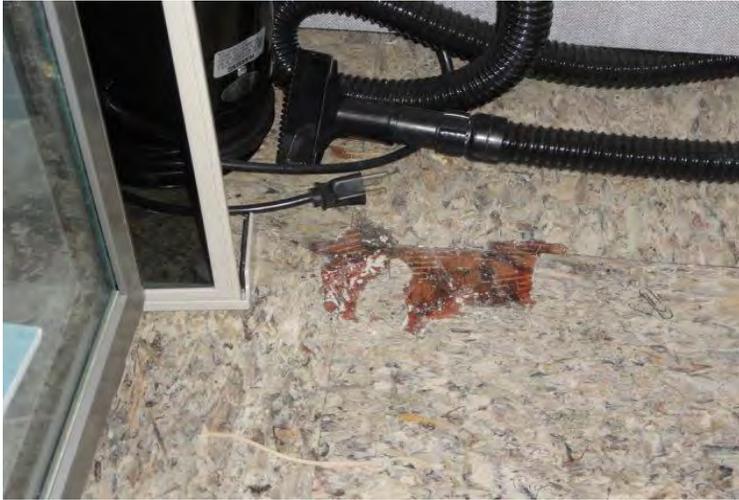
Sample 121  
Floor tile  
Floor 15

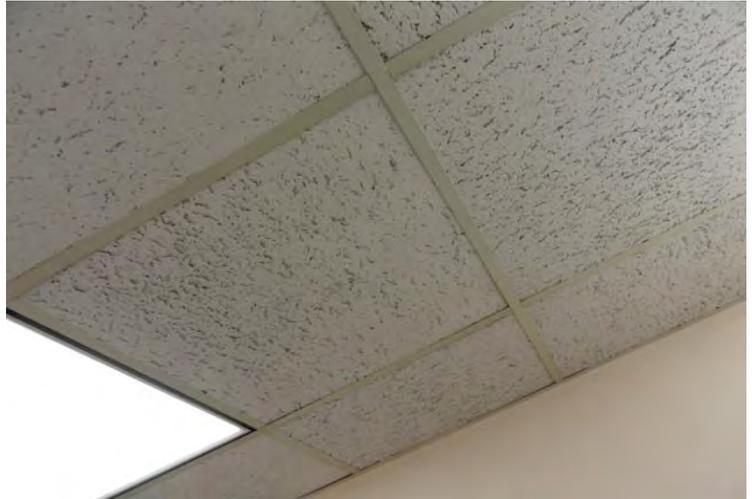
Sample 122  
Ceiling tile  
Floor 15

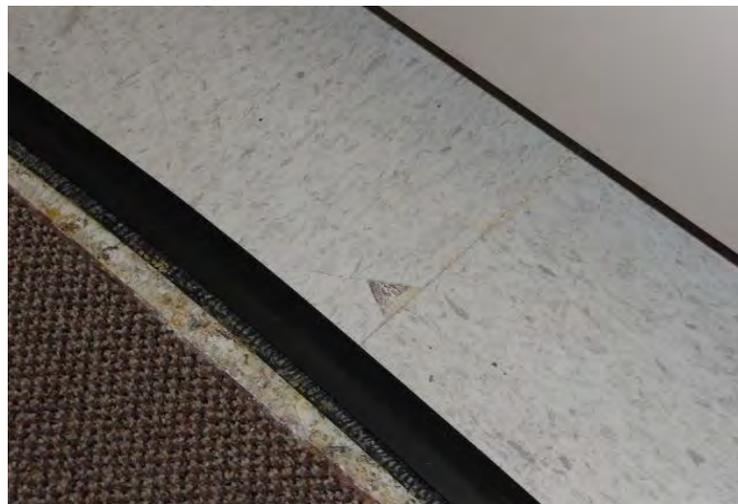
Sample 123  
Floor tile  
Floor 15

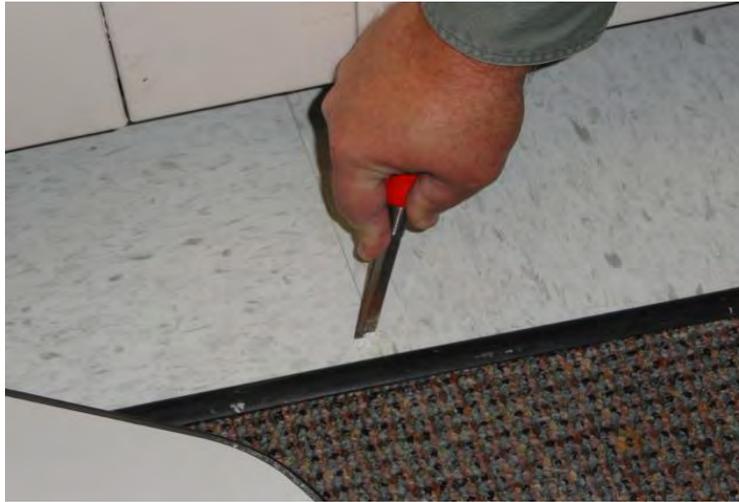
Sample 120  
Floor tile  
Floor 16

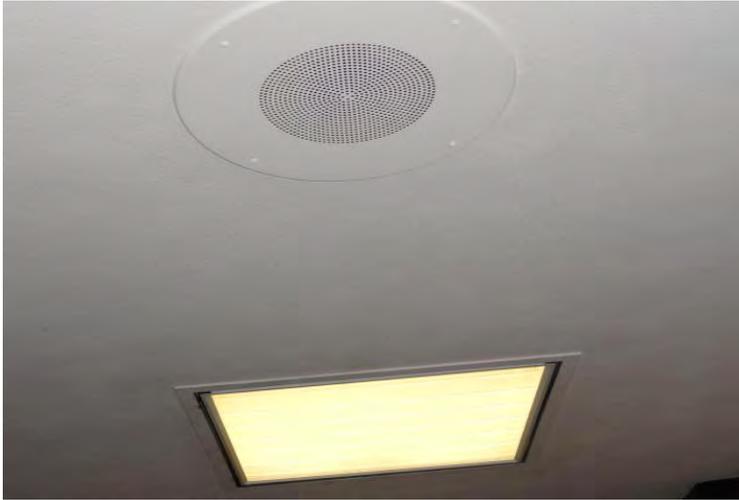
Sample 118  
Ceiling tile  
Floor 17

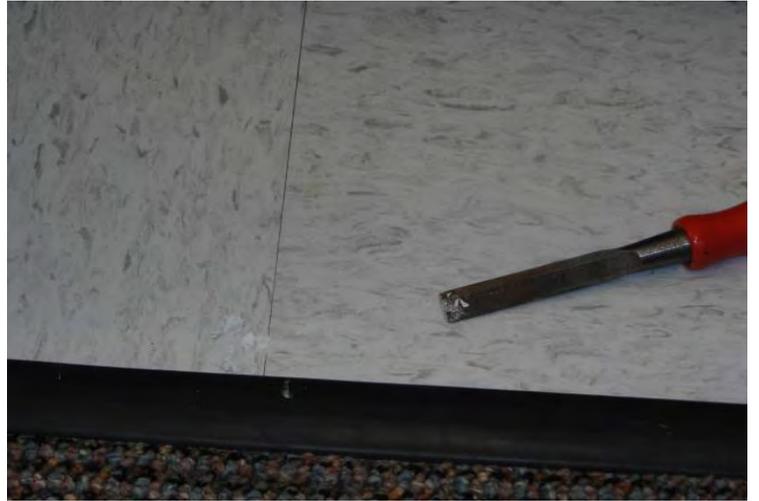
Sample 119  
Floor tile  
Floor 17

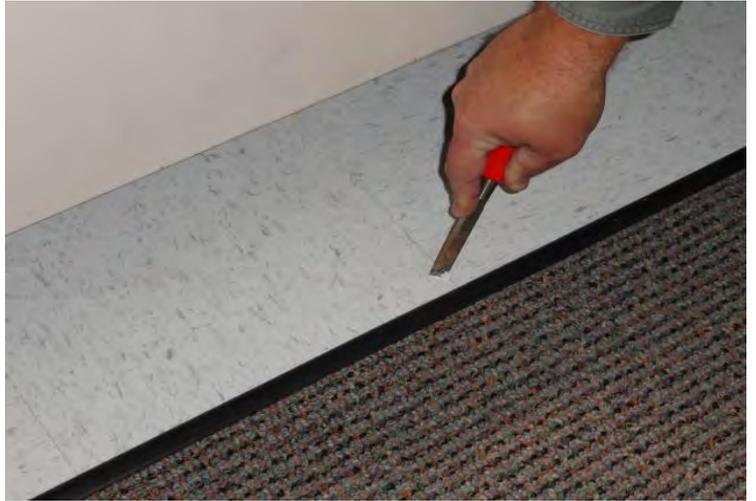
Sample 117  
Floor tile  
Floor 18

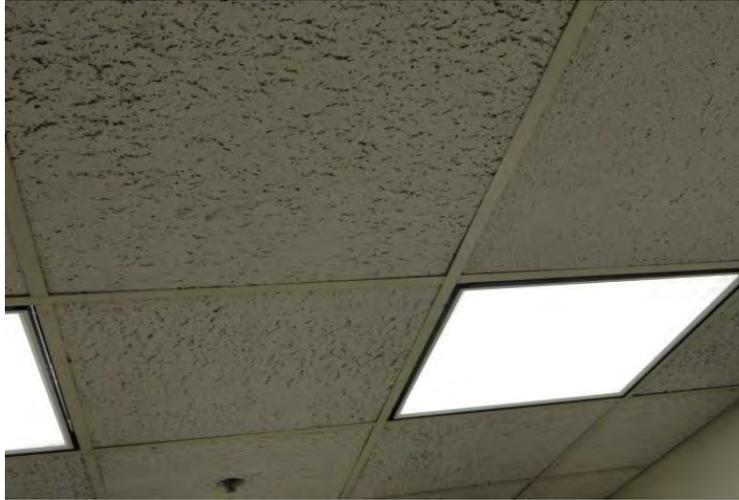
Sample 115  
Ceiling tile  
Floor 19

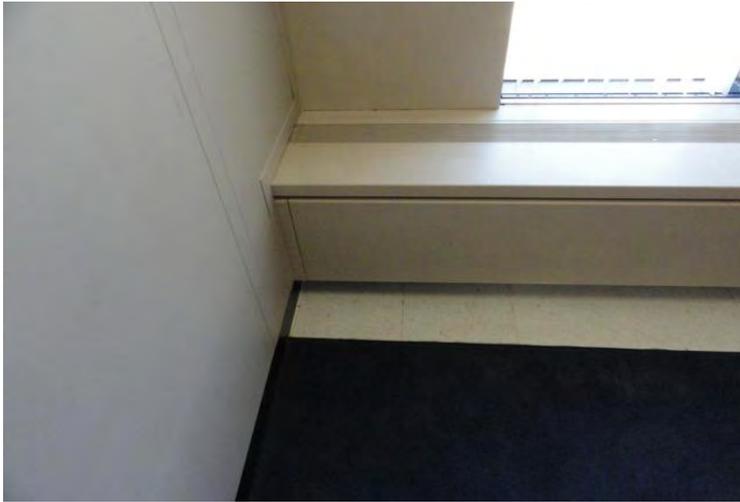
Sample 114  
Floor tile  
Floor 20

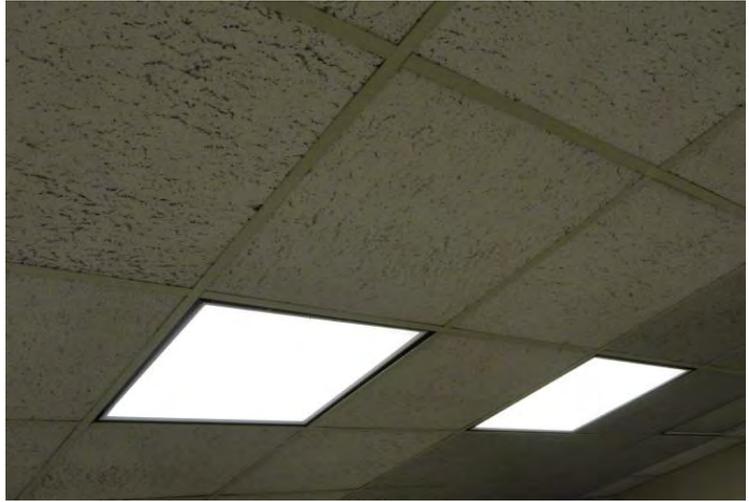
Sample 112  
Ceiling tile  
Floor 21

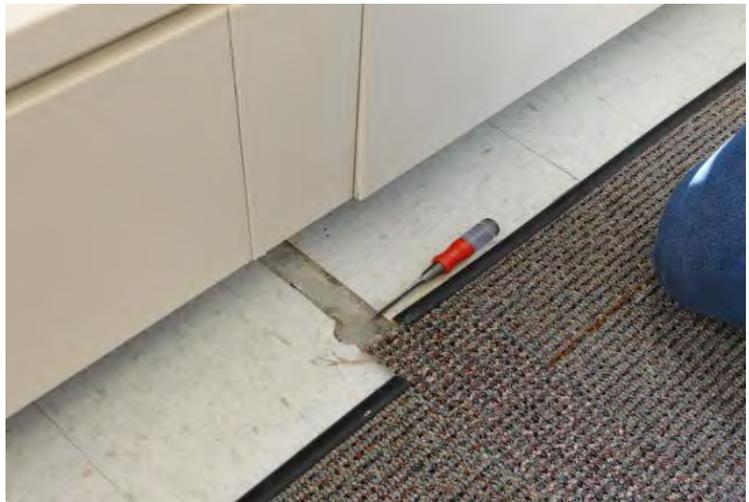
Sample 113  
Floor tile  
Floor 21

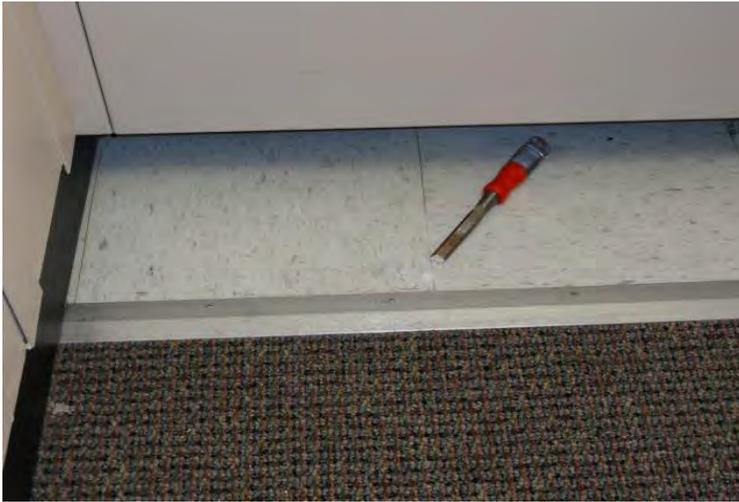
Sample 110  
Floor tile  
Floor 22

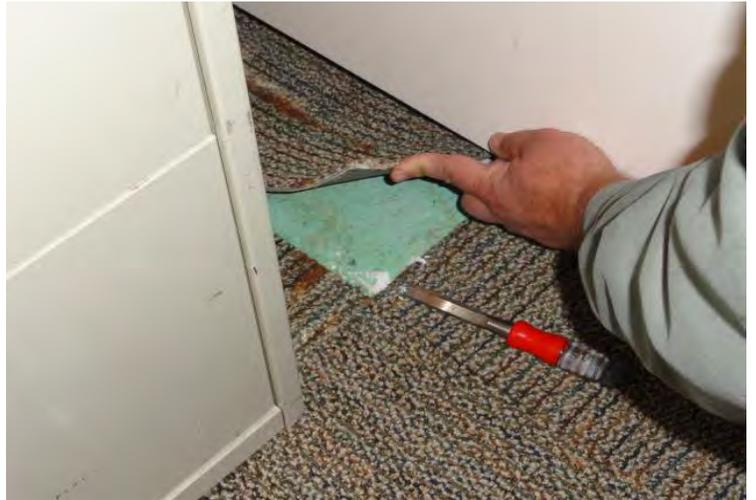
Sample 109  
Floor tile  
Floor 23

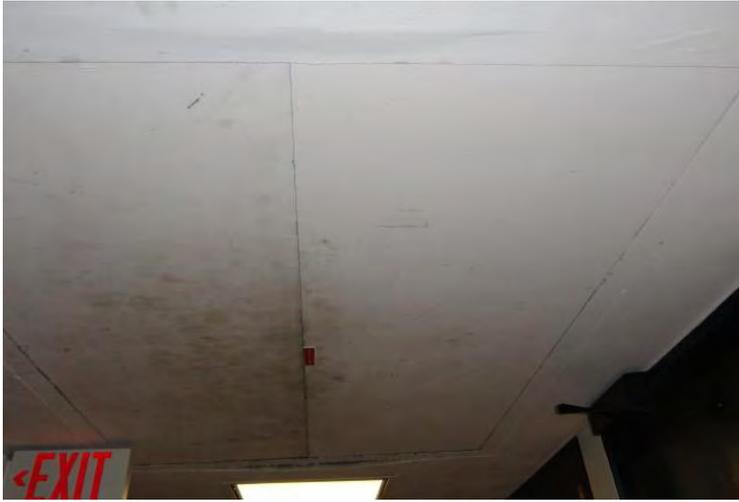
Sample 106  
Ceiling plaster  
Floor 24

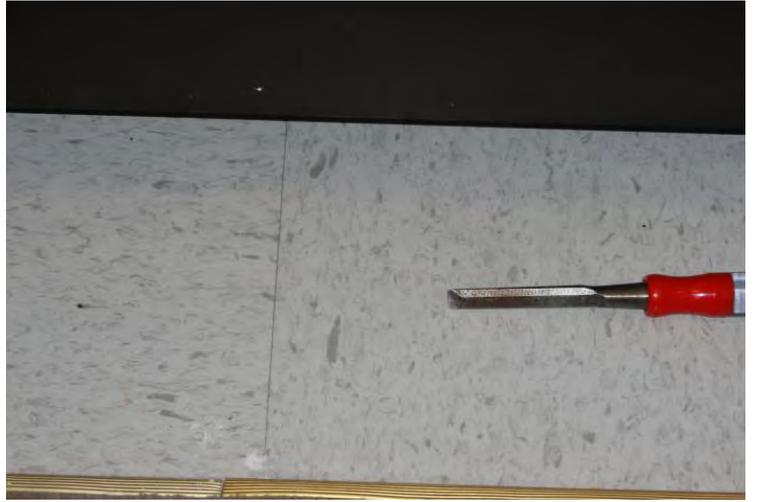
Sample 107  
Floor tile  
Floor 24

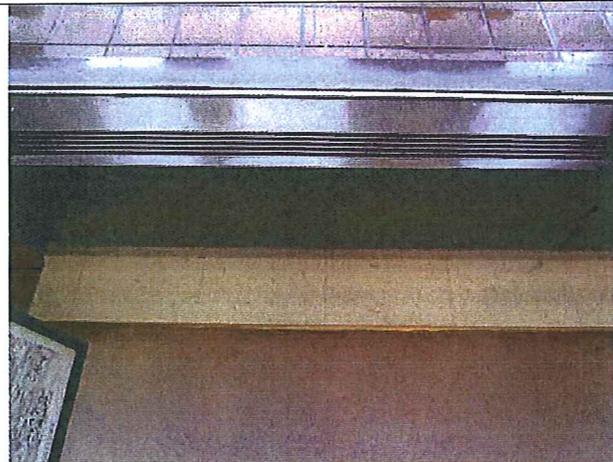
Photograph #1: Sample CT-24-1: 12" Floor Tile (white).

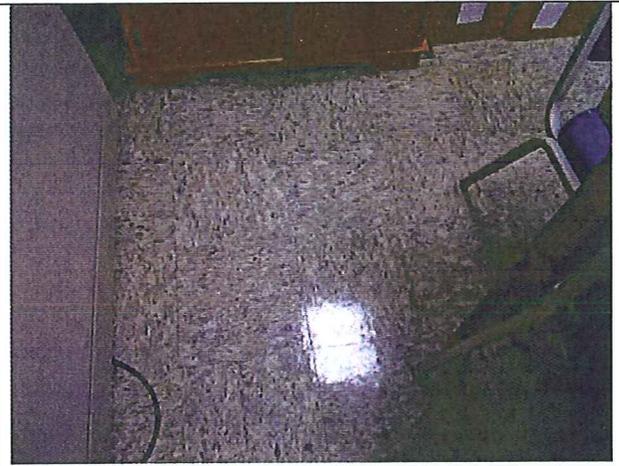
Photograph #4: Sample CT-15-1, CT-15-2 & CT-15-3: 12" Floor Tile (grey).

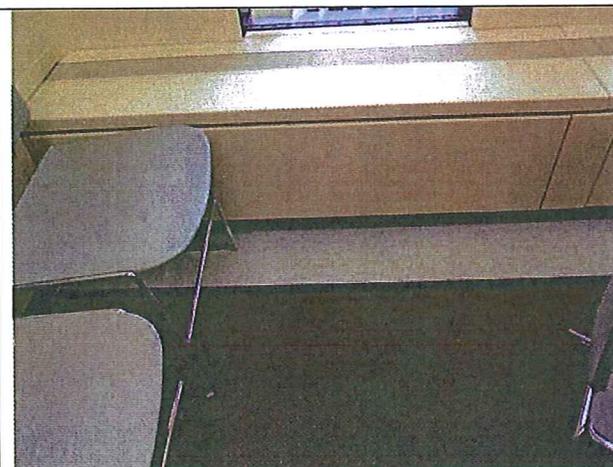
Photograph #5: Sample CT-15-4" 12" Floor Tile (white).

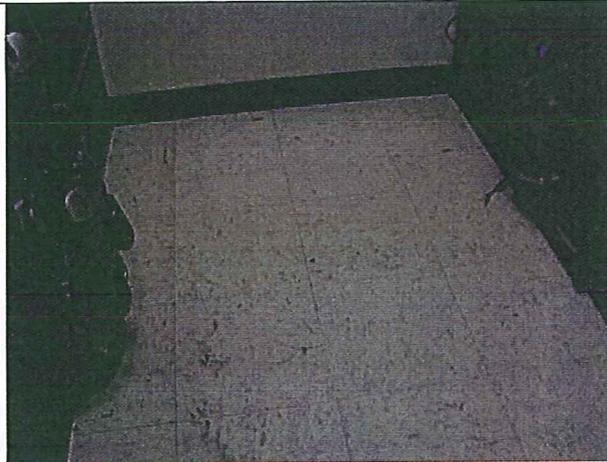
Photograph #7: Sample CT-2 & CT-7: 12" white floor tile with black mastic.

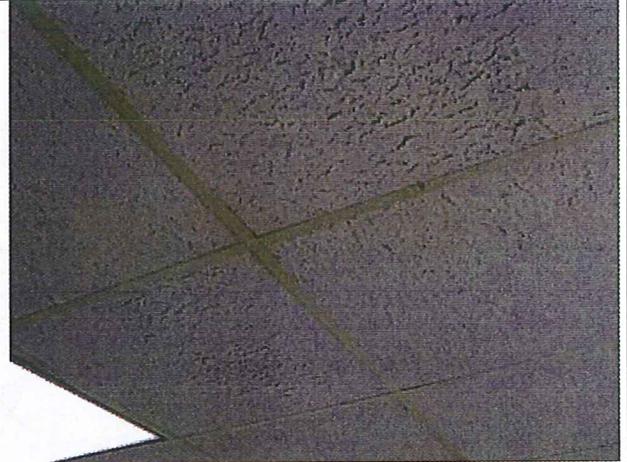
Photograph #8: Sample CT-3 & CT-8: 2'x2' Drop Ceiling Tile.

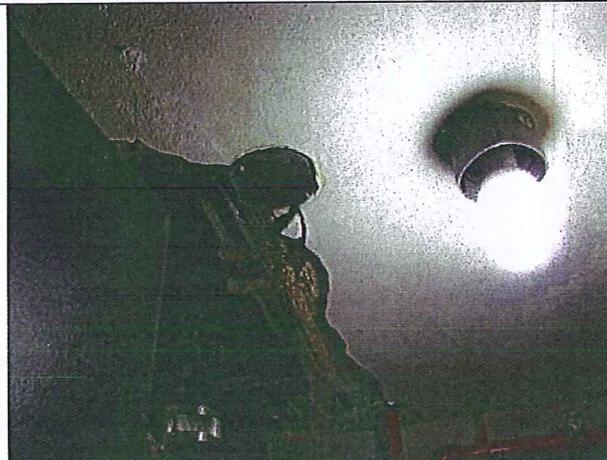
Photograph #9: Sample CT-4 & CT-9: Plaster Ceilings.

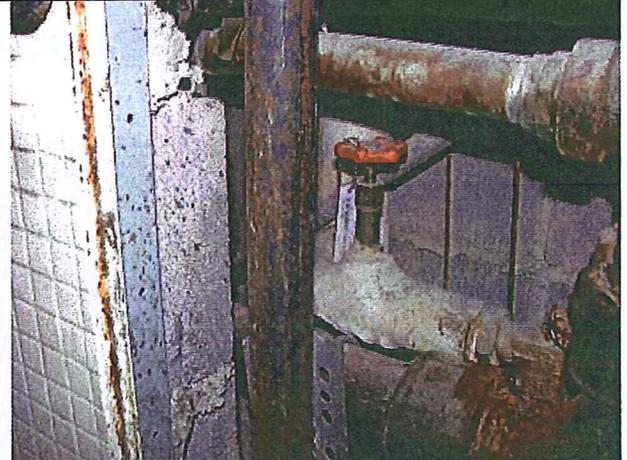
Photograph #10: Sample CT-5: 3" Pipe Joint Compound.

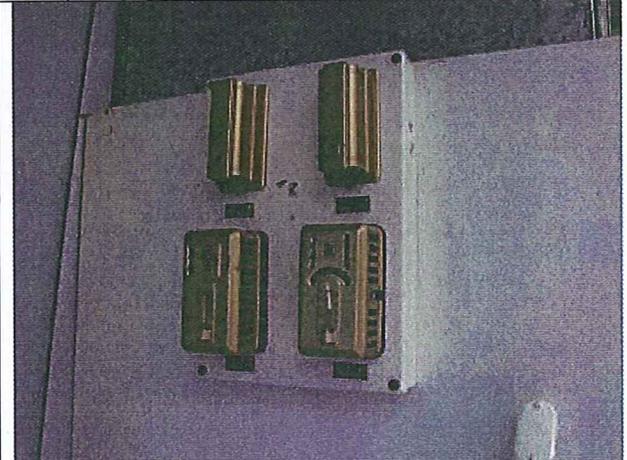
Photograph #12: Mercury containing thermostats located in the server rooms.

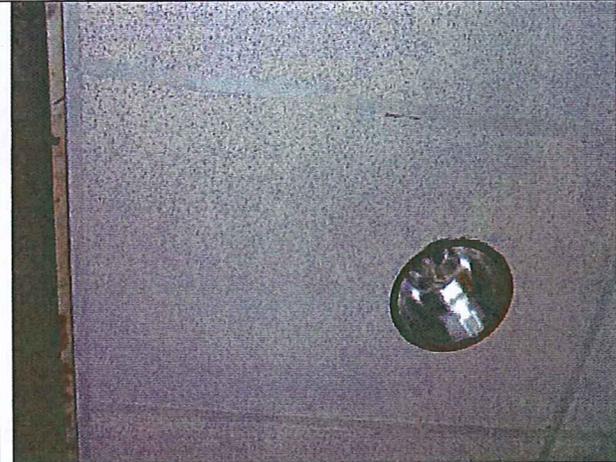
Photograph #18: Sample CT-Mez-1, CT-Mez-2 & CT-Mez-3: 2'x4' Drop Ceiling Tile.

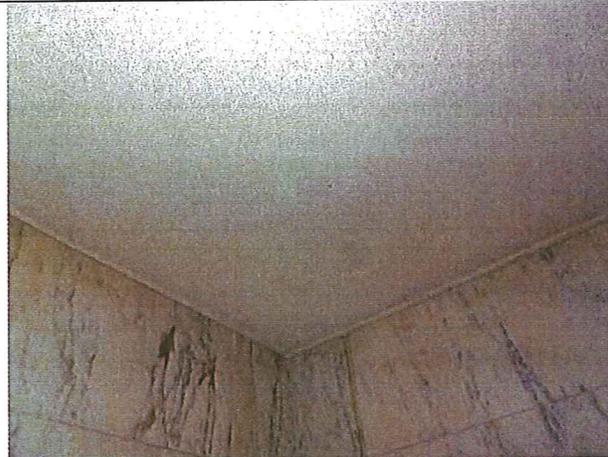
Photograph #19: Sample CT-Mez-4, CT-Mez-5 & CT-Mez-6: Textured Ceiling

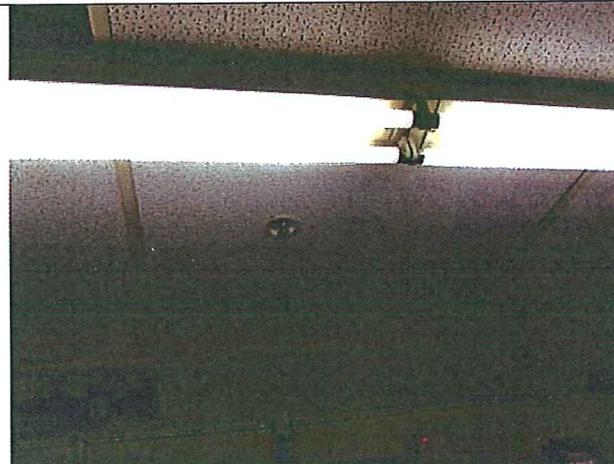
Photograph #21: Sample CT-Mez-8, CT-Mez-9 & CT-Mez-10: '3'x3' Drop Ceiling Tile.

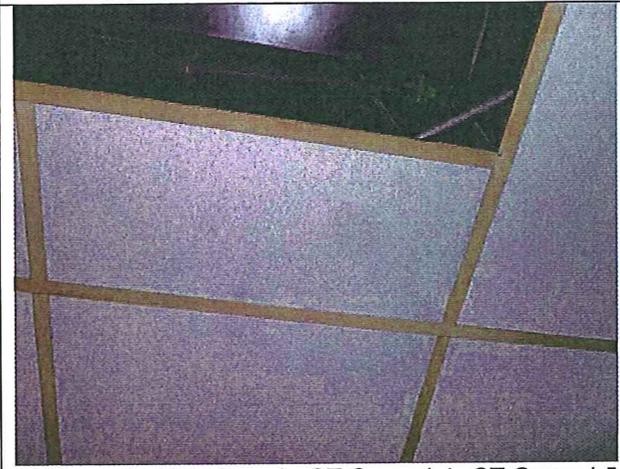
Photograph #24: Sample CT-Ground-4, CT-Ground-5 & CT-Ground-6: 2'x2' Drop Ceiling Tile.
